## FENCE REPAIR AND RESTORATION

FENCE RESTORATION

## **Abstract**

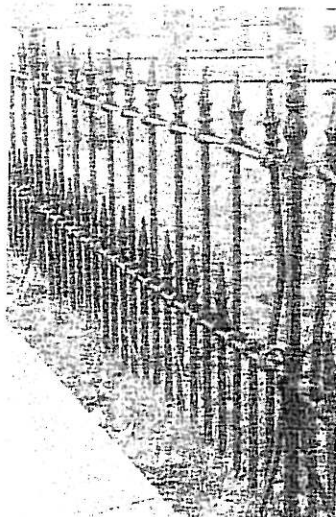
Each section of fence measures 8 feet long and is approximately 4 feet 2 inches in height (Figure 3). Each section consists of an upper, middle and lower rail. Each rail also has two small tubular iron rails. The top rail has 10 iron spiked pickets, while the middle rail, off centered from the top, consists of 9 spiked pickets. A bottom rail, located at or near ground level, has no ornamentation. In total, 20 sections of fence exist and three half sections.

*Figure 3: Presbyterian/Central Cemetery Fence section, showing iron rails and pickets.*

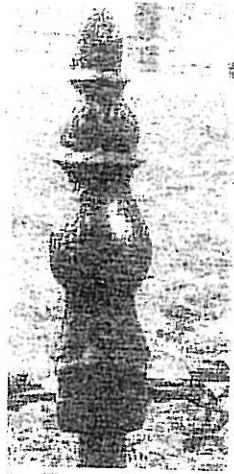
A scroll like iron buttress located at each side of the fence post further anchors it to the concrete base and provides lateral support. The top portion of the fence post is decorated with a flame like finial (Figure 4). This motif is a common design element for cemetery and death iconography. Figures 5 & 6 show an equivalent cemetery fence with a more exaggerated flame. Where each rail from the fence section meets the fence post a metal tongue with a hole attaches the fence section to the fence post. A bolt is used to attach each section.

Figure 4: Fence Post finial

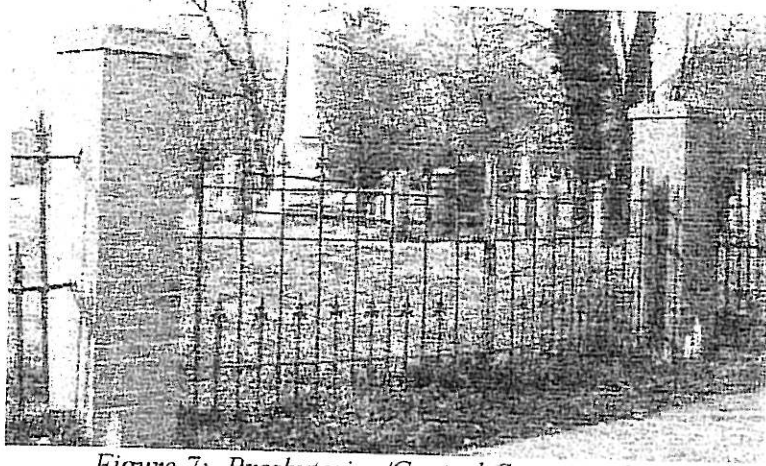
Two gate openings exist. The first gate is located at the 68-foot mark from the northeast corner (Figure 7). Two brick piers form the gateposts. They are approx. 6 feet in height x 1.5 feet square. Each pier is capped with a cement coping block with re-enforcing rods. The brick piers appear to be modern 20<sup>th</sup> century replacements of older gateposts. The gate opening between the two piers measures 12 feet 5 inches from post to post. The gates comprise two swing style gates anchored to each gatepost. The iron gates also appear to be modern 20<sup>th</sup> century replacement. Although the gate opening at this section of the cemetery is modern its location suggests an original gate opening. No pathway exists anymore at this opening but it does open at a section were a linear path separating rows of family burial plots did exist.

*Figure 7: Presbyterian/Central Cemetery Gate*

The first gate, located at the 68 foot mark from the northeast corner, is closed and no longer used for access. The landscape prohibits the gate from swinging. Each gate post has a cement coping cap. These caps have deteriorated exposing the iron tie rods. In addition to this damage the fence sections are loosely anchored to the gate post.

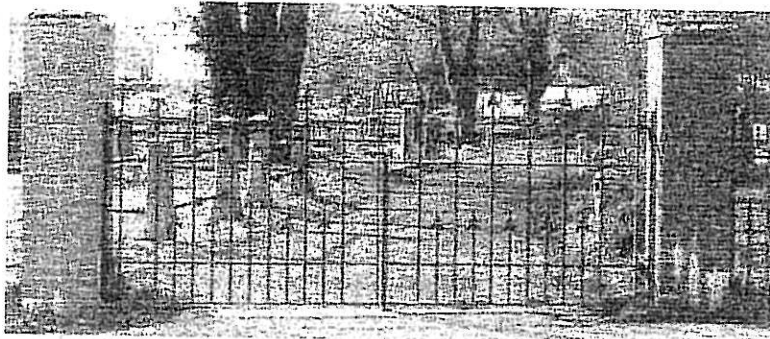
The second gate opening is located at the 137-foot mark from the northeast corner (Figure 8). Two brick piers form the gateposts. They are approx. 5 feet 6 inches in height x 1.5 feet square. Each pier is capped with a cement coping block with re-enforcing rods. The brick piers appear to be modern 20<sup>th</sup> century replacements of older gateposts. The gate opening between the two piers measures 10 feet 6 inches from post to post. The gate comprises two swing style gates anchored to each gatepost. The iron gates also appear to be modern 20<sup>th</sup> century replacements. The gate opening at this section of the cemetery is modern although its location suggests an original gate opening. Currently a paved pathway exists that separates the Presbyterian Cemetery from the Central Cemetery Association. This opening is currently used for pedestrian and on occasion vehicular traffic.

*Figure 8: Presbyterian/Central Cemetery Gate*

The second gate opening has a damaged but functional gate. Some of the decorative elements are missing and part of the gate is bent and twisted. The cement caps have also deteriorated exposing iron tie rods.

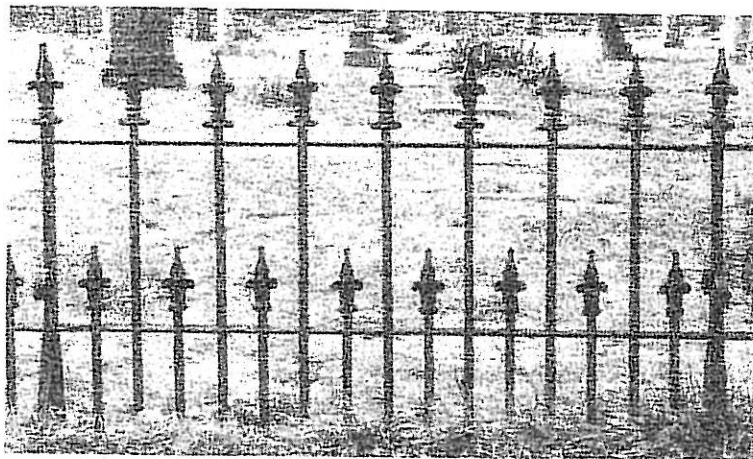
The total length from the datum of the Willow Grove Cemetery Fence to the northwest corner of the New Brunswick Public Library's property is 324 feet. In total 51 sections of fence each of which measure 5 feet 8 inches long and 3 feet 8 inches in height make up the entire Willow Grove Cemetery fence (Figure 10). Each section consists of a top row of 7-iron spike shaped pickets and a bottom row just off centered from the top with 7-iron spike shaped pickets. An overlapping joint attaches each section to a fence post.

*Figure 10: Willow Grove Cemetery fence section*

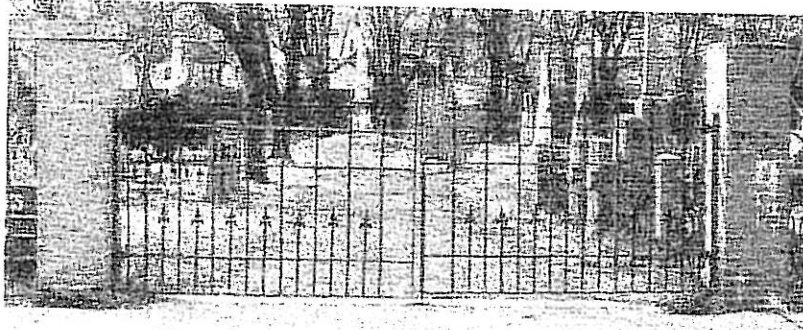
Two gate openings exist. The first gate is located at the 143 foot mark from the datum of the Willow Grove Cemetery Fence (Figure 11). Two brick piers form the gateposts. They are approx. 5 feet 7 inches in height x 1.5 feet square. Each pier is capped with a cement coping block with re-enforcing rods. The brick piers appear to be modern 20<sup>th</sup> century replacements of older gate posts. The gate opening between the two piers measures 12 feet 6 inches from post to post. The gate comprises two swing style gates anchored to each gate post. The iron gates also appear to be modern 20<sup>th</sup> century replacement. The gate opening at this section of the cemetery appears to be modern although its location suggests an original gate opening. Currently a paved pathway exists that leads to the cemetery's board of director's monument. This opening is currently used for pedestrian and on occasion vehicular traffic.

*Figure 11: Willow Grove Cemetery gate*

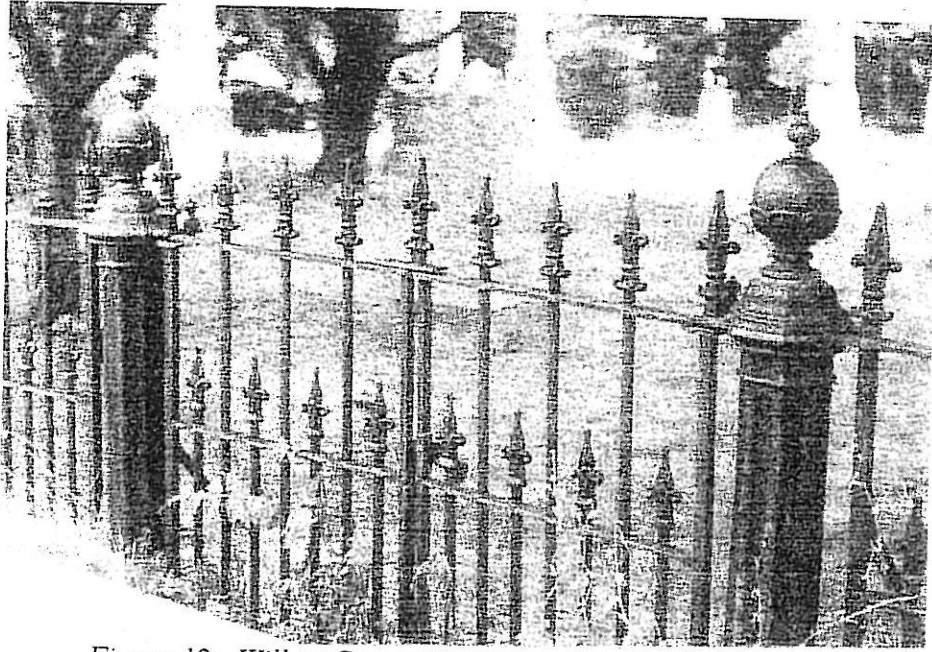
The second gate opening is located at the 232 foot mark from the datum of the Willow Grove Cemetery Fence (Figure 12). The gateposts and gates appear to be original 19<sup>th</sup> century design features of the fence. Two cast iron piers form the gateposts. They are approx. 4 feet 8 inches in height. The gate opening between the two gateposts measures 4 feet 8 inches from post to post. The gate post rests on a concrete base. The post is a fluted column that is in four sections. Near the top a decorative collar keeps the four sections together. A bulbous cast iron ball caps the collar with a small finial at the top. The gates comprise two swing style gates anchored to each gate post. This opening is no longer used but its size suggests an original pedestrian entrance. No manufacturers mark could be found on the gate.

*Figure 12: Willow Grove Cemetery original pedestrian gate*

The historic gate is in a remarkable state of preservation. All of its decorative features are intact and in good condition.

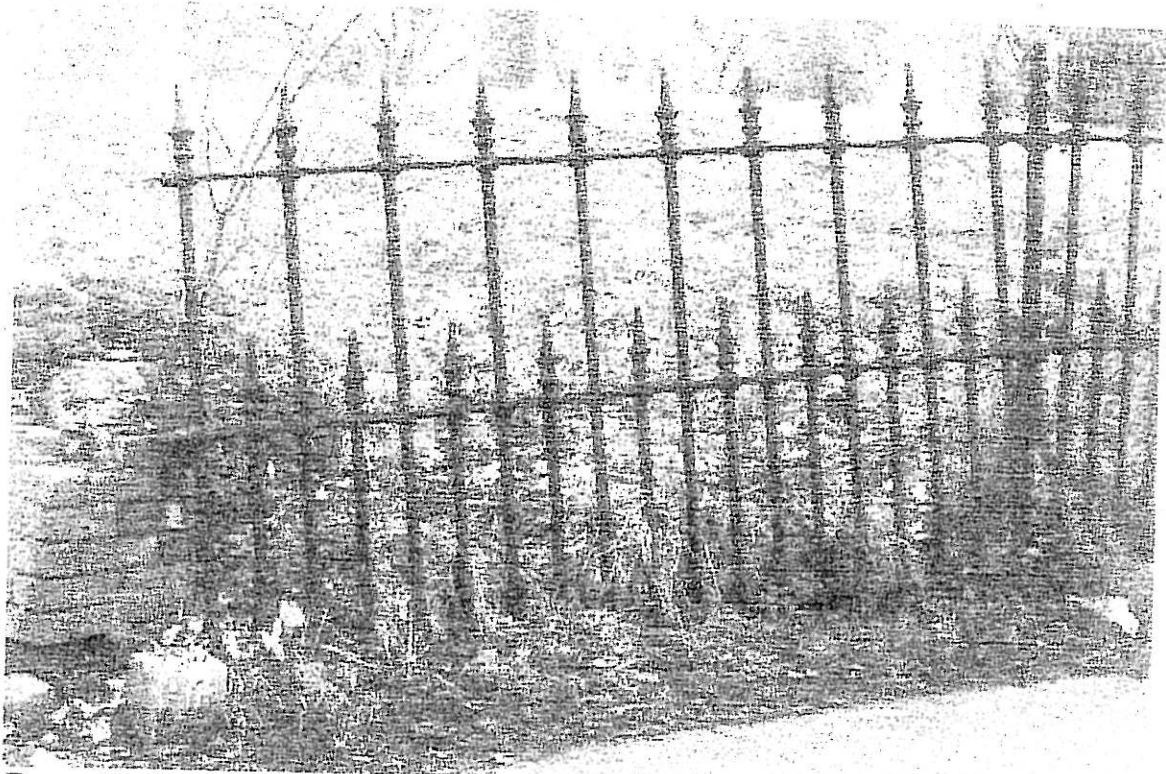
Much of the bottom rail for the entire fence is buried allowing moisture to rest against the fence. This is especially true near the northeast corner as the ground rises above the fence. The bottom portions of each fence section are completely buried and in the first section of fence, near the datum, the ground is pushing the fence forward (Figure 13).

*Figure 13: Presbyterian/Central Cemetery fence section showing buried bottom portion.*

The Presbyterian/Central Cemetery Fence is in poorer condition than the Willow Grove Cemetery fence. It may be easier to dismantle, restore and reinstall the fence. Each fence section would have to be cleaned, repaired and repainted. The fence sections should be set so that the bottom rails do not come in contact with the ground.

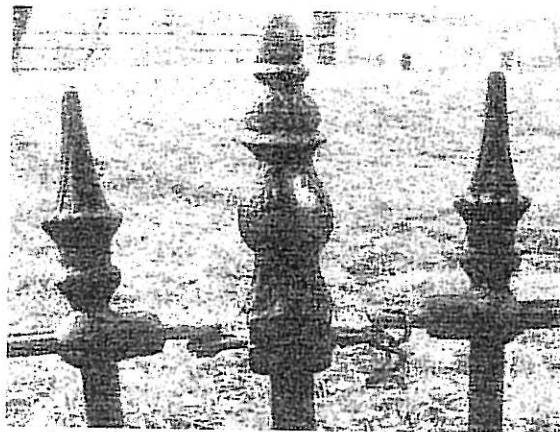
The iron bolts which anchor each fence section to the fence posts are severely deteriorated. A number of the metal tongues that hold the fence sections in place are also damaged (Figure 14). Because they are not adequately anchored to the fence posts many of the fence sections have become loose. In some cases the bolts have deteriorated and inappropriate repairs have taken place including metal wire which has also deteriorated. The decorative elements on the fence posts have survived with the exception of one, which has major damage to its decorative finial. Each fence posts has a scroll like buttress to further anchor it to the ground. At the 95 foot mark two scroll like buttresses are missing from one fence post. In addition minor damage to one buttress can be seen at the 105 foot mark.

*Figure 14: Fence sections have detached from fenceposts. Poor repairs have been made and in many cases failed.*

Many of the fence sections in the Presbyterian/Central Cemetery have loosened from the fence posts and are no longer sufficiently anchored. These loose sections are more susceptible to theft or becoming a public hazard. The City of New Brunswick should look to have loose fence sections more adequately anchored to the fence posts with nonferrous materials. The fence section at the northeast corner is in the worst shape. The brick fence post it was attached to has deteriorated to a rubble mess leaving no support for the fence section. The post should be rebuilt and the fence reattached.

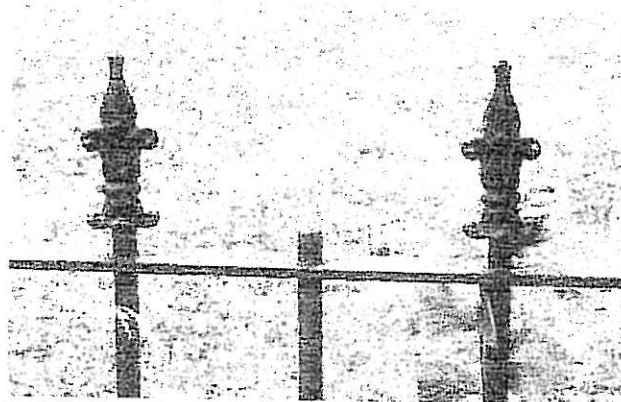
The fence that forms the border for Willow Grove Cemetery is in better shape than the Presbyterian/Central Cemetery fence. The fence sections exhibit a variety of damage. In total major damage consists of 5 missing pickets from the top row and 2 missing pickets from the bottom row (Figure 15). A section of fence at the 181 foot mark is completely missing. Minor damage to the fence pickets include missing tips to the fence picket spikes. In total 25 are missing from the top row and 33 from the bottom row. Other damage includes a fence section at the 25 foot mark that is bent and cracked as if hit by a blunt object, such as an automobile.

*Figure 15: Missing elements from the Willow Grove Cemetery Fence*

The Willow Grove Cemetery fence is in better shape than the Presbyterian/Central Cemetery Fence. Major missing elements of the fence, such as the fence pickets, could be replicated and welded on site. Re-grading of the ground to uncover the bottom rail will prevent future deterioration. Once restoration work and re-grading have been finished the fence could be painted.

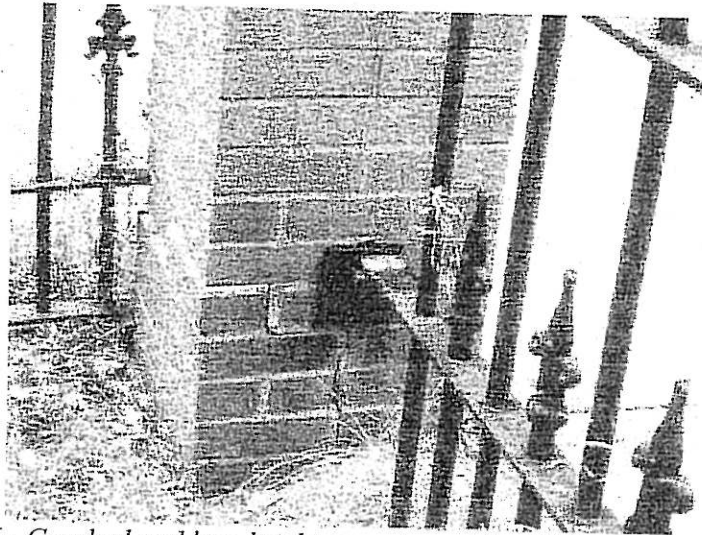
The gate opening for Willow Grove cemetery swings freely. However the iron that ties the gate into the gatepost has become loose at the bottom. The gateposts also exhibit damage. One post has shifted causing the bricks at the lower level to loosen and crack (Figure 16). The cement coping caps are also missing. A white accretion typical of efflorescence is also evident.

*Figure 16: Cracked and loose bricks on gate post for Willow Grove Cemetery*

The brick gateposts at each entrance of the cemetery have deteriorated. In most cases the cement caps are loose or have deteriorated to the point that the iron tie rods are exposed. A structural engineer should check the gatepost for the main entrance into Willow Grove Cemetery. The brick pier has shifted causing bricks on the lower section to shift and crack. This condition could be exasperated, as the gate is open and closed. If a structural engineer determines that the brick pier is unsound it should be rebuilt and the fence reattached. It may be at some point in the future more advisable to replace the gates with a more appropriate design typical to what is depicted on the historic cemetery map of Willow Grove Cemetery. (Figure 17). Several companies could help to replicate this design feature.
