HISTORIC PRESERVATION PLAN

WILLOW GROVE CEMETERY

New Brunswick, Middlesex County, New Jersey

DATE: 4 October 2010

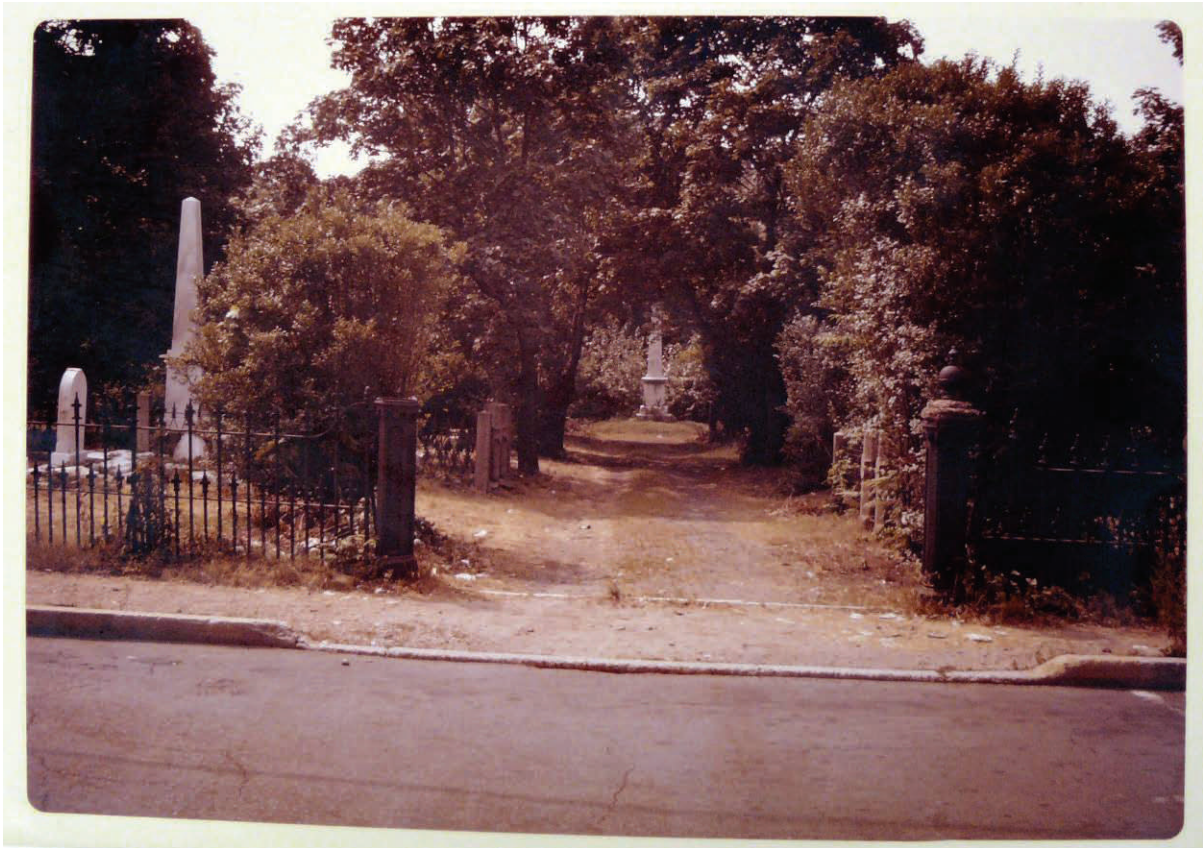
Figure No. 17
Image of Willow Grove Cemetery, 1972

Image showing conditions of the Willow Grove Cemetery in 1972 showing the original carriage gate.

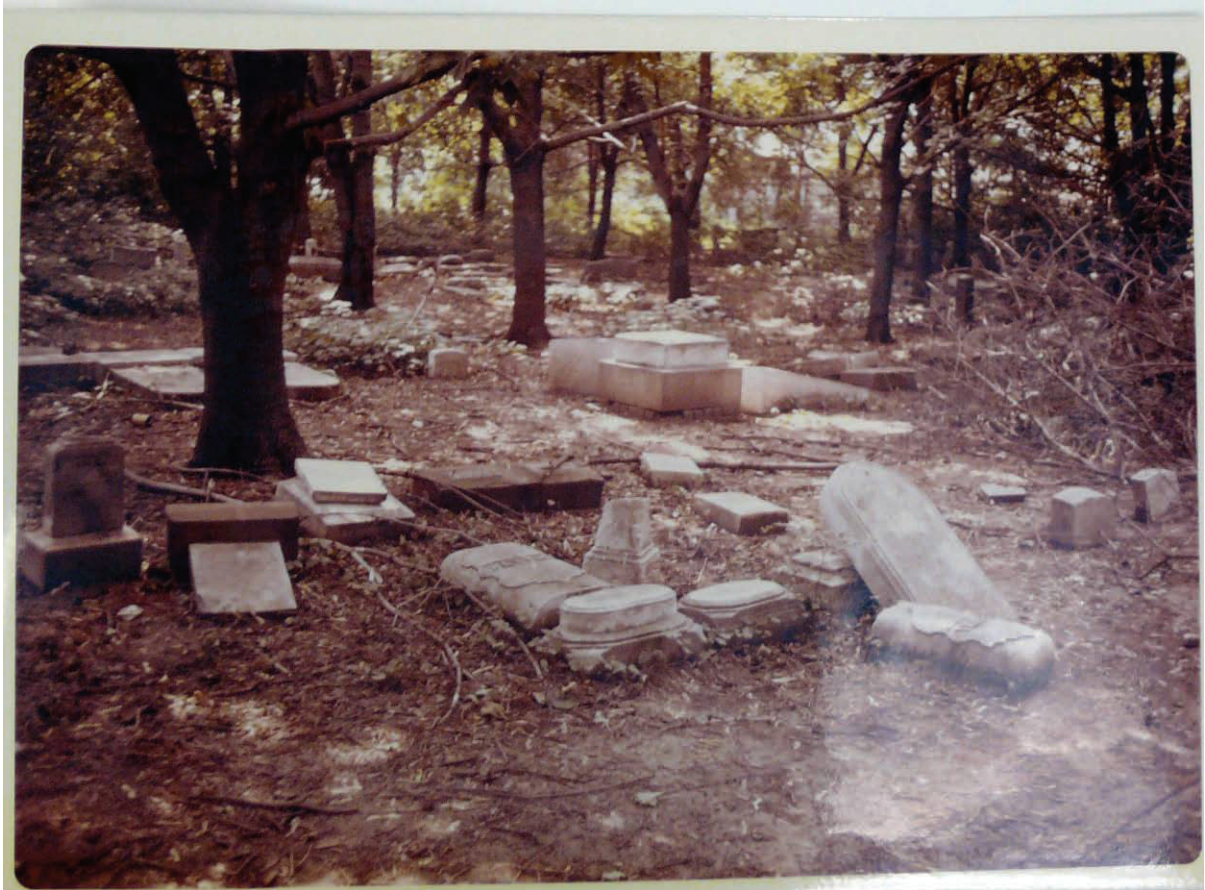
Figure No. 18
Image of Willow Grove Cemetery, 1972

Image showing conditions of the Willow Grove Cemetery in 1972, here including multiple fallen gravestones and debris.

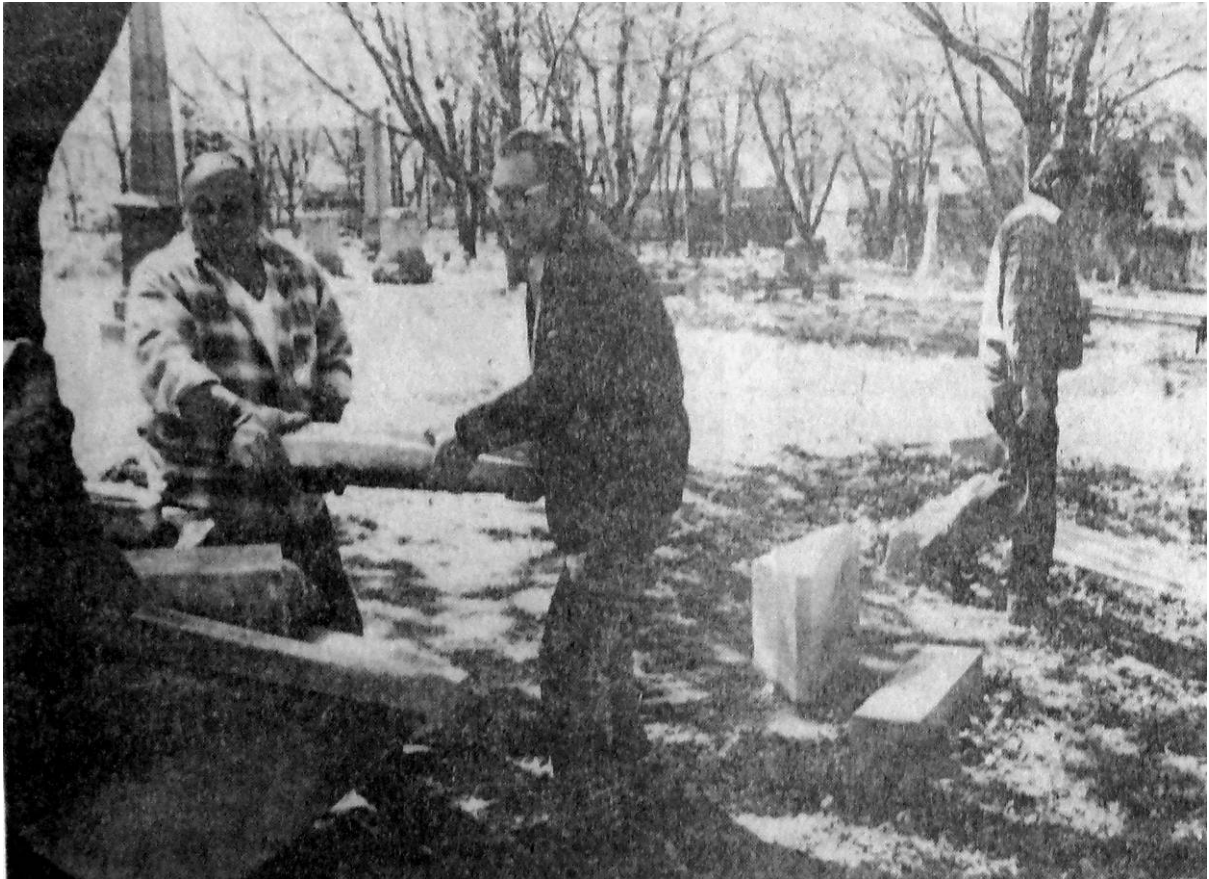
Figure No. 19
Image of Willow Grove Cemetery, 1978

Image showing workers during the clean-up efforts of the Cemetery in 1978, including moving fallen grave markers.

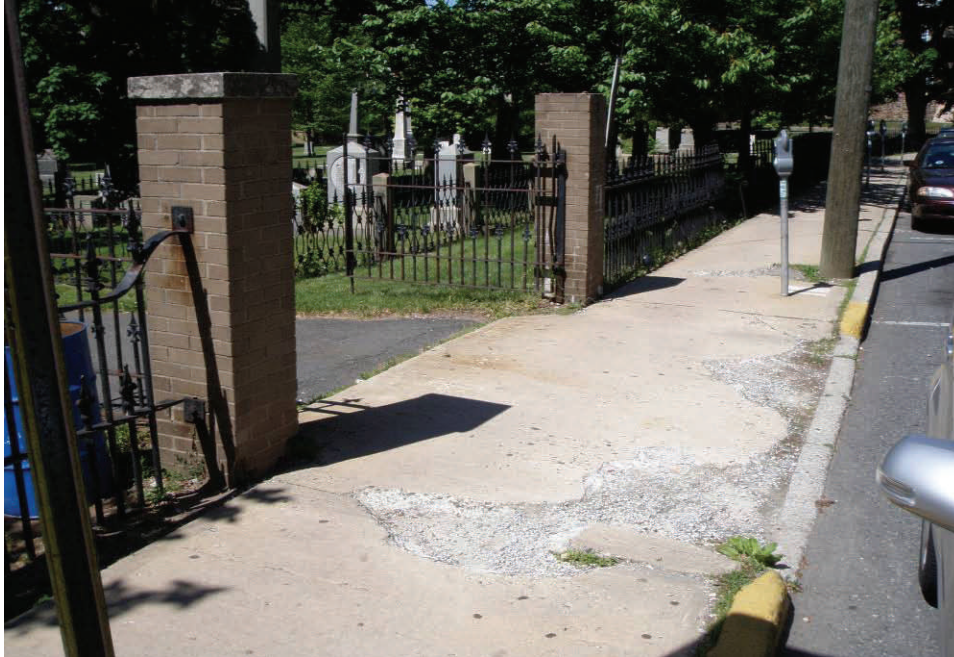
Photo 1:
North border on Morris Street. Note the poor condition of the public sidewalk.

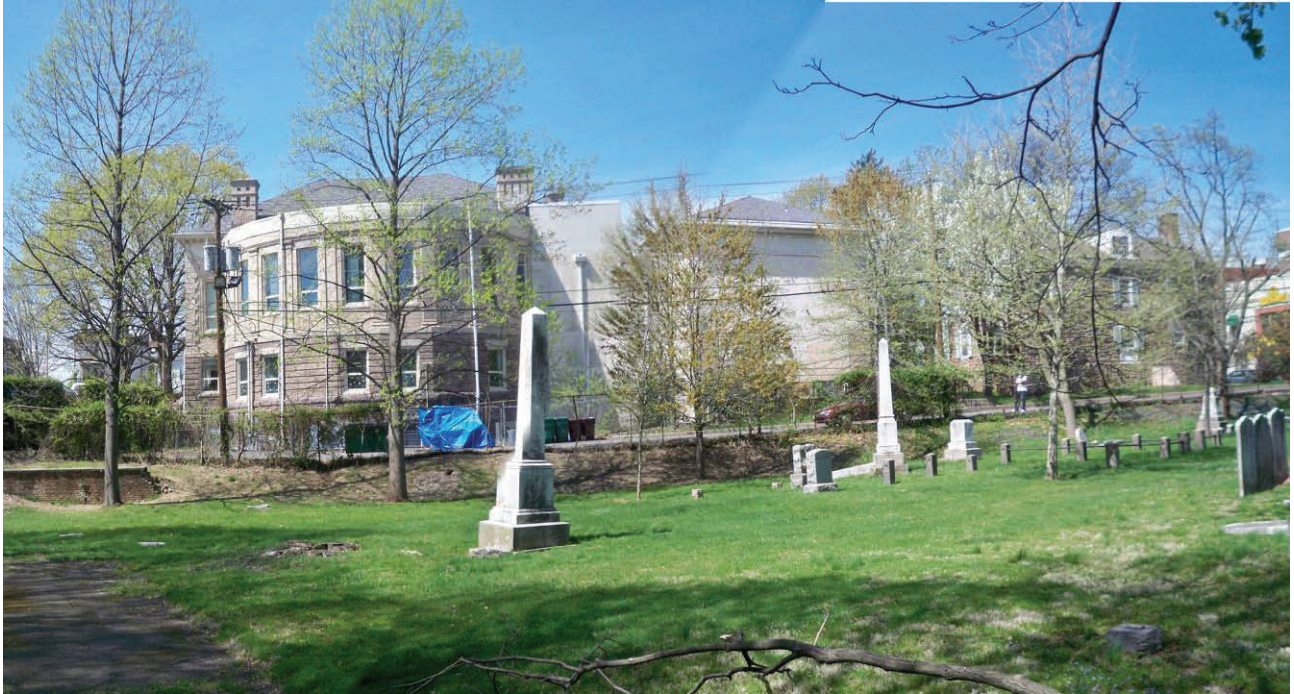
Photo 4:

The wall at the library parking area in the southwest corner of the lot.

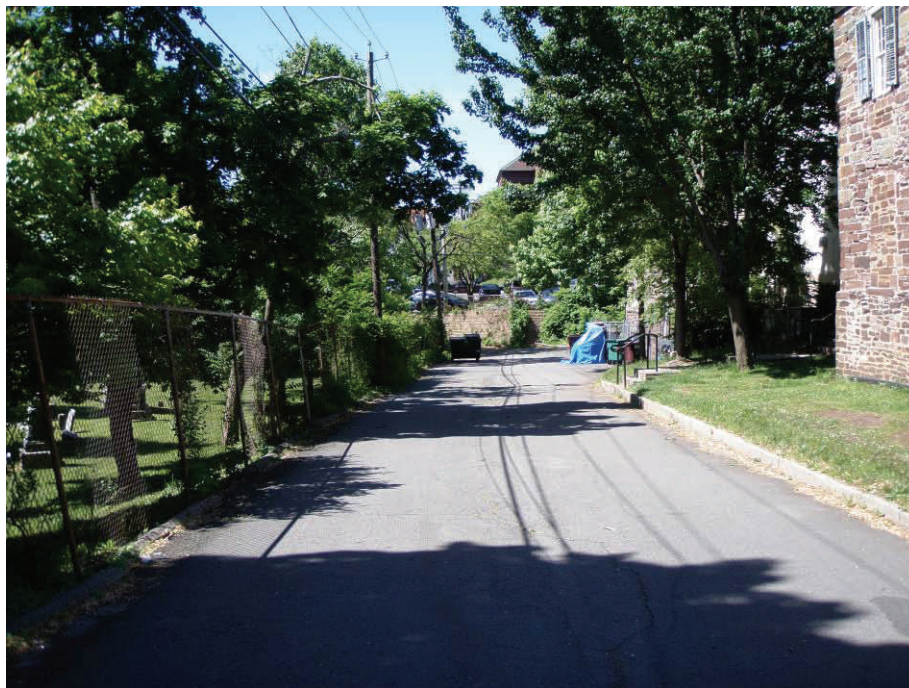
Photo 7:

The retaining walls along the south border. The soundness of these walls should be investigated.

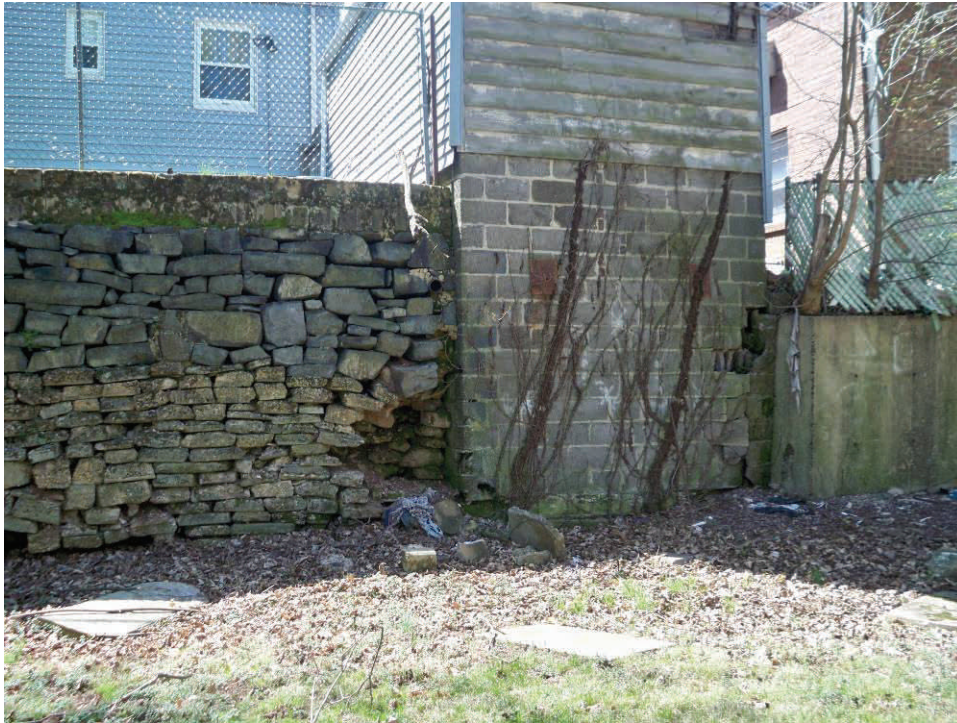
Photo 8:

The retaining walls along the south border. The various building materials and states of repair make this area appear unkempt and ignored. Consequently this area of the site has become popular for illegal activity.

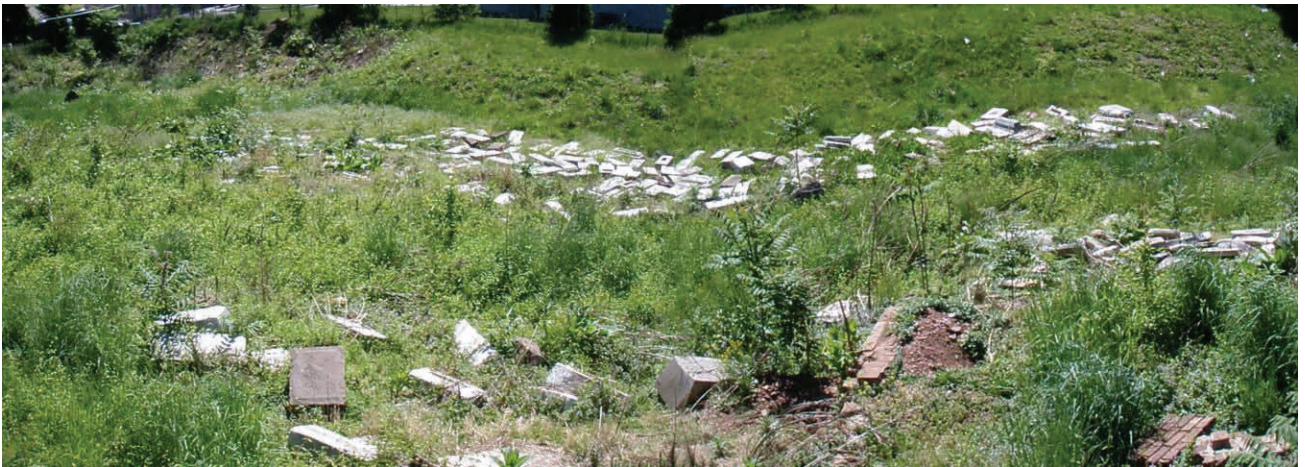
Photo 10:
The southeast corner of the site. Note the neatly placed markers and bases.

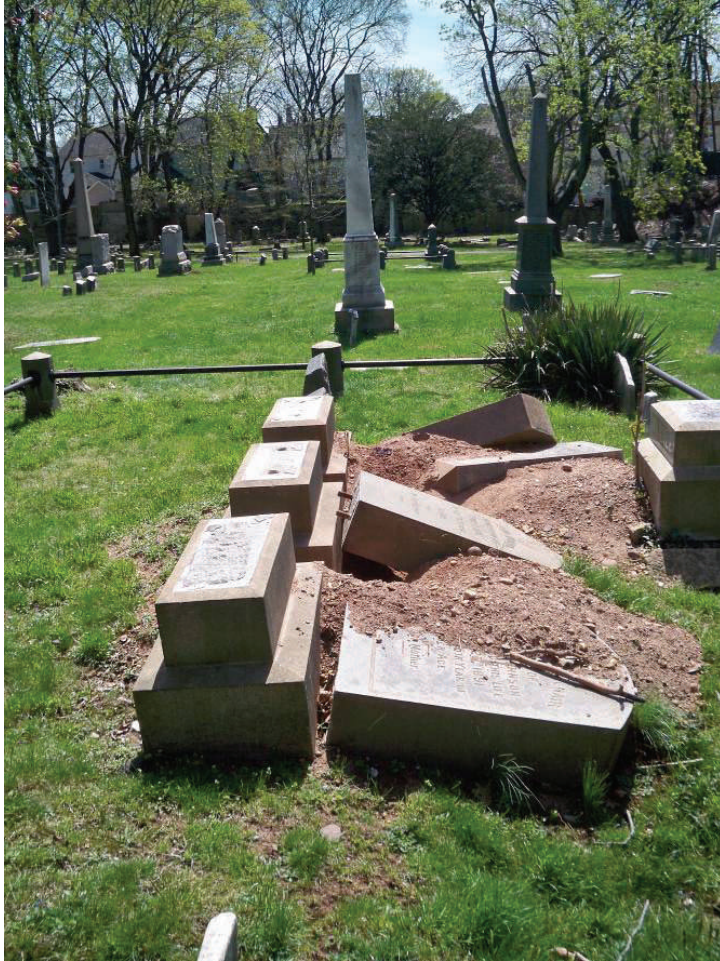
Photo 22:

A groundhog burrow having shifted and caused general upheaval of a group plot.

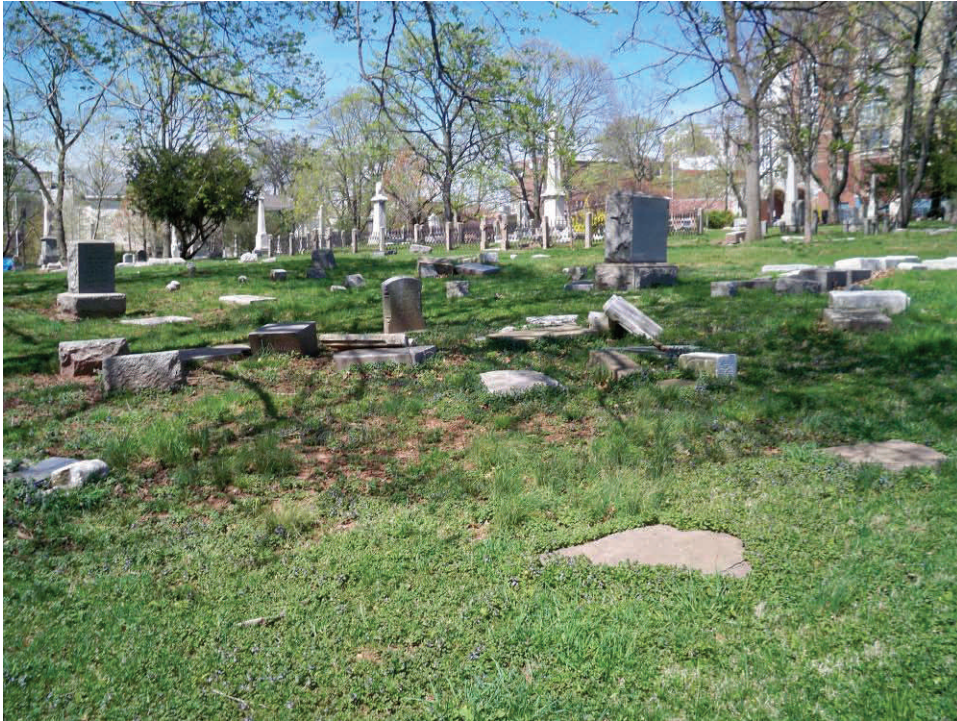
Photo 24:
An example of the gravemarkers toppled and laying horizontally.

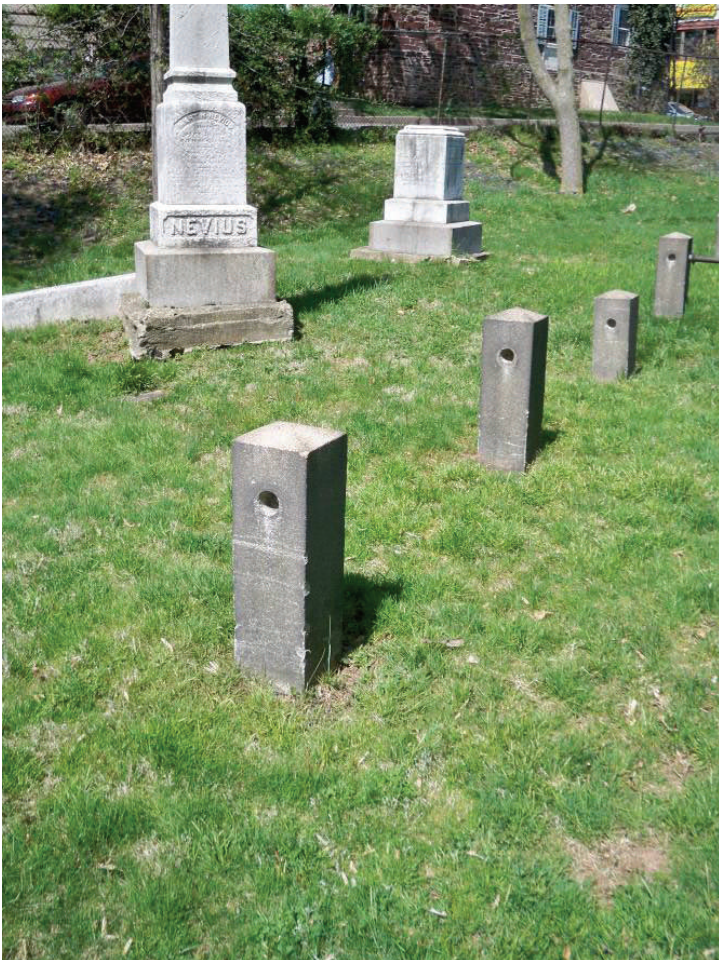
Photo 25:
Loss of the group plot fencing.

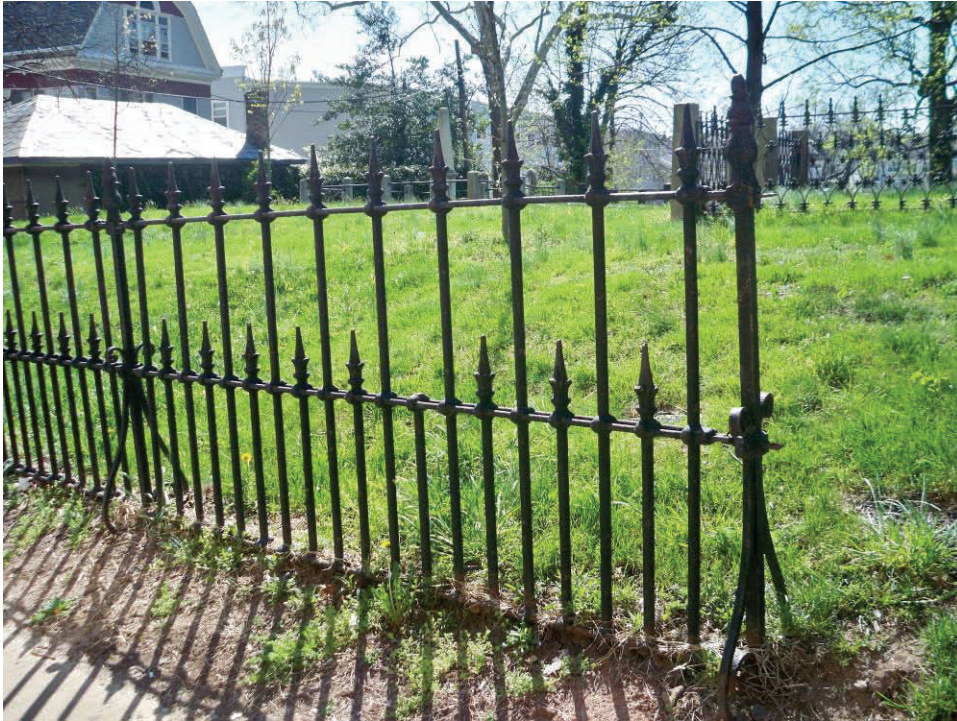
Photo 26:
A typical section of the Presbyterian and Cheesman section fencing. Note that the grade is above the base rail. In this section, the problem seems to be coming from the site.

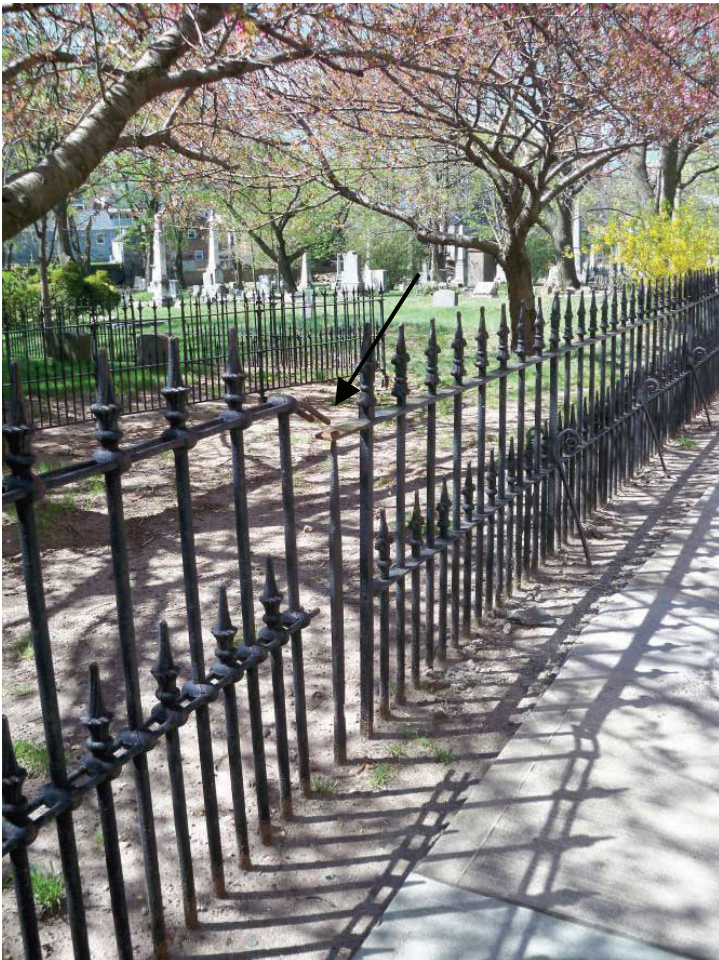
Photo 27:
A broken attachment and loss of a post.

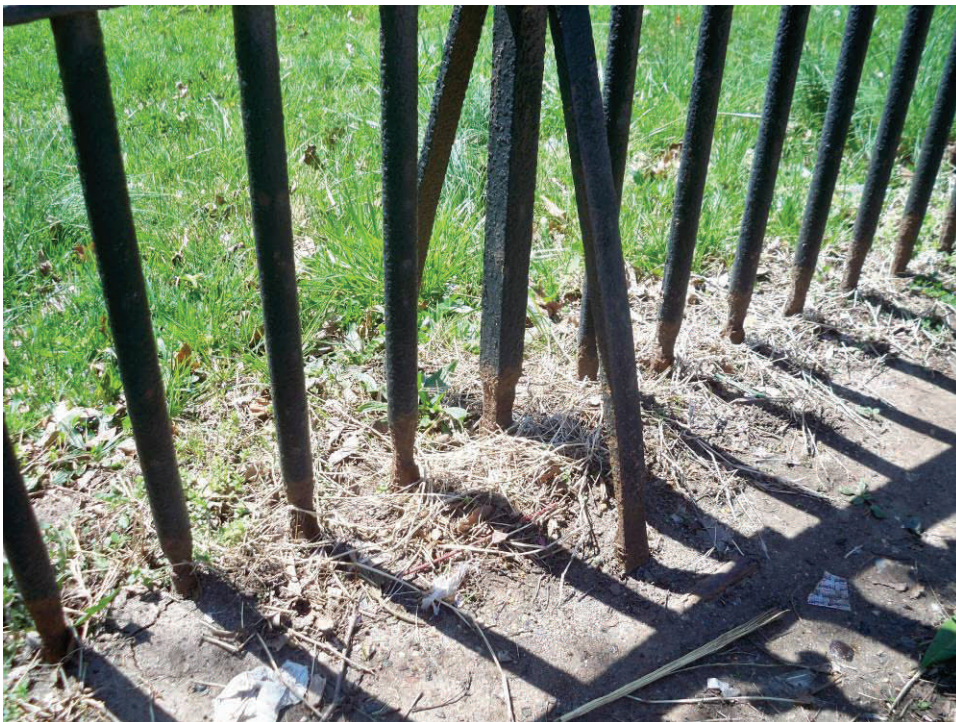
Photo 30:

The only remaining historic gate. This was a pedestrian gate. There was at least one additional historic pedestrian gate and one vehicular gate in 1972.

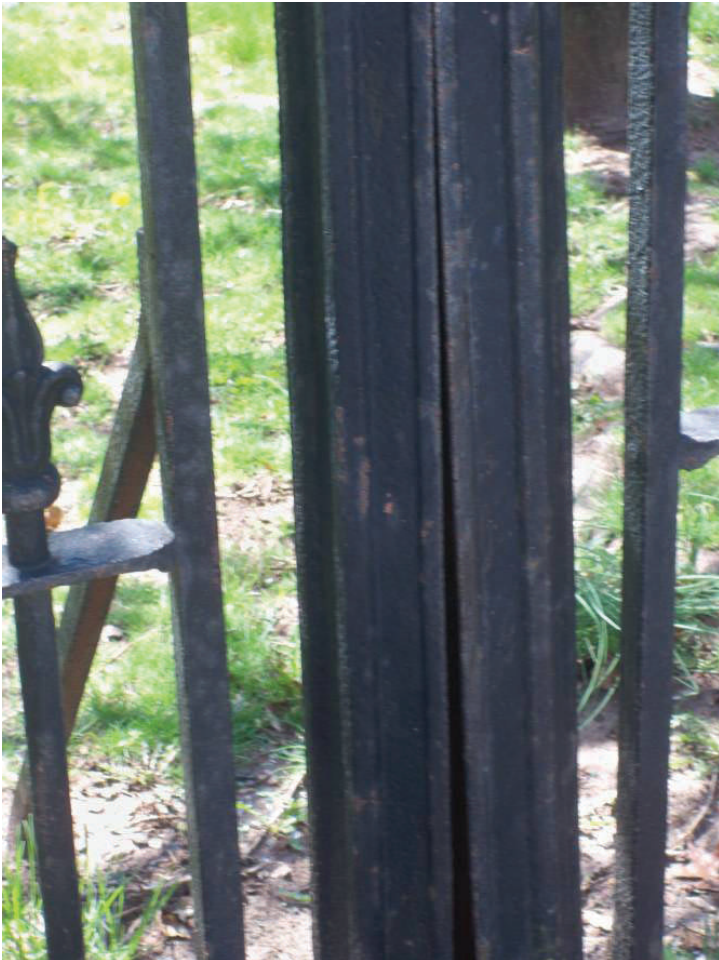
Photo 31:

Separation at the seam in the pedestrian gate posts.

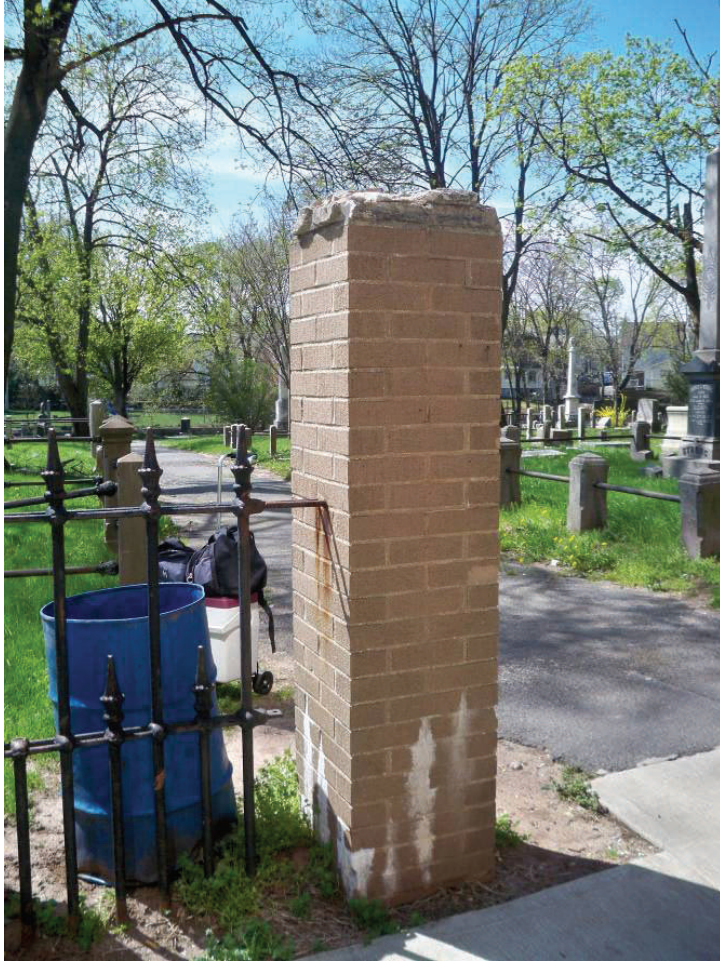
Photo 32:
A typical masonry pier. These date to the late twentieth century and are currently in poor condition. They do not match the historic gate posts.

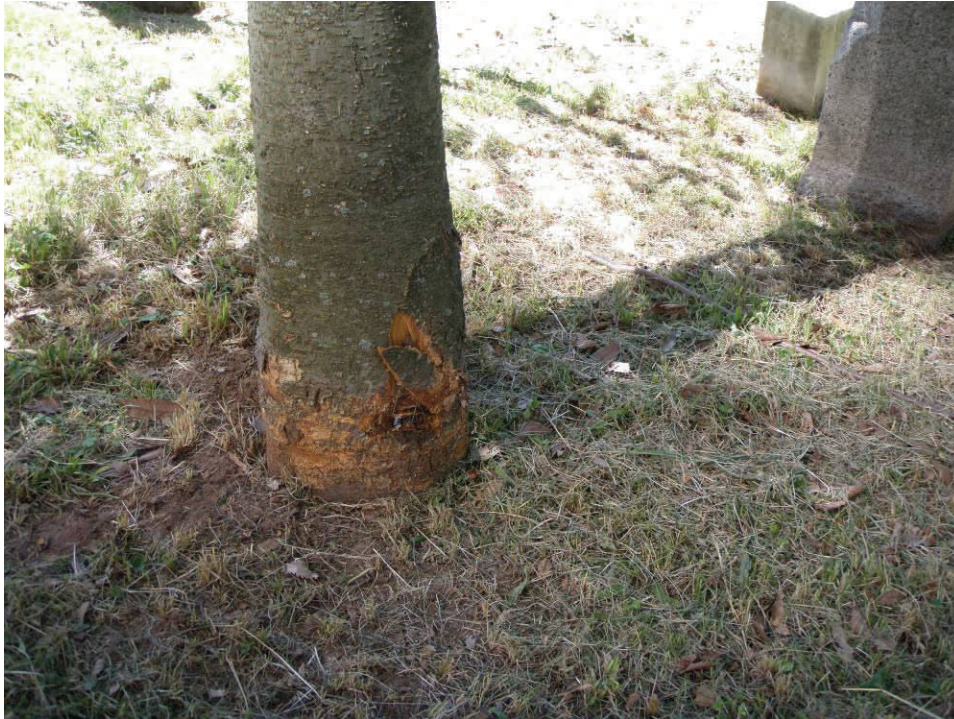
Photo 34:
String trimmer damage to a young tree.

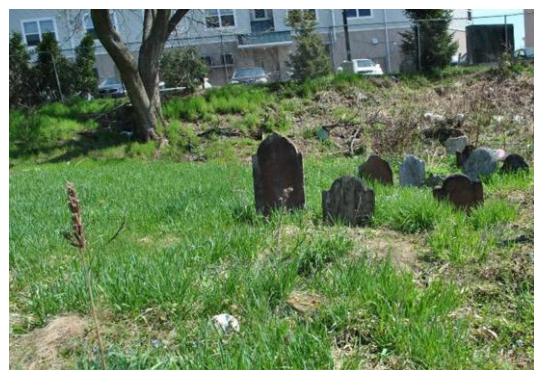
Presbyterian section, view within the cemetery.

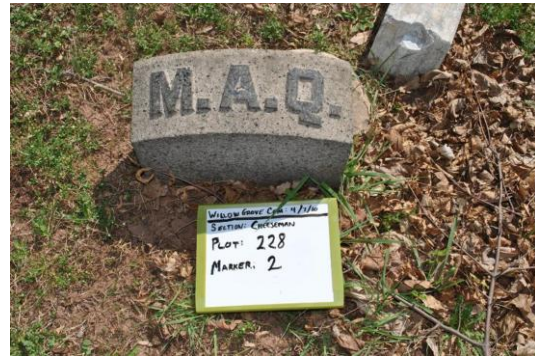
Typical initialed granite marker which was likely installed in the 20th century to replace a deteriorated marker.

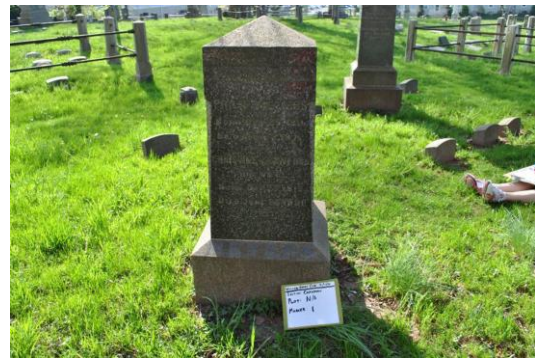
Typical family marker intended to designate multiple burials within a given plot, likely dating to the 20th century.

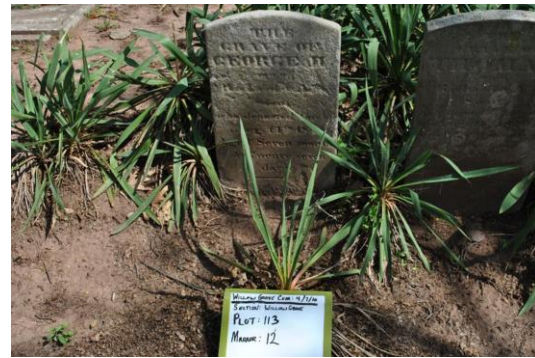
Typical headstone (slab).

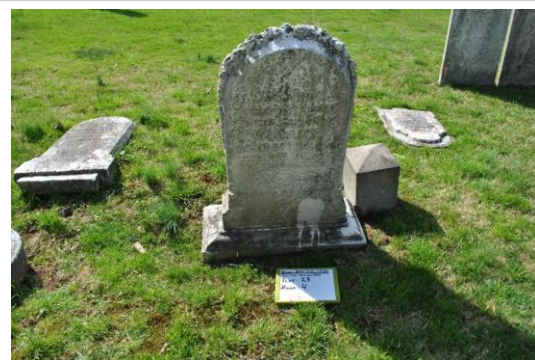
Headstone on base (rare surviving example).

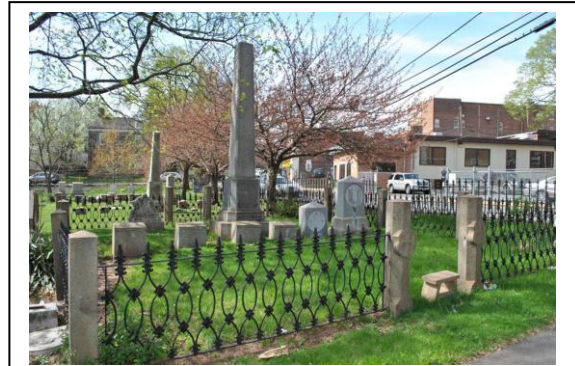
Site features include posts, rails and fences surrounding plots.

In light of the fact that nearly all markers were cut from natural stone (marble, granite, sandstone and slate), corrosion is an issue which primarily affects site features such as posts, rails and gates rather than markers. When treatment is possible, such features may be treated with corrosion-removal products, and coated with rust-inhibited primers and finish coats.

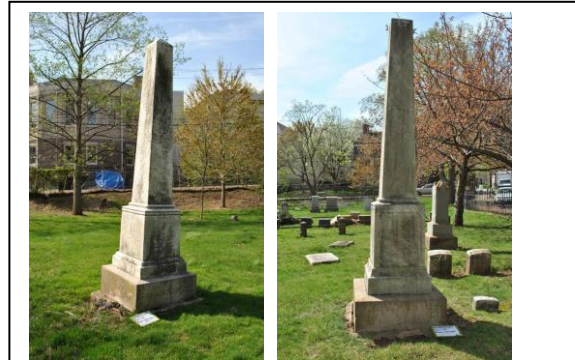
Typical obelisks.

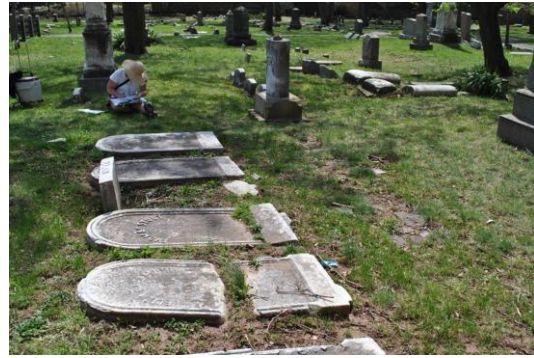
Although the precise date at which the headstones were toppled and the bases discarded is not known, it is reasonable to suspect that those interventions occurred after the improvements in the mid-1930s, when efforts were made to repair damage and replace

Toppled markers.

- Documenting and archiving existing discarded bases.
- Archaeology to determine location of burial site.
- Excavation to install pea gravel and/or mortar pad.
- Setting and leveling of base.
- Preparation of headstone and bases (including cleaning of points which will come into contact with one another).
- Stabilization and repairs to headstone, if required.
- Re-setting headstone into (tongue-in cavity, mortar bed) or onto (new pins, pointed joints) base.
- Cleaning and other restoration work if desired.

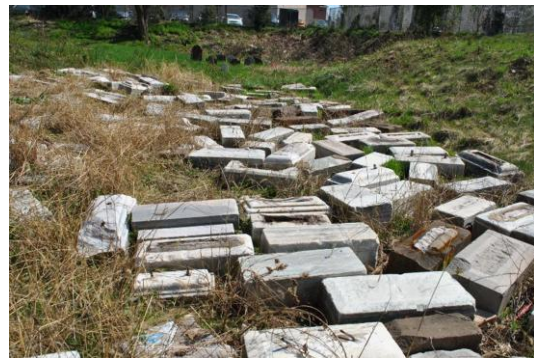
Toppled markers consist of those which have been intentionally removed from their bases, most in conjunction with an orchestrated late 20th century campaign which may have sought to minimize the potential both for vandalism and safety risks. This condition was noted for nearly 40% of those markers surveyed (within that subset, approximately two-thirds are markers whose bases have been removed and discarded, and one-third are markers whose bases remain in the immediate vicinity). Toppled markers constitute the most significant marker-related issue, both with respect to the visual impact which this conditions impart and from a conservation standpoint. Although toppling is believed to have been for the most part intentional, the visual effect is of a cemetery which has been vandalized and/or poorly maintained, even though landscaping crews regularly work throughout the site. The cemetery does not currently read as it was intended to, given that headstones which once stood vertically now lie flat against the ground. In some cases, inscribed/carved surfaces face skyward; rainwater pooling on these surfaces encourages dissolution, biological growth and soil retention, all of which have accelerated deterioration of identifying details such as names, dates and character-defining inscriptions. In others, inscribed faces are face-down; the extent to which identifying details survive is not known. In any case, all such markers are in constant contact with a source of moisture which, over the long term, will compromise material stability.

Discarded bases within drainage trough.

Markers which have been toppled (either intentionally or unintentionally) or that have shifted or tilted should be reset either on their existing base, on a compatible base found within the stock of previously-discarded bases or on a newly fabricated base. The conservation process for such markers may include:

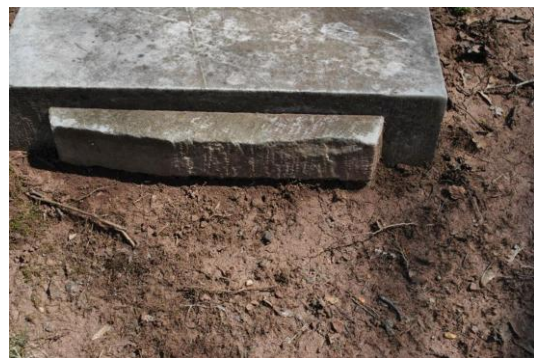
Tongue at base of toppled marker.

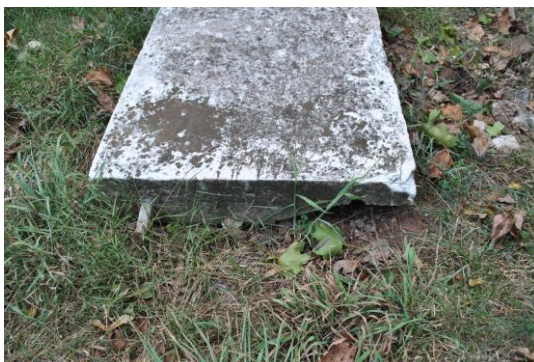
Pins at base of toppled marker.

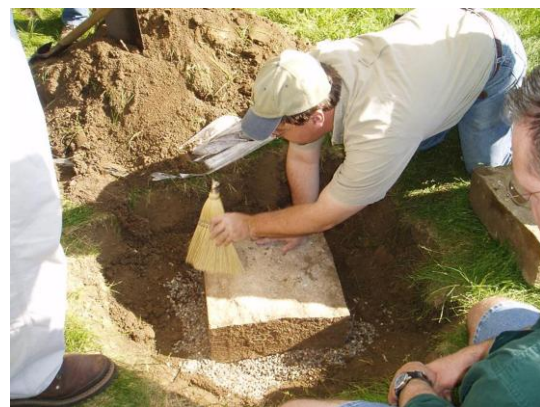
Treatment: Typical excavation and setting on pea gravel (not this site – NCPTT Cemetery Conservation Workshop 2005).

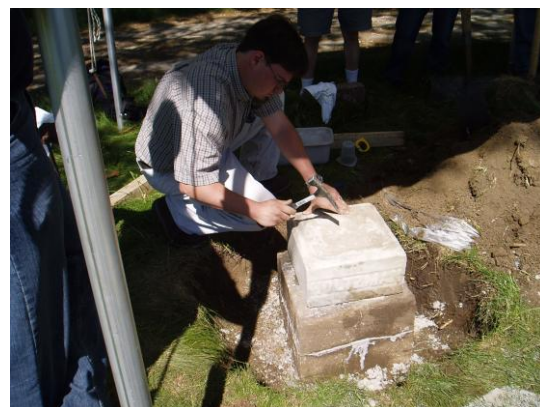
Treatment: Typical resetting/leveling of base (not this site – NCPTT Cemetery Conservation Workshop 2005).

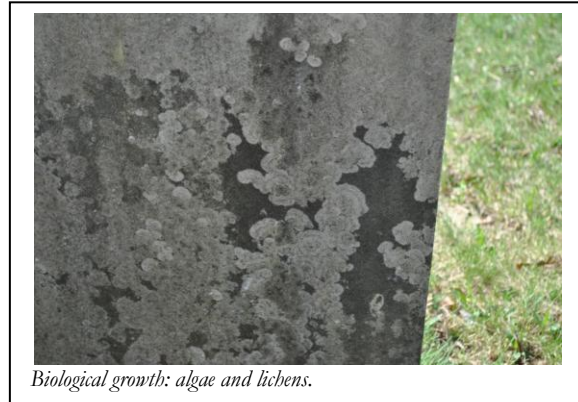
Present both in the form of algae and lichens, biological growth consists of green and black vegetation. Biogrowth occurs primarily on surfaces which are chronically saturated with moisture, such as those which are located in areas with poor drainage and those which are shaded by trees and/or site features. Although generally superficial, some types of growth can react with minerals in stone substrates, exacerbating damage and deterioration. This condition has been noted within 87.11% (169 of 194) of survey entries for markers.

Biological growth: algae and lichens.

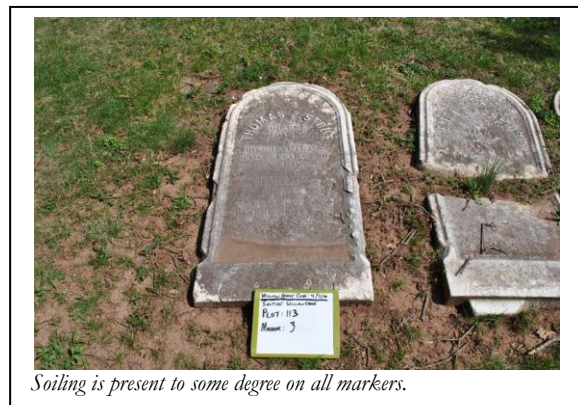
Some degree of soiling is present on virtually every marker and site feature. Survey recorded only instances of severe soiling or deposition which may compromise the weathering surface of the stone substrate. This condition has been noted as a notable aesthetic condition within 52.57% (102 of 194) of survey entries, but is present to some degree on all surfaces.

Soiling is present to some degree on all markers.

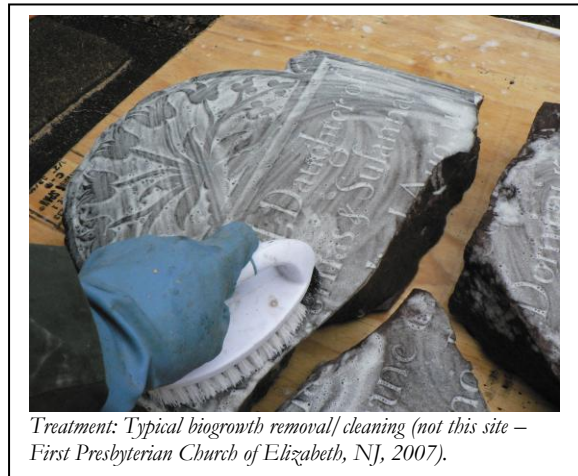
Treatment: Typical biogrowth removal/cleaning (not this site – First Presbyterian Church of Elizabeth, NJ, 2007).

Only the gentlest effective method for achieving the goals of the cleaning process should be used. Rinsing with water and cleaning with a natural bristle brush may be sufficient for some markers. Non-ionic detergents and masonry cleaners may be used; these do not contribute to the formation of soluble salts, which are widely absent from these markers.

Products which may warrant consideration for growth removal include mild anti-fungals based on quaternary ammonia compounds such as D/2 Biological Solution (www.cathedralstone.com). Non-ionic detergents frequently used in marker/monument treatment programs include Orvus WA Paste and Triton X-100 (www.talasonline.com). Under no circumstances should aggressive chemical cleaners or abrasives be considered.

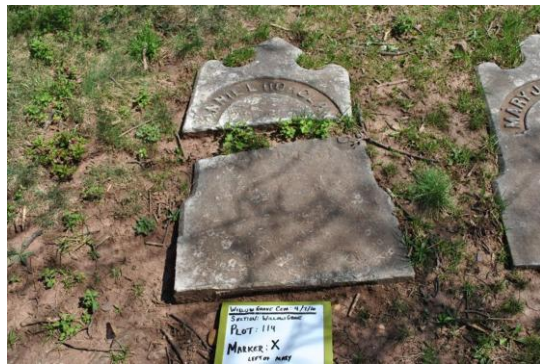
Broken, partially submerged marker (cracking).

There are many potential treatment options for pinning (titanium, stainless steel, fiberglass, nylon – www.mcmastercarr.com), adhesion (epoxy, modified epoxy, mineral-based masonry adhesives and grouts) and patching (cementitious products such as Jahn Repair Mortars – www.cathedralstone.com and those based on natural hydraulic lime such as Lithomex – www.limeworks.us). Specific treatment options should be proposed by an architectural conservator based on successful previous experience with similar conditions.

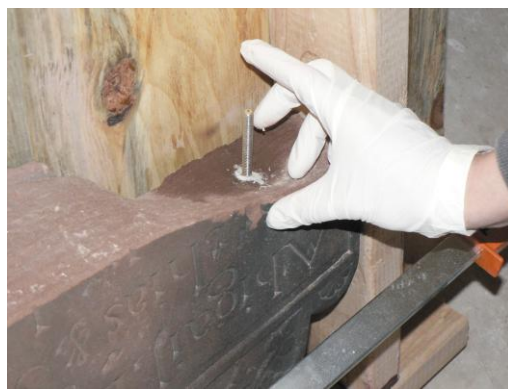
Treatment: Typical installation of pins (not this site – First Presbyterian Church of Elizabeth, NJ, 2007).

When toppled, some markers broke apart into multiple fragments. The techniques and materials used to repair such damage and stabilize such markers will vary, but generally will include: 1) minimal excavation to facilitate removal of any fragments which have become partially submerged, 2) cleaning to remove growth and soil from fracture boundaries, 3) installing pins and/or adhesive, 4) fitting broken fragments back together and 5) installing composite patching material to fill cavities along the fracture boundaries.

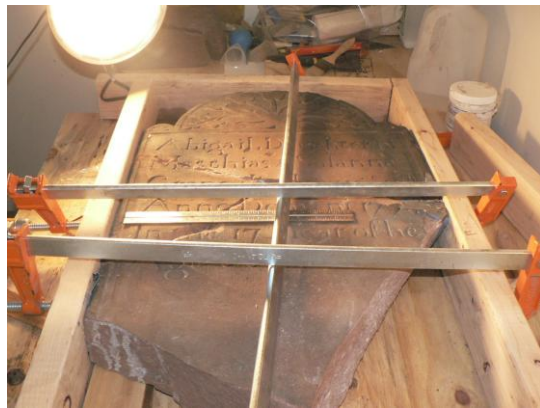
Treatment: Typical re-fitting of adhesive-bonded broken fragments (not this site – First Presbyterian Church of Elizabeth, NJ, 2007).

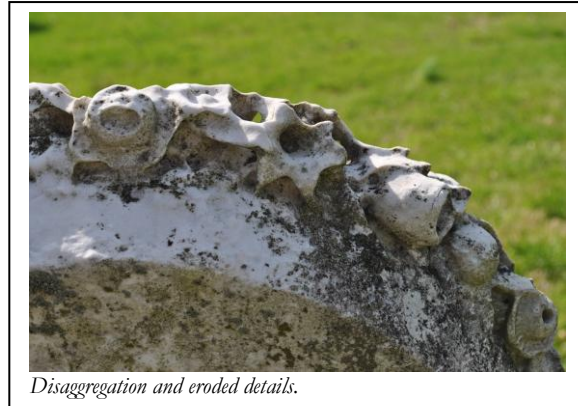
Disaggregation, the loss of individual crystals, and erosion, the pronounced effect of large-scale disaggregation, was noted to some degree on virtually every marble marker in the cemetery. These conditions develop as water-soluble components in the carbonate-bearing marble dissolve in the presence of rainwater over an extended period of time. To some degree, the effects of disaggregation and erosion are enhanced by the presence of weak acids in the rain. This condition has been noted within 43.81% (85 of 194) of survey entries.

Although disaggregation and erosion are common throughout the cemetery, and despite the fact that chemical consolidation treatments which might arrest or slow the progress of deterioration are available, it is not advisable to treat these conditions on a large scale at this point because 1) other conditions are far more critical, 2) consolidation is irreversible, and 3) consolidation should be undertaken only if the results of testing can justify its cost. Consolidation is the reestablishment of intergranular cohesion of stone. Consolidants either form adhesive bonds between loose mineral grains or saturate the space between loose mineral grains to lock the grains in place. Application of chemical consolidating treatment prevents additional loss of material and of detail. Many commercial consolidants do not comply with current VOC regulations.

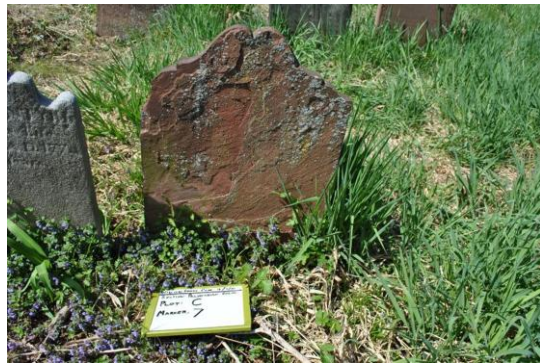
Delamination of a sandstone marker.

Stabilizing detached material may be accomplished with proprietary injection grouts (Jahn M32 and M40 Micro Injection Grout – www.cathedralstone.com) or custom field mixes. Delamination/exfoliation boundaries may be filled with tinted composite repair mortars once re-attachment has been completed.

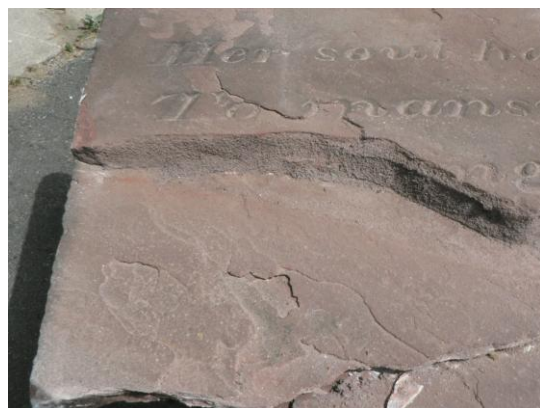
Treatment: Typical patching for delaminated boundary (not this site – First Presbyterian Church of Elizabeth, NJ, 2007).

Delamination/exfoliation occurs when sheets of minerals detach along bedding or foliate planes. This condition is minor within the context of this cemetery, and was noted on only a handful of sandstone markers within the Presbyterian section. Stabilizing detached material may be accomplished with proprietary injection grouts. Delamination/exfoliation boundaries may be filled with tinted composite repair mortars once re-attachment has been completed.

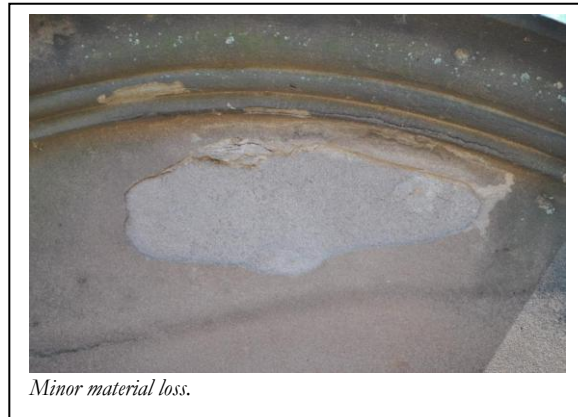
Minor material loss.

Cementitious or lime-based composite material is applied to compensate for previous damage. Voids are filled with compounds that are compatible in both physical (permeability, strength) and visual (color, texture) properties. This process stabilizes the original material to minimize the likelihood that additional damage may occur. Proprietary composite materials (cementitious products such as Jahn Repair Mortars – www.cathedralstone.com and those based on natural hydraulic lime such as Lithomex – www.limeworks.us) may be considered. Specific treatment options should be proposed by an architectural conservator based on successful previous experience with similar conditions.

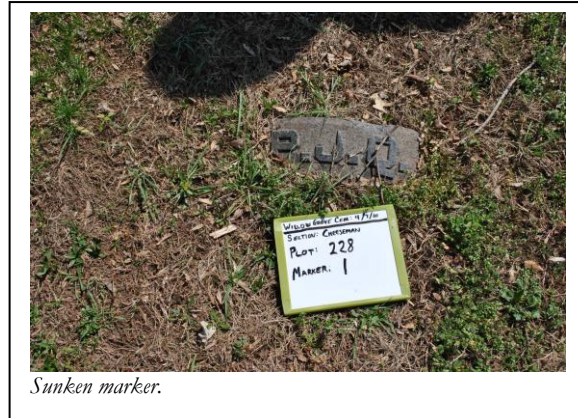
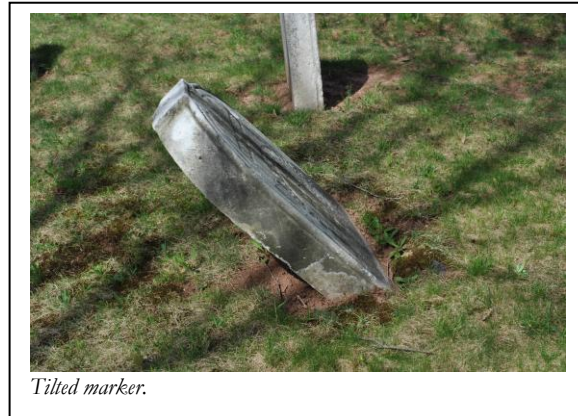
Markers which have sunk below the surface to varying degrees as a result of geophysical movement or the impact of the weight of the marker on poorly-compacted soil were noted in various locations. This condition has been noted within 5.67% (11 of 194) of survey entries.

Markers which have tilted beyond a plane which is perpendicular to the surrounding soil are not common. Within this cemetery, tilt is currently a more significant concern for monuments and obelisks than for headstones, simply because the sheer height of the former renders them more susceptible to collapse and also because many of the latter have already been intentionally toppled. This condition has been noted within 8.76% (17 of 194) of survey entries.

Sunken and tilted markers do not constitute a significant priority in this cemetery. When appropriate, addressing such markers may include:

- Excavation and temporary removal of the marker.
- Installation of a pea gravel base and/or mortar pad.
- Stabilization and repairs to headstone, if required.
- Setting and leveling marker.
- Backfilling soil.
- Cleaning and other restoration work if desired.

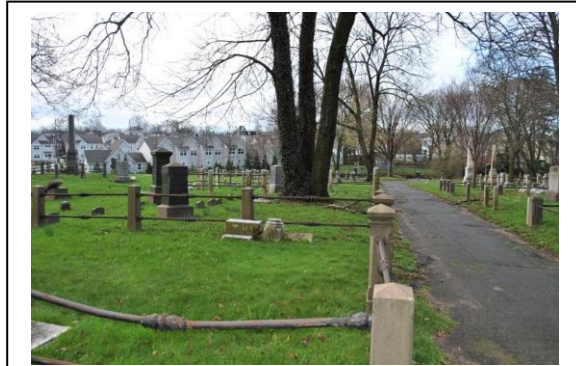
Topography slopes down from high ground on Morris Street.

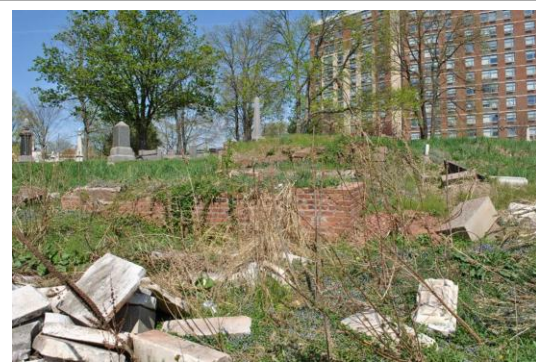
Minimally visible area in southeast corner.

Broad, sitewide issues such as security, drainage and animal activity (groundhogs) were also noted during survey work. Although the scope of addressing those concerns is beyond the purview of this study, they should be addressed within the larger context during any future work on the site.

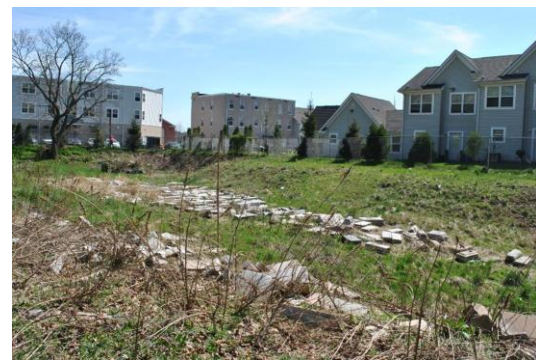
De-facto drainage trough into Presbyterian section.

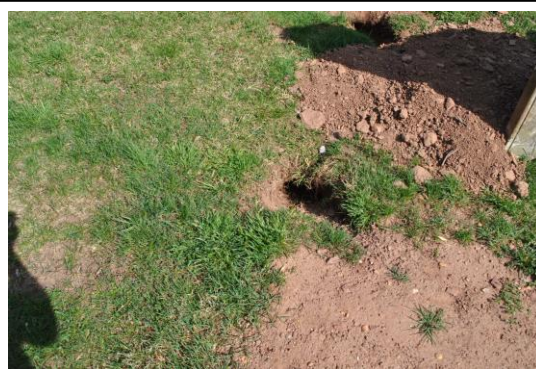
Groundhog activity in Willow Grove section.
