HISTORIC PRESERVATION PLAN

WILLOW GROVE CEMETERY

New Brunswick, Middlesex County, New Jersey

DATE: 4 October 2010

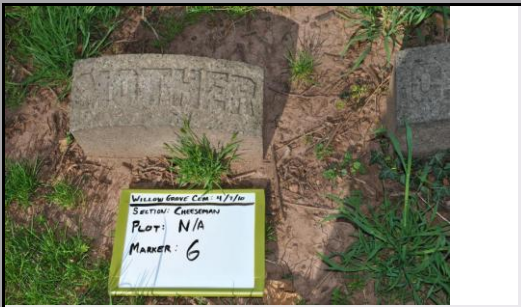
V. MATERIAL CONDITIONS						
<input checked="" type="checkbox"/> Biological - Algae	<input type="checkbox"/> Biological - Lichens	<input type="checkbox"/> Crack	<input type="checkbox"/> Delamination/Exfoliation			
<input type="checkbox"/> Disaggregation/Erosion	<input type="checkbox"/> Graffiti	<input type="checkbox"/> Off base (missing)	<input type="checkbox"/> Off base (adjacent)			
<input type="checkbox"/> Missing Fragment (s)	<input type="checkbox"/> Previous Repair	<input checked="" type="checkbox"/> Soiling	<input type="checkbox"/> Sunken			
<input type="checkbox"/> Tilt	<input type="checkbox"/> Corrosion					
<input type="checkbox"/> Other:	_____					
VI. TREATMENT RECOMMENDATIONS						
<input type="checkbox"/> Archaeology	<input type="checkbox"/> Excavate	<input type="checkbox"/> Reset on exist base	<input type="checkbox"/> Reset on salvaged base (if poss)			
<input checked="" type="checkbox"/> Clean/bio removal	<input type="checkbox"/> Consolidate	<input type="checkbox"/> Composite repair	<input type="checkbox"/> Pin/adhesive repair

VII. ADDITIONAL INFORMATION						
Not specifically listed in previous survey.

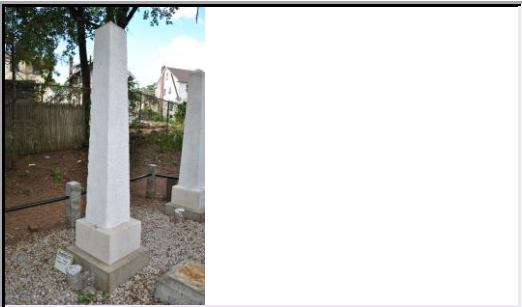
<input checked="" type="checkbox"/> Other:	Marker was restored in 2010. No immediate action required.					
VI. PHOTOGRAPHS						
Photo 1:			Photo 2:

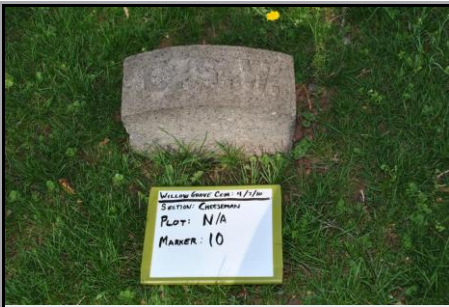
V. MATERIAL CONDITIONS						
<input checked="" type="checkbox"/> Biological - Algae	<input type="checkbox"/> Biological - Lichens	<input type="checkbox"/> Crack	<input type="checkbox"/> Delamination/Exfoliation			
<input type="checkbox"/> Disaggregation/Erosion	<input type="checkbox"/> Graffiti	<input type="checkbox"/> Off base (missing)	<input type="checkbox"/> Off base (adjacent)			
<input type="checkbox"/> Missing Fragment (s)	<input type="checkbox"/> Previous Repair	<input checked="" type="checkbox"/> Soiling	<input type="checkbox"/> Sunken			
<input type="checkbox"/> Tilt	<input type="checkbox"/> Corrosion					
<input type="checkbox"/> Other:	_____					
VI. TREATMENT RECOMMENDATIONS						
<input type="checkbox"/> Archaeology	<input type="checkbox"/> Excavate	<input type="checkbox"/> Reset on exist base	<input type="checkbox"/> Reset on salvaged base (if poss)			
<input checked="" type="checkbox"/> Clean/bio removal	<input type="checkbox"/> Consolidate	<input type="checkbox"/> Composite repair	<input type="checkbox"/> Pin/adhesive repair

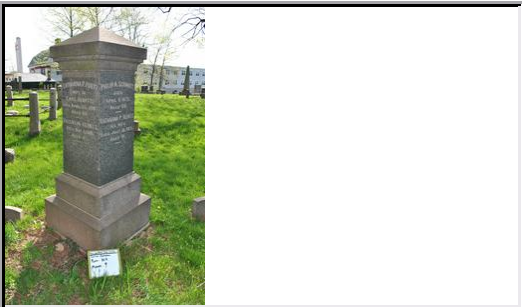
V. MATERIAL CONDITIONS						
<input checked="" type="checkbox"/> Biological - Algae	<input type="checkbox"/> Biological - Lichens	<input type="checkbox"/> Crack	<input type="checkbox"/> Delamination/Exfoliation			
<input type="checkbox"/> Disaggregation/Erosion	<input type="checkbox"/> Graffiti	<input type="checkbox"/> Off base (missing)	<input type="checkbox"/> Off base (adjacent)			
<input type="checkbox"/> Missing Fragment (s)	<input type="checkbox"/> Previous Repair	<input type="checkbox"/> Soiling	<input type="checkbox"/> Sunken			
<input type="checkbox"/> Tilt	<input type="checkbox"/> Corrosion					
<input type="checkbox"/> Other:	Algae growth primarily in recessed/carved surfaces.					
VI. TREATMENT RECOMMENDATIONS						
<input type="checkbox"/> Archaeology	<input type="checkbox"/> Excavate	<input type="checkbox"/> Reset on exist base	<input type="checkbox"/> Reset on salvaged base (if poss)

VII. ADDITIONAL INFORMATION						
Not specifically listed in previous survey. Names listed on marker include Philip (d. 1875), Catharine Heintz (d. 1871), Catharine Portz (d. 1867), Valentin Heintz (d. 1881), Gertrude Justin (d. 1901), Catharina Schmidt (d. 1870), Fred Wolff (d. 1912).

<input checked="" type="checkbox"/> Clean/bio removal	<input type="checkbox"/> Consolidate	<input type="checkbox"/> Composite repair	<input type="checkbox"/> Pin/adhesive repair			
<input type="checkbox"/> Other:	_____					
VI. PHOTOGRAPHS						
Photo 1:			Photo 2:

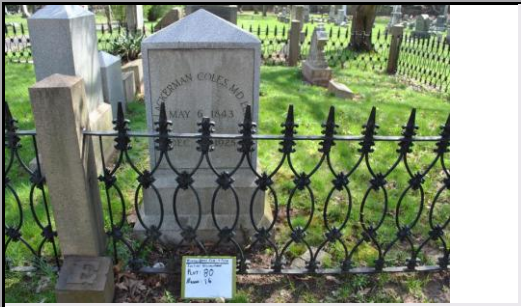
I. BURIAL INFORMATION					II. PRIORITIZATION	
First name	Last name	Birth	Death	Survey date	Condition	Prioritization
J. Ackerman	Coles			4/7/2010	Excellent	Long term
III. LOCATION						
Cemetery Section	Plot/Marker Number	Original Location	Original Marker/Feature			
Willow Grove	080.16	Yes	No			
IV. MARKER INFORMATION						
Marker Type						
Headstone w/ base		Height: 56	Width: 34	Depth: 20		
<input type="checkbox"/> Marble	<input checked="" type="checkbox"/> Granite	<input type="checkbox"/> Sandstone	<input type="checkbox"/> Slate			
<input type="checkbox"/> Brick	<input type="checkbox"/> Iron	<input type="checkbox"/> Other: _____

V. MATERIAL CONDITIONS						
<input checked="" type="checkbox"/> Biological - Algae	<input type="checkbox"/> Biological - Lichens	<input type="checkbox"/> Crack	<input type="checkbox"/> Delamination/Exfoliation			
<input type="checkbox"/> Disaggregation/Erosion	<input type="checkbox"/> Graffiti	<input type="checkbox"/> Off base (missing)	<input type="checkbox"/> Off base (adjacent)			
<input type="checkbox"/> Missing Fragment (s)	<input type="checkbox"/> Previous Repair	<input checked="" type="checkbox"/> Soiling	<input type="checkbox"/> Sunken			
<input type="checkbox"/> Tilt	<input type="checkbox"/> Corrosion					
<input type="checkbox"/> Other:	_____					
VI. TREATMENT RECOMMENDATIONS						
<input type="checkbox"/> Archaeology	<input type="checkbox"/> Excavate	<input type="checkbox"/> Reset on exist base	<input type="checkbox"/> Reset on salvaged base (if poss)			
<input checked="" type="checkbox"/> Clean/bio removal	<input type="checkbox"/> Consolidate	<input type="checkbox"/> Composite repair	<input type="checkbox"/> Pin/adhesive repair

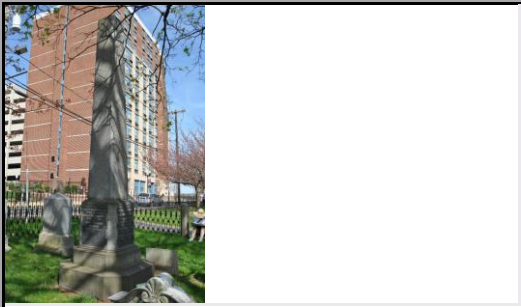
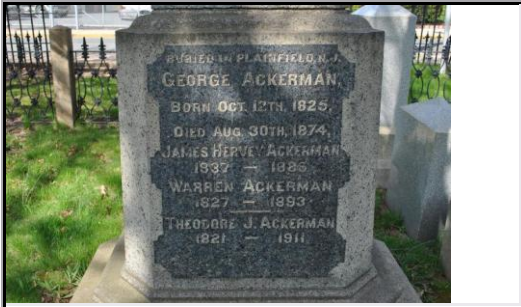
I. BURIAL INFORMATION					II. PRIORITIZATION	
First name	Last name	Birth	Death	Survey date	Condition	Prioritization
				4/7/2010	Excellent	Long term
III. LOCATION						
Cemetery Section	Plot/Marker Number	Original Location	Original Marker/Feature			
Willow Grove	080.00.F	Yes	No			
IV. MARKER INFORMATION						
Marker Type						
Family Marker		Height: 164	Width: 48	Depth: 48		
<input type="checkbox"/> Marble	<input checked="" type="checkbox"/> Granite	<input type="checkbox"/> Sandstone	<input type="checkbox"/> Slate			
<input type="checkbox"/> Brick	<input type="checkbox"/> Iron	<input type="checkbox"/> Other: _____

V. MATERIAL CONDITIONS						
<input type="checkbox"/> Biological - Algae	<input type="checkbox"/> Biological - Lichens	<input type="checkbox"/> Crack	<input type="checkbox"/> Delamination/Exfoliation			
<input type="checkbox"/> Disaggregation/Erosion	<input type="checkbox"/> Graffiti	<input type="checkbox"/> Off base (missing)	<input type="checkbox"/> Off base (adjacent)			
<input type="checkbox"/> Missing Fragment (s)	<input type="checkbox"/> Previous Repair	<input type="checkbox"/> Soiling	<input type="checkbox"/> Sunken			
<input type="checkbox"/> Tilt	<input type="checkbox"/> Corrosion					
<input type="checkbox"/> Other:	_____					
VI. TREATMENT RECOMMENDATIONS						
<input type="checkbox"/> Archaeology	<input type="checkbox"/> Excavate	<input type="checkbox"/> Reset on exist base	<input type="checkbox"/> Reset on salvaged base (if poss)			
<input type="checkbox"/> Clean/bio removal	<input type="checkbox"/> Consolidate	<input type="checkbox"/> Composite repair	<input type="checkbox"/> Pin/adhesive repair

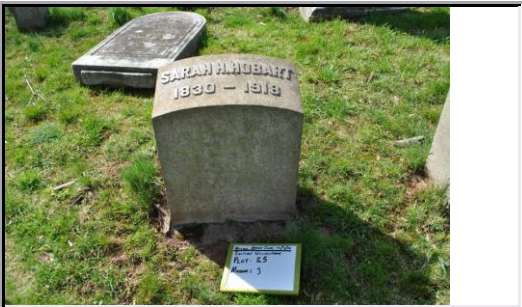
I. BURIAL INFORMATION					II. PRIORITIZATION	
First name	Last name	Birth	Death	Survey date	Condition	Prioritization
Sarah	Hobart	1830	1918	4/7/2010	Excellent	Long term
III. LOCATION						
Cemetery Section	Plot/Marker Number	Original Location	Original Marker/Feature			
Willow Grove	025.03	Unknown	No			
IV. MARKER INFORMATION						
Marker Type						
Headstone		Height: 24	Width: 20	Depth: 10		
<input type="checkbox"/> Marble	<input checked="" type="checkbox"/> Granite	<input type="checkbox"/> Sandstone	<input type="checkbox"/> Slate			
<input type="checkbox"/> Brick	<input type="checkbox"/> Iron	<input type="checkbox"/> Other: _____

V. MATERIAL CONDITIONS						
<input checked="" type="checkbox"/> Biological - Algae	<input type="checkbox"/> Biological - Lichens	<input type="checkbox"/> Crack	<input type="checkbox"/> Delamination/Exfoliation			
<input type="checkbox"/> Disaggregation/Erosion	<input type="checkbox"/> Graffiti	<input type="checkbox"/> Off base (missing)	<input type="checkbox"/> Off base (adjacent)			
<input type="checkbox"/> Missing Fragment (s)	<input type="checkbox"/> Previous Repair	<input type="checkbox"/> Soiling	<input type="checkbox"/> Sunken			
<input type="checkbox"/> Tilt	<input type="checkbox"/> Corrosion					
<input type="checkbox"/> Other:	_____					
VI. TREATMENT RECOMMENDATIONS						
<input type="checkbox"/> Archaeology	<input type="checkbox"/> Excavate	<input type="checkbox"/> Reset on exist base	<input type="checkbox"/> Reset on salvaged base (if poss)			
<input checked="" type="checkbox"/> Clean/bio removal	<input type="checkbox"/> Consolidate	<input type="checkbox"/> Composite repair	<input type="checkbox"/> Pin/adhesive repair

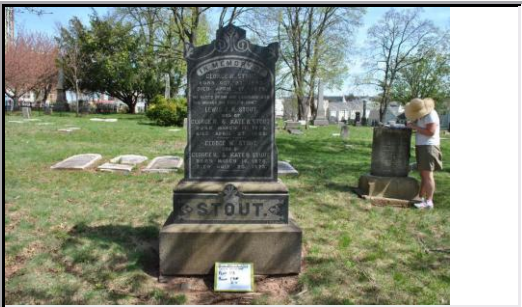
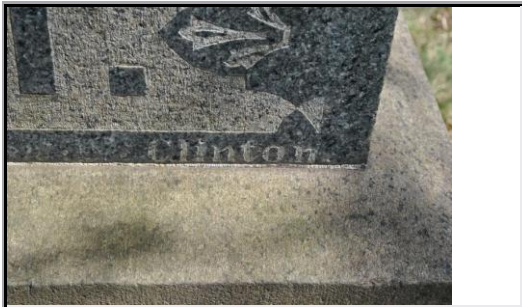
I. BURIAL INFORMATION					II. PRIORITIZATION	
First name	Last name	Birth	Death	Survey date	Condition	Prioritization
	Stout			4/7/2010	Excellent	Long term
III. LOCATION						
Cemetery Section	Plot/Marker Number	Original Location	Original Marker/Feature			
Willow Grove	113.00.F	Unknown	No			
IV. MARKER INFORMATION						
Marker Type						
Family Marker		Height: 72	Width: 42	Depth: 3		
<input type="checkbox"/> Marble	<input checked="" type="checkbox"/> Granite	<input type="checkbox"/> Sandstone	<input type="checkbox"/> Slate			
<input type="checkbox"/> Brick	<input type="checkbox"/> Iron	<input type="checkbox"/> Other: _____

V. MATERIAL CONDITIONS						
<input type="checkbox"/> Biological - Algae	<input type="checkbox"/> Biological - Lichens	<input type="checkbox"/> Crack	<input type="checkbox"/> Delamination/Exfoliation			
<input type="checkbox"/> Disaggregation/Erosion	<input type="checkbox"/> Graffiti	<input type="checkbox"/> Off base (missing)	<input type="checkbox"/> Off base (adjacent)			
<input type="checkbox"/> Missing Fragment (s)	<input type="checkbox"/> Previous Repair	<input type="checkbox"/> Soiling	<input type="checkbox"/> Sunken			
<input type="checkbox"/> Tilt	<input type="checkbox"/> Corrosion					
<input checked="" type="checkbox"/> Other:	Lead/mortar joint failing.					
VI. TREATMENT RECOMMENDATIONS						
<input type="checkbox"/> Archaeology	<input type="checkbox"/> Excavate	<input type="checkbox"/> Reset on exist base	<input type="checkbox"/> Reset on salvaged base (if poss)			
<input checked="" type="checkbox"/> Clean/bio removal	<input type="checkbox"/> Consolidate	<input type="checkbox"/> Composite repair	<input type="checkbox"/> Pin/adhesive repair

VII. ADDITIONAL INFORMATION						
Carver's mark "Clinton" at base.

<input checked="" type="checkbox"/> Other:	Repoint or install new lead joint at junction with base.					
VI. PHOTOGRAPHS						
Photo 1:			Photo 2:

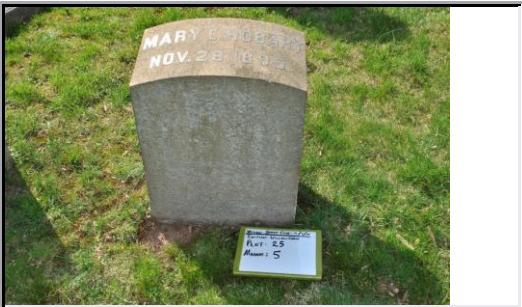
I. BURIAL INFORMATION					II. PRIORITIZATION	
First name	Last name	Birth	Death	Survey date	Condition	Prioritization
Mary E.	Hobart		1895	4/7/2010	Excellent	Long term
III. LOCATION						
Cemetery Section	Plot/Marker Number	Original Location	Original Marker/Feature			
Willow Grove	025.05	Unknown	No			
IV. MARKER INFORMATION						
Marker Type						
Headstone		Height: 24	Width: 20	Depth: 10		
<input type="checkbox"/> Marble	<input checked="" type="checkbox"/> Granite	<input type="checkbox"/> Sandstone	<input type="checkbox"/> Slate			
<input type="checkbox"/> Brick	<input type="checkbox"/> Iron	<input type="checkbox"/> Other: _____

V. MATERIAL CONDITIONS						
<input checked="" type="checkbox"/> Biological - Algae	<input type="checkbox"/> Biological - Lichens	<input type="checkbox"/> Crack	<input type="checkbox"/> Delamination/Exfoliation			
<input type="checkbox"/> Disaggregation/Erosion	<input type="checkbox"/> Graffiti	<input type="checkbox"/> Off base (missing)	<input type="checkbox"/> Off base (adjacent)			
<input type="checkbox"/> Missing Fragment (s)	<input type="checkbox"/> Previous Repair	<input type="checkbox"/> Soiling	<input type="checkbox"/> Sunken			
<input type="checkbox"/> Tilt	<input type="checkbox"/> Corrosion					
<input type="checkbox"/> Other:	_____					
VI. TREATMENT RECOMMENDATIONS						
<input type="checkbox"/> Archaeology	<input type="checkbox"/> Excavate	<input type="checkbox"/> Reset on exist base	<input type="checkbox"/> Reset on salvaged base (if poss)			
<input checked="" type="checkbox"/> Clean/bio removal	<input type="checkbox"/> Consolidate	<input type="checkbox"/> Composite repair	<input type="checkbox"/> Pin/adhesive repair

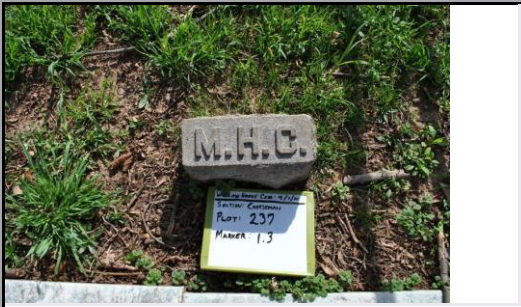
I. BURIAL INFORMATION					II. PRIORITIZATION	
First name	Last name	Birth	Death	Survey date	Condition	Prioritization
M.H.	C	1828	1911	4/7/2010	Excellent	Long term
III. LOCATION						
Cemetery Section	Plot/Marker Number	Original Location	Original Marker/Feature			
Cheesman	237.01.3	Unknown	No			
IV. MARKER INFORMATION						
Marker Type						
Headstone		Height: 9	Width: 15	Depth: 6		
<input type="checkbox"/> Marble	<input checked="" type="checkbox"/> Granite	<input type="checkbox"/> Sandstone	<input type="checkbox"/> Slate			
<input type="checkbox"/> Brick	<input type="checkbox"/> Iron	<input type="checkbox"/> Other: _____

V. MATERIAL CONDITIONS						
<input checked="" type="checkbox"/> Biological - Algae	<input type="checkbox"/> Biological - Lichens	<input type="checkbox"/> Crack	<input type="checkbox"/> Delamination/Exfoliation			
<input type="checkbox"/> Disaggregation/Erosion	<input type="checkbox"/> Graffiti	<input type="checkbox"/> Off base (missing)	<input type="checkbox"/> Off base (adjacent)			
<input type="checkbox"/> Missing Fragment (s)	<input type="checkbox"/> Previous Repair	<input type="checkbox"/> Soiling	<input type="checkbox"/> Sunken			
<input type="checkbox"/> Tilt	<input type="checkbox"/> Corrosion					
<input type="checkbox"/> Other:	_____					
VI. TREATMENT RECOMMENDATIONS						
<input type="checkbox"/> Archaeology	<input type="checkbox"/> Excavate	<input type="checkbox"/> Reset on exist base	<input type="checkbox"/> Reset on salvaged base (if poss)			
<input checked="" type="checkbox"/> Clean/bio removal	<input type="checkbox"/> Consolidate	<input type="checkbox"/> Composite repair	<input type="checkbox"/> Pin/adhesive repair

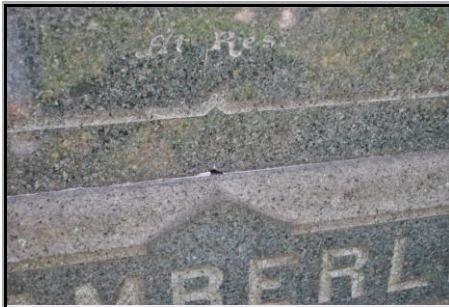
I. BURIAL INFORMATION					II. PRIORITIZATION	
First name	Last name	Birth	Death	Survey date	Condition	Prioritization
Laban, Christianna	Chamberlain	1821	1898	4/7/2010	Excellent	Long term
III. LOCATION						
Cemetery Section	Plot/Marker Number	Original Location	Original Marker/Feature			
Willow Grove	N/A	Unknown	No			
IV. MARKER INFORMATION						
Marker Type						
Headstone w/ base		Height: 64	Width: 48	Depth: 19		
<input type="checkbox"/> Marble	<input checked="" type="checkbox"/> Granite	<input type="checkbox"/> Sandstone	<input type="checkbox"/> Slate			
<input type="checkbox"/> Brick	<input type="checkbox"/> Iron	<input type="checkbox"/> Other: _____

V. MATERIAL CONDITIONS						
<input type="checkbox"/> Biological - Algae	<input type="checkbox"/> Biological - Lichens	<input type="checkbox"/> Crack	<input type="checkbox"/> Delamination/Exfoliation			
<input type="checkbox"/> Disaggregation/Erosion	<input type="checkbox"/> Graffiti	<input type="checkbox"/> Off base (missing)	<input type="checkbox"/> Off base (adjacent)			
<input type="checkbox"/> Missing Fragment (s)	<input type="checkbox"/> Previous Repair	<input type="checkbox"/> Soiling	<input type="checkbox"/> Sunken			
<input type="checkbox"/> Tilt	<input type="checkbox"/> Corrosion					
<input checked="" type="checkbox"/> Other:	Mortar/lead missing at junction of headstone stone and base. Concrete base cracking.					
VI. TREATMENT RECOMMENDATIONS						
<input type="checkbox"/> Archaeology	<input type="checkbox"/> Excavate	<input type="checkbox"/> Reset on exist base	<input type="checkbox"/> Reset on salvaged base (if poss)

<input type="checkbox"/> Clean/bio removal	<input type="checkbox"/> Consolidate	<input type="checkbox"/> Composite repair	<input type="checkbox"/> Pin/adhesive repair			
<input checked="" type="checkbox"/> Other:	Repoint as required.					
VI. PHOTOGRAPHS						
Photo 1:			Photo 2:

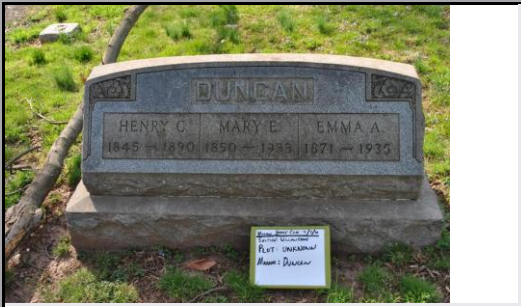
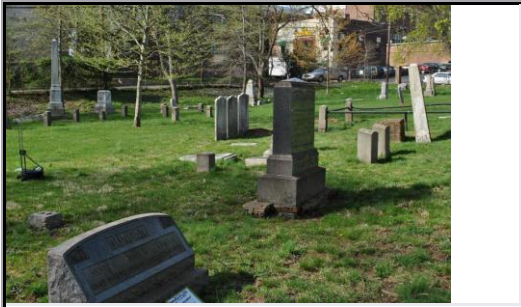
I. BURIAL INFORMATION					II. PRIORITIZATION	
First name	Last name	Birth	Death	Survey date	Condition	Prioritization
Henry, Mary, Emm	Duncan	1845	1890	4/7/2010	Excellent	Long term
III. LOCATION						
Cemetery Section	Plot/Marker Number	Original Location	Original Marker/Feature			
Willow Grove	N/A	Unknown	No			
IV. MARKER INFORMATION						
Marker Type						
Headstone w/ base		Height: 27	Width: 56	Depth: 18		
<input type="checkbox"/> Marble	<input checked="" type="checkbox"/> Granite	<input type="checkbox"/> Sandstone	<input type="checkbox"/> Slate			
<input type="checkbox"/> Brick	<input type="checkbox"/> Iron	<input type="checkbox"/> Other: _____

V. MATERIAL CONDITIONS						
<input checked="" type="checkbox"/> Biological - Algae	<input type="checkbox"/> Biological - Lichens	<input type="checkbox"/> Crack	<input type="checkbox"/> Delamination/Exfoliation			
<input type="checkbox"/> Disaggregation/Erosion	<input type="checkbox"/> Graffiti	<input type="checkbox"/> Off base (missing)	<input type="checkbox"/> Off base (adjacent)			
<input type="checkbox"/> Missing Fragment (s)	<input type="checkbox"/> Previous Repair	<input type="checkbox"/> Soiling	<input type="checkbox"/> Sunken			
<input type="checkbox"/> Tilt	<input type="checkbox"/> Corrosion					
<input checked="" type="checkbox"/> Other:	Mortar/lead missing at junction of headstone stone and base. Concrete base cracking.					
VI. TREATMENT RECOMMENDATIONS						
<input type="checkbox"/> Archaeology	<input type="checkbox"/> Excavate	<input type="checkbox"/> Reset on exist base	<input type="checkbox"/> Reset on salvaged base (if poss)

<input checked="" type="checkbox"/> Clean/bio removal	<input type="checkbox"/> Consolidate	<input type="checkbox"/> Composite repair	<input type="checkbox"/> Pin/adhesive repair			
<input checked="" type="checkbox"/> Other:	Repoint as required.					
VI. PHOTOGRAPHS						
Photo 1:			Photo 2:

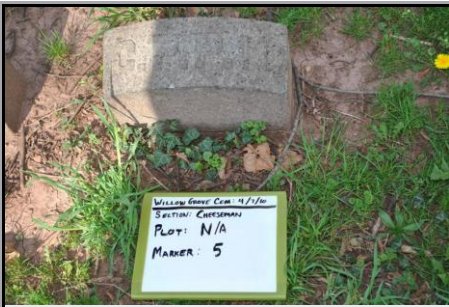
VI. PHOTOGRAPHS	
Photo 1:

I. BURIAL INFORMATION					II. PRIORITIZATION	
First name	Last name	Birth	Death	Survey date	Condition	Prioritization
C.P.P.	H.			4/7/2010	Excellent	Long term

V. MATERIAL CONDITIONS			
<input checked="" type="checkbox"/> Biological - Algae	<input type="checkbox"/> Biological - Lichens	<input type="checkbox"/> Crack	<input type="checkbox"/> Delamination/Exfoliation
<input type="checkbox"/> Disaggregation/Erosion	<input type="checkbox"/> Graffiti	<input type="checkbox"/> Off base (missing)	<input type="checkbox"/> Off base (adjacent)
<input type="checkbox"/> Missing Fragment (s)	<input type="checkbox"/> Previous Repair	<input checked="" type="checkbox"/> Soiling	<input type="checkbox"/> Sunken
<input type="checkbox"/> Tilt	<input type="checkbox"/> Corrosion		
<input type="checkbox"/> Other:	_____

VI. TREATMENT RECOMMENDATIONS			
<input type="checkbox"/> Archaeology	<input type="checkbox"/> Excavate	<input type="checkbox"/> Reset on exist base	<input type="checkbox"/> Reset on salvaged base (if poss)
<input checked="" type="checkbox"/> Clean/bio removal	<input type="checkbox"/> Consolidate	<input type="checkbox"/> Composite repair	<input type="checkbox"/> Pin/adhesive repair
<input type="checkbox"/> Other:	_____

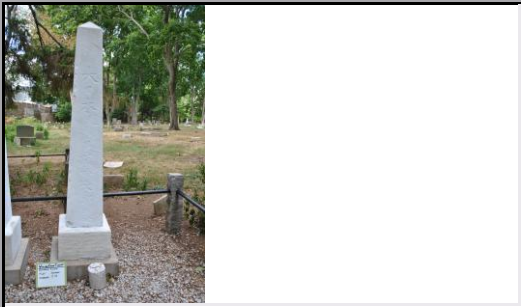
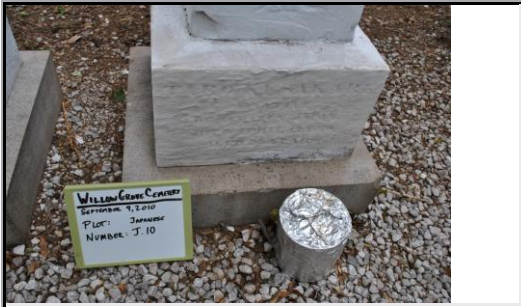
I. BURIAL INFORMATION					II. PRIORITIZATION	
First name	Last name	Birth	Death	Survey date	Condition	Prioritization
Taro	Kusakabe	0	1870	9/9/2010	Excellent	Long term
III. LOCATION						
Cemetery Section	Plot/Marker Number	Original Location	Original Marker/Feature			
Willow Grove	J.10	Yes	Yes			
IV. MARKER INFORMATION						
Marker Type						
Obelisk	Height: 96	Width: 26	Depth: 26			
<input checked="" type="checkbox"/> Marble	<input checked="" type="checkbox"/> Granite	<input type="checkbox"/> Sandstone	<input type="checkbox"/> Slate			
<input type="checkbox"/> Brick	<input type="checkbox"/> Iron	<input checked="" type="checkbox"/> Other: Slurry, limewash

V. MATERIAL CONDITIONS						
<input type="checkbox"/> Biological - Algae	<input type="checkbox"/> Biological - Lichens	<input type="checkbox"/> Crack	<input type="checkbox"/> Delamination/Exfoliation			
<input type="checkbox"/> Disaggregation/Erosion	<input type="checkbox"/> Graffiti	<input type="checkbox"/> Off base (missing)	<input type="checkbox"/> Off base (adjacent)			
<input type="checkbox"/> Missing Fragment (s)	<input checked="" type="checkbox"/> Previous Repair	<input type="checkbox"/> Soiling	<input type="checkbox"/> Sunken			
<input type="checkbox"/> Tilt	<input type="checkbox"/> Corrosion					
<input type="checkbox"/> Other:						
VI. TREATMENT RECOMMENDATIONS						
<input type="checkbox"/> Archaeology	<input type="checkbox"/> Excavate	<input type="checkbox"/> Reset on exist base	<input type="checkbox"/> Reset on salvaged base (if poss)			
<input type="checkbox"/> Clean/bio removal	<input type="checkbox"/> Consolidate	<input type="checkbox"/> Composite repair	<input type="checkbox"/> Pin/adhesive repair

<input checked="" type="checkbox"/> Other:	Marker was restored in 2010. No immediate action required.					
VI. PHOTOGRAPHS						
Photo 1:			Photo 2:

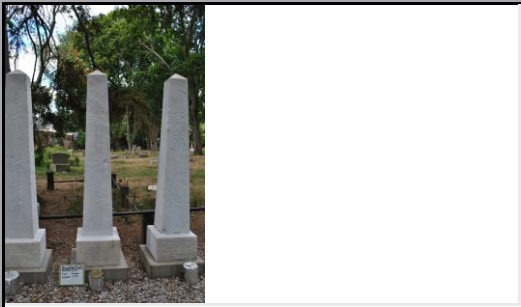
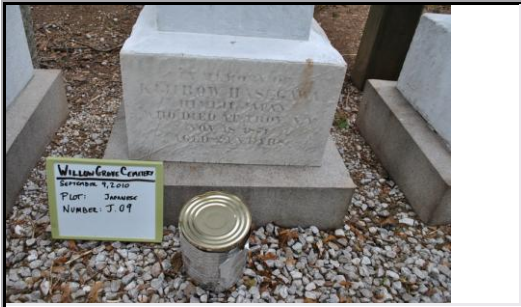
I. BURIAL INFORMATION					II. PRIORITIZATION	
First name	Last name	Birth	Death	Survey date	Condition	Prioritization
Kijiro	Hasegawa	0	1871	9/9/2010	Excellent	Long term
III. LOCATION						
Cemetery Section	Plot/Marker Number	Original Location	Original Marker/Feature			
Willow Grove	J.09	Yes	Yes			
IV. MARKER INFORMATION						
Marker Type						
Obelisk	Height: 96	Width: 26	Depth: 26			
<input checked="" type="checkbox"/> Marble	<input checked="" type="checkbox"/> Granite	<input type="checkbox"/> Sandstone	<input type="checkbox"/> Slate			
<input type="checkbox"/> Brick	<input type="checkbox"/> Iron	<input checked="" type="checkbox"/> Other: Slurry, limewash

V. MATERIAL CONDITIONS						
<input type="checkbox"/> Biological - Algae	<input type="checkbox"/> Biological - Lichens	<input type="checkbox"/> Crack	<input type="checkbox"/> Delamination/Exfoliation			
<input type="checkbox"/> Disaggregation/Erosion	<input type="checkbox"/> Graffiti	<input type="checkbox"/> Off base (missing)	<input type="checkbox"/> Off base (adjacent)			
<input type="checkbox"/> Missing Fragment (s)	<input type="checkbox"/> Previous Repair	<input checked="" type="checkbox"/> Soiling	<input type="checkbox"/> Sunken			
<input type="checkbox"/> Tilt	<input type="checkbox"/> Corrosion					
<input type="checkbox"/> Other:						
VI. TREATMENT RECOMMENDATIONS						
<input type="checkbox"/> Archaeology	<input type="checkbox"/> Excavate	<input type="checkbox"/> Reset on exist base	<input type="checkbox"/> Reset on salvaged base (if poss)			
<input type="checkbox"/> Clean/bio removal	<input type="checkbox"/> Consolidate	<input type="checkbox"/> Composite repair	<input type="checkbox"/> Pin/adhesive repair

<input checked="" type="checkbox"/> Other:	Marker was restored in 2010. No immediate action required.					
VI. PHOTOGRAPHS						
Photo 1:			Photo 2:

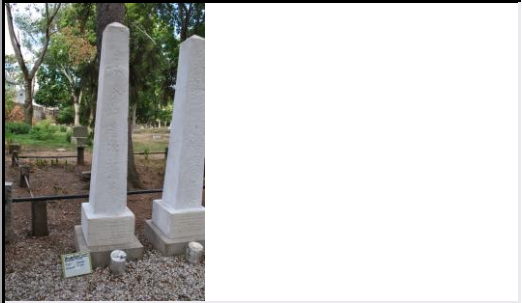
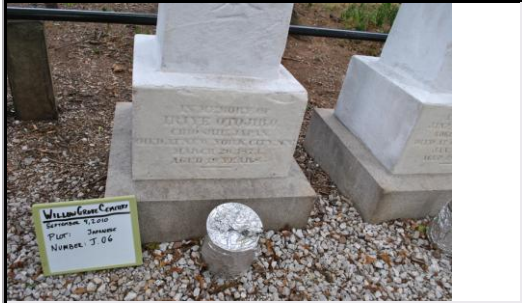
I. BURIAL INFORMATION					II. PRIORITIZATION	
First name	Last name	Birth	Death	Survey date	Condition	Prioritization
Otojiro	Irie	0	1874	9/9/2010	Excellent	Long term

V. MATERIAL CONDITIONS			
<input type="checkbox"/> Biological - Algae	<input type="checkbox"/> Biological - Lichens	<input type="checkbox"/> Crack	<input type="checkbox"/> Delamination/Exfoliation
<input type="checkbox"/> Disaggregation/Erosion	<input type="checkbox"/> Graffiti	<input type="checkbox"/> Off base (missing)	<input type="checkbox"/> Off base (adjacent)
<input type="checkbox"/> Missing Fragment (s)	<input checked="" type="checkbox"/> Previous Repair	<input type="checkbox"/> Soiling	<input type="checkbox"/> Sunken
<input type="checkbox"/> Tilt	<input type="checkbox"/> Corrosion		
<input type="checkbox"/> Other:

VI. TREATMENT RECOMMENDATIONS			
<input type="checkbox"/> Archaeology	<input type="checkbox"/> Excavate	<input type="checkbox"/> Reset on exist base	<input type="checkbox"/> Reset on salvaged base (if poss)
<input type="checkbox"/> Clean/bio removal	<input type="checkbox"/> Consolidate	<input type="checkbox"/> Composite repair	<input type="checkbox"/> Pin/adhesive repair
<input checked="" type="checkbox"/> Other:	Marker was restored in 2010. No immediate action required.

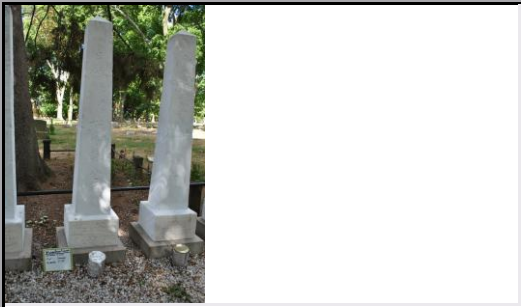
I. BURIAL INFORMATION					II. PRIORITIZATION	
First name	Last name	Birth	Death	Survey date	Condition	Prioritization
Kosuke	Matsukata	0	1872	9/9/2010	Excellent	Long term
III. LOCATION						
Cemetery Section	Plot/Marker Number	Original Location	Original Marker/Feature			
Willow Grove	J.08	Yes	Yes			
IV. MARKER INFORMATION						
Marker Type						
Obelisk		Height: 96	Width: 26	Depth: 26		
<input checked="" type="checkbox"/> Marble	<input checked="" type="checkbox"/> Granite	<input type="checkbox"/> Sandstone	<input type="checkbox"/> Slate			
<input type="checkbox"/> Brick	<input type="checkbox"/> Iron	<input checked="" type="checkbox"/> Other: Slurry, limewash

V. MATERIAL CONDITIONS						
<input type="checkbox"/> Biological - Algae	<input type="checkbox"/> Biological - Lichens	<input type="checkbox"/> Crack	<input type="checkbox"/> Delamination/Exfoliation			
<input type="checkbox"/> Disaggregation/Erosion	<input type="checkbox"/> Graffiti	<input type="checkbox"/> Off base (missing)	<input type="checkbox"/> Off base (adjacent)			
<input type="checkbox"/> Missing Fragment (s)	<input type="checkbox"/> Previous Repair	<input checked="" type="checkbox"/> Soiling	<input type="checkbox"/> Sunken			
<input type="checkbox"/> Tilt	<input type="checkbox"/> Corrosion					
<input type="checkbox"/> Other:						
VI. TREATMENT RECOMMENDATIONS						
<input type="checkbox"/> Archaeology	<input type="checkbox"/> Excavate	<input type="checkbox"/> Reset on exist base	<input type="checkbox"/> Reset on salvaged base (if poss)			
<input type="checkbox"/> Clean/bio removal	<input type="checkbox"/> Consolidate	<input type="checkbox"/> Composite repair	<input type="checkbox"/> Pin/adhesive repair

<input checked="" type="checkbox"/> Other:	Marker was restored in 2010. No immediate action required.					
VI. PHOTOGRAPHS						
Photo 1:			Photo 2:

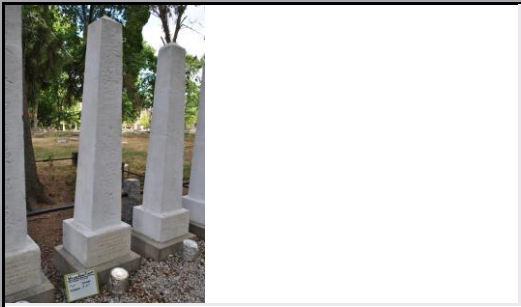
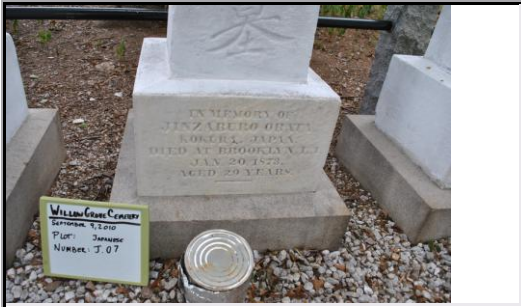
I. BURIAL INFORMATION					II. PRIORITIZATION	
First name	Last name	Birth	Death	Survey date	Condition	Prioritization
Jinzabura	Obata	0	1873	9/9/2010	Excellent	Long term
III. LOCATION						
Cemetery Section	Plot/Marker Number	Original Location	Original Marker/Feature			
Willow Grove	J.07	Yes	Yes			
IV. MARKER INFORMATION						
Marker Type						
Obelisk	Height: 96	Width: 26	Depth: 26			
<input checked="" type="checkbox"/> Marble	<input checked="" type="checkbox"/> Granite	<input type="checkbox"/> Sandstone	<input type="checkbox"/> Slate			
<input type="checkbox"/> Brick	<input type="checkbox"/> Iron	<input checked="" type="checkbox"/> Other: Slurry, limewash

V. MATERIAL CONDITIONS						
<input type="checkbox"/> Biological - Algae	<input type="checkbox"/> Biological - Lichens	<input type="checkbox"/> Crack	<input type="checkbox"/> Delamination/Exfoliation			
<input type="checkbox"/> Disaggregation/Erosion	<input type="checkbox"/> Graffiti	<input type="checkbox"/> Off base (missing)	<input type="checkbox"/> Off base (adjacent)			
<input type="checkbox"/> Missing Fragment (s)	<input checked="" type="checkbox"/> Previous Repair	<input type="checkbox"/> Soiling	<input type="checkbox"/> Sunken			
<input type="checkbox"/> Tilt	<input type="checkbox"/> Corrosion					
<input type="checkbox"/> Other:						
VI. TREATMENT RECOMMENDATIONS						
<input type="checkbox"/> Archaeology	<input type="checkbox"/> Excavate	<input type="checkbox"/> Reset on exist base	<input type="checkbox"/> Reset on salvaged base (if poss)			
<input type="checkbox"/> Clean/bio removal	<input type="checkbox"/> Consolidate	<input type="checkbox"/> Composite repair	<input type="checkbox"/> Pin/adhesive repair

<input checked="" type="checkbox"/> Other:	Marker was restored in 2010. No immediate action required.					
VI. PHOTOGRAPHS						
Photo 1:			Photo 2:

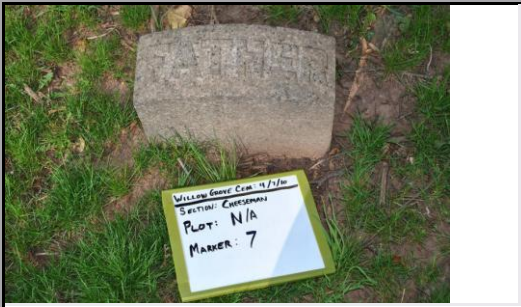
I. BURIAL INFORMATION					II. PRIORITIZATION	
First name	Last name	Birth	Death	Survey date	Condition	Prioritization
Father				4/7/2010	Excellent	Long term
III. LOCATION						
Cemetery Section	Plot/Marker Number	Original Location	Original Marker/Feature			
Cheesman	250.07	Unknown	No			
IV. MARKER INFORMATION						
Marker Type						
Headstone		Height: 10	Width: 16	Depth: 5		
<input type="checkbox"/> Marble	<input checked="" type="checkbox"/> Granite	<input type="checkbox"/> Sandstone	<input type="checkbox"/> Slate			
<input type="checkbox"/> Brick	<input type="checkbox"/> Iron	<input type="checkbox"/> Other: _____

V. MATERIAL CONDITIONS						
<input checked="" type="checkbox"/> Biological - Algae	<input type="checkbox"/> Biological - Lichens	<input type="checkbox"/> Crack	<input type="checkbox"/> Delamination/Exfoliation			
<input type="checkbox"/> Disaggregation/Erosion	<input type="checkbox"/> Graffiti	<input type="checkbox"/> Off base (missing)	<input type="checkbox"/> Off base (adjacent)			
<input type="checkbox"/> Missing Fragment (s)	<input type="checkbox"/> Previous Repair	<input checked="" type="checkbox"/> Soiling	<input type="checkbox"/> Sunken			
<input type="checkbox"/> Tilt	<input type="checkbox"/> Corrosion					
<input type="checkbox"/> Other:	_____					
VI. TREATMENT RECOMMENDATIONS						
<input type="checkbox"/> Archaeology	<input type="checkbox"/> Excavate	<input type="checkbox"/> Reset on exist base	<input type="checkbox"/> Reset on salvaged base (if poss)			
<input checked="" type="checkbox"/> Clean/bio removal	<input type="checkbox"/> Consolidate	<input type="checkbox"/> Composite repair	<input type="checkbox"/> Pin/adhesive repair

VII. ADDITIONAL INFORMATION						
Not specifically listed in previous survey.

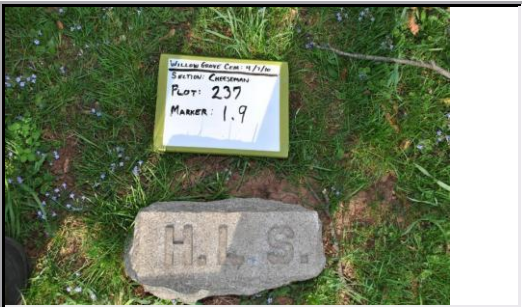
I. BURIAL INFORMATION					II. PRIORITIZATION	
First name	Last name	Birth	Death	Survey date	Condition	Prioritization
H.L.	S	1861	1883	4/7/2010	Excellent	Long term
III. LOCATION						
Cemetery Section	Plot/Marker Number	Original Location	Original Marker/Feature			
Cheesman	237.01.9	Unknown	No			
IV. MARKER INFORMATION						
Marker Type						
Headstone		Height: 9	Width: 15	Depth: 6		
<input type="checkbox"/> Marble	<input checked="" type="checkbox"/> Granite	<input type="checkbox"/> Sandstone	<input type="checkbox"/> Slate			
<input type="checkbox"/> Brick	<input type="checkbox"/> Iron	<input type="checkbox"/> Other: _____

V. MATERIAL CONDITIONS						
<input checked="" type="checkbox"/> Biological - Algae	<input type="checkbox"/> Biological - Lichens	<input type="checkbox"/> Crack	<input type="checkbox"/> Delamination/Exfoliation			
<input type="checkbox"/> Disaggregation/Erosion	<input type="checkbox"/> Graffiti	<input type="checkbox"/> Off base (missing)	<input type="checkbox"/> Off base (adjacent)			
<input type="checkbox"/> Missing Fragment (s)	<input type="checkbox"/> Previous Repair	<input type="checkbox"/> Soiling	<input type="checkbox"/> Sunken			
<input type="checkbox"/> Tilt	<input type="checkbox"/> Corrosion					
<input type="checkbox"/> Other:	_____					
VI. TREATMENT RECOMMENDATIONS						
<input type="checkbox"/> Archaeology	<input type="checkbox"/> Excavate	<input type="checkbox"/> Reset on exist base	<input type="checkbox"/> Reset on salvaged base (if poss)			
<input checked="" type="checkbox"/> Clean/bio removal	<input type="checkbox"/> Consolidate	<input type="checkbox"/> Composite repair	<input type="checkbox"/> Pin/adhesive repair

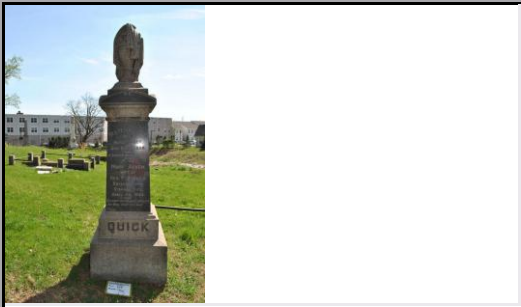
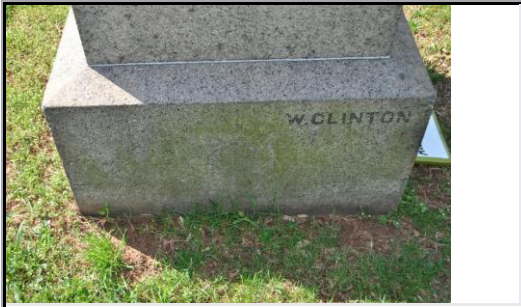
I. BURIAL INFORMATION					II. PRIORITIZATION	
First name	Last name	Birth	Death	Survey date	Condition	Prioritization
				4/7/2010	Excellent	Long term
III. LOCATION						
Cemetery Section	Plot/Marker Number	Original Location	Original Marker/Feature			
Cheesman	228.00.F	Unknown	No			
IV. MARKER INFORMATION						
Marker Type						
Family Marker		Height: 120	Width: 33	Depth: 33		
<input type="checkbox"/> Marble	<input checked="" type="checkbox"/> Granite	<input type="checkbox"/> Sandstone	<input type="checkbox"/> Slate			
<input type="checkbox"/> Brick	<input type="checkbox"/> Iron	<input type="checkbox"/> Other: _____

V. MATERIAL CONDITIONS						
<input checked="" type="checkbox"/> Biological - Algae	<input type="checkbox"/> Biological - Lichens	<input type="checkbox"/> Crack	<input type="checkbox"/> Delamination/Exfoliation			
<input type="checkbox"/> Disaggregation/Erosion	<input checked="" type="checkbox"/> Graffiti	<input type="checkbox"/> Off base (missing)	<input type="checkbox"/> Off base (adjacent)			
<input type="checkbox"/> Missing Fragment (s)	<input type="checkbox"/> Previous Repair	<input type="checkbox"/> Soiling	<input type="checkbox"/> Sunken			
<input type="checkbox"/> Tilt	<input type="checkbox"/> Corrosion					
<input type="checkbox"/> Other:	_____					
VI. TREATMENT RECOMMENDATIONS						
<input type="checkbox"/> Archaeology	<input type="checkbox"/> Excavate	<input type="checkbox"/> Reset on exist base	<input type="checkbox"/> Reset on salvaged base (if poss)			
<input checked="" type="checkbox"/> Clean/bio removal	<input type="checkbox"/> Consolidate	<input type="checkbox"/> Composite repair	<input type="checkbox"/> Pin/adhesive repair

VII. ADDITIONAL INFORMATION						
Name of carver inscribed on base: "W. Clinton."

<input checked="" type="checkbox"/> Other:	Remove graffiti.					
VI. PHOTOGRAPHS						
Photo 1:			Photo 2:

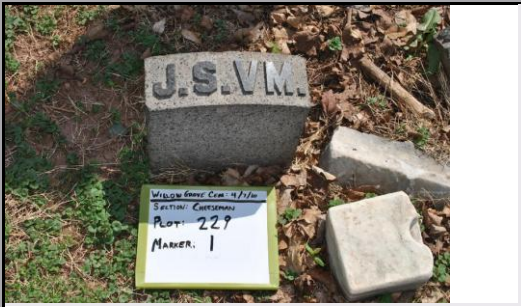
I. BURIAL INFORMATION					II. PRIORITIZATION	
First name	Last name	Birth	Death	Survey date	Condition	Prioritization
J.S.	Van Marter	1837	1908	4/7/2010	Excellent	Long term
III. LOCATION						
Cemetery Section	Plot/Marker Number	Original Location	Original Marker/Feature			
Cheesman	229.01	Unknown	No			
IV. MARKER INFORMATION						
Marker Type						
Headstone		Height: 13	Width: 12	Depth: 4		
<input type="checkbox"/> Marble	<input checked="" type="checkbox"/> Granite	<input type="checkbox"/> Sandstone	<input type="checkbox"/> Slate			
<input type="checkbox"/> Brick	<input type="checkbox"/> Iron	<input type="checkbox"/> Other: _____

V. MATERIAL CONDITIONS						
<input type="checkbox"/> Biological - Algae	<input type="checkbox"/> Biological - Lichens	<input type="checkbox"/> Crack	<input type="checkbox"/> Delamination/Exfoliation			
<input type="checkbox"/> Disaggregation/Erosion	<input type="checkbox"/> Graffiti	<input type="checkbox"/> Off base (missing)	<input type="checkbox"/> Off base (adjacent)			
<input type="checkbox"/> Missing Fragment (s)	<input type="checkbox"/> Previous Repair	<input type="checkbox"/> Soiling	<input type="checkbox"/> Sunken			
<input type="checkbox"/> Tilt	<input type="checkbox"/> Corrosion					
<input type="checkbox"/> Other:	_____					
VI. TREATMENT RECOMMENDATIONS						
<input type="checkbox"/> Archaeology	<input type="checkbox"/> Excavate	<input type="checkbox"/> Reset on exist base	<input type="checkbox"/> Reset on salvaged base (if poss)			
<input checked="" type="checkbox"/> Clean/bio removal	<input type="checkbox"/> Consolidate	<input type="checkbox"/> Composite repair	<input type="checkbox"/> Pin/adhesive repair

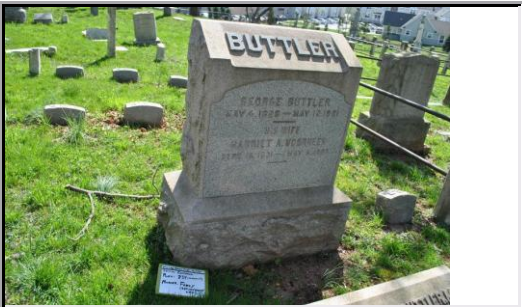
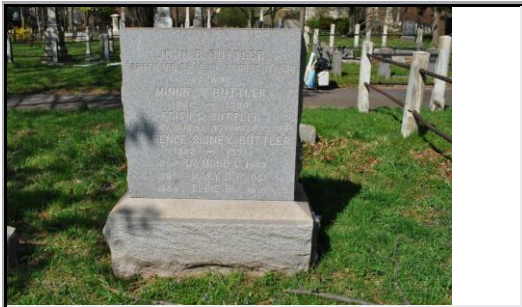
I. BURIAL INFORMATION					II. PRIORITIZATION	
First name	Last name	Birth	Death	Survey date	Condition	Prioritization
	Buttler			4/7/2010	Excellent	Long term
III. LOCATION						
Cemetery Section	Plot/Marker Number	Original Location	Original Marker/Feature			
Cheesman	234.00.F	Unknown	No			
IV. MARKER INFORMATION						
Marker Type						
Footstone		Height: 53	Width: 44	Depth: 23		
<input type="checkbox"/> Marble	<input checked="" type="checkbox"/> Granite	<input type="checkbox"/> Sandstone	<input type="checkbox"/> Slate			
<input type="checkbox"/> Brick	<input type="checkbox"/> Iron	<input type="checkbox"/> Other: _____

V. MATERIAL CONDITIONS						
<input type="checkbox"/> Biological - Algae	<input type="checkbox"/> Biological - Lichens	<input type="checkbox"/> Crack	<input type="checkbox"/> Delamination/Exfoliation			
<input type="checkbox"/> Disaggregation/Erosion	<input type="checkbox"/> Graffiti	<input type="checkbox"/> Off base (missing)	<input type="checkbox"/> Off base (adjacent)			
<input type="checkbox"/> Missing Fragment (s)	<input type="checkbox"/> Previous Repair	<input type="checkbox"/> Soiling	<input type="checkbox"/> Sunken			
<input type="checkbox"/> Tilt	<input type="checkbox"/> Corrosion					
<input checked="" type="checkbox"/> Other:	Very light metallic staining.					
VI. TREATMENT RECOMMENDATIONS						
<input type="checkbox"/> Archaeology	<input type="checkbox"/> Excavate	<input type="checkbox"/> Reset on exist base	<input type="checkbox"/> Reset on salvaged base (if poss)			
<input checked="" type="checkbox"/> Clean/bio removal	<input type="checkbox"/> Consolidate	<input type="checkbox"/> Composite repair	<input type="checkbox"/> Pin/adhesive repair

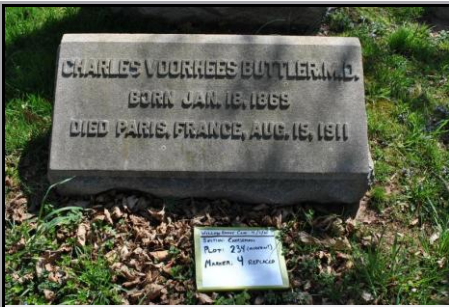
V. MATERIAL CONDITIONS						
<input checked="" type="checkbox"/> Biological - Algae	<input type="checkbox"/> Biological - Lichens	<input type="checkbox"/> Crack	<input type="checkbox"/> Delamination/Exfoliation			
<input type="checkbox"/> Disaggregation/Erosion	<input type="checkbox"/> Graffiti	<input type="checkbox"/> Off base (missing)	<input type="checkbox"/> Off base (adjacent)			
<input type="checkbox"/> Missing Fragment (s)	<input type="checkbox"/> Previous Repair	<input type="checkbox"/> Soiling	<input type="checkbox"/> Sunken			
<input type="checkbox"/> Tilt	<input type="checkbox"/> Corrosion					
<input type="checkbox"/> Other:	_____					
VI. TREATMENT RECOMMENDATIONS						
<input type="checkbox"/> Archaeology	<input type="checkbox"/> Excavate	<input type="checkbox"/> Reset on exist base	<input type="checkbox"/> Reset on salvaged base (if poss)			
<input checked="" type="checkbox"/> Clean/bio removal	<input type="checkbox"/> Consolidate	<input type="checkbox"/> Composite repair	<input type="checkbox"/> Pin/adhesive repair

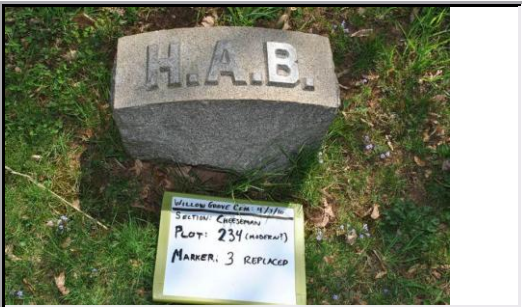
I. BURIAL INFORMATION					II. PRIORITIZATION	
First name	Last name	Birth	Death	Survey date	Condition	Prioritization
H.A.	B.	1831	1905	4/7/2010	Excellent	Long term
III. LOCATION						
Cemetery Section	Plot/Marker Number	Original Location	Original Marker/Feature			
Cheesman	234.03	Unknown	No			
IV. MARKER INFORMATION						
Marker Type						
Headstone		Height: 12	Width: 16	Depth: 8		
<input type="checkbox"/> Marble	<input type="checkbox"/> Granite	<input type="checkbox"/> Sandstone	<input type="checkbox"/> Slate			
<input type="checkbox"/> Brick	<input type="checkbox"/> Iron	<input type="checkbox"/> Other: _____

V. MATERIAL CONDITIONS						
<input type="checkbox"/> Biological - Algae	<input type="checkbox"/> Biological - Lichens	<input type="checkbox"/> Crack	<input type="checkbox"/> Delamination/Exfoliation			
<input type="checkbox"/> Disaggregation/Erosion	<input type="checkbox"/> Graffiti	<input type="checkbox"/> Off base (missing)	<input type="checkbox"/> Off base (adjacent)			
<input type="checkbox"/> Missing Fragment (s)	<input type="checkbox"/> Previous Repair	<input type="checkbox"/> Soiling	<input type="checkbox"/> Sunken			
<input type="checkbox"/> Tilt	<input type="checkbox"/> Corrosion					
<input type="checkbox"/> Other:	_____					
VI. TREATMENT RECOMMENDATIONS						
<input type="checkbox"/> Archaeology	<input type="checkbox"/> Excavate	<input type="checkbox"/> Reset on exist base	<input type="checkbox"/> Reset on salvaged base (if poss)			
<input checked="" type="checkbox"/> Clean/bio removal	<input type="checkbox"/> Consolidate	<input type="checkbox"/> Composite repair	<input type="checkbox"/> Pin/adhesive repair

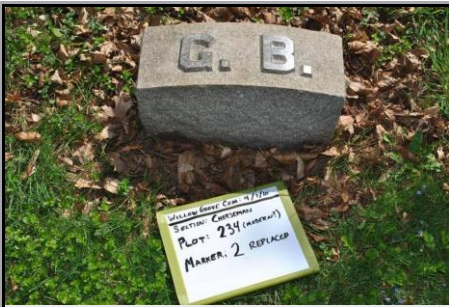
I. BURIAL INFORMATION					II. PRIORITIZATION	
First name	Last name	Birth	Death	Survey date	Condition	Prioritization
G.	B.	1828	1901	4/7/2010	Excellent	Long term
III. LOCATION						
Cemetery Section	Plot/Marker Number	Original Location	Original Marker/Feature			
Cheesman	234.02	Unknown	No			
IV. MARKER INFORMATION						
Marker Type						
Headstone		Height: 12	Width: 16	Depth: 8		
<input type="checkbox"/> Marble	<input checked="" type="checkbox"/> Granite	<input type="checkbox"/> Sandstone	<input type="checkbox"/> Slate			
<input type="checkbox"/> Brick	<input type="checkbox"/> Iron	<input type="checkbox"/> Other: _____

V. MATERIAL CONDITIONS						
<input type="checkbox"/> Biological - Algae	<input type="checkbox"/> Biological - Lichens	<input type="checkbox"/> Crack	<input type="checkbox"/> Delamination/Exfoliation			
<input type="checkbox"/> Disaggregation/Erosion	<input type="checkbox"/> Graffiti	<input type="checkbox"/> Off base (missing)	<input type="checkbox"/> Off base (adjacent)			
<input type="checkbox"/> Missing Fragment (s)	<input type="checkbox"/> Previous Repair	<input type="checkbox"/> Soiling	<input type="checkbox"/> Sunken			
<input type="checkbox"/> Tilt	<input type="checkbox"/> Corrosion					
<input type="checkbox"/> Other:	_____					
VI. TREATMENT RECOMMENDATIONS						
<input type="checkbox"/> Archaeology	<input type="checkbox"/> Excavate	<input type="checkbox"/> Reset on exist base	<input type="checkbox"/> Reset on salvaged base (if poss)			
<input type="checkbox"/> Clean/bio removal	<input type="checkbox"/> Consolidate	<input type="checkbox"/> Composite repair	<input type="checkbox"/> Pin/adhesive repair

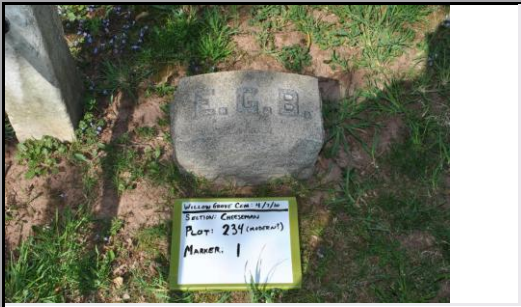
I. BURIAL INFORMATION					II. PRIORITIZATION	
First name	Last name	Birth	Death	Survey date	Condition	Prioritization
E.G.	B.	1857	1860	4/7/2010	Excellent	Long term
III. LOCATION						
Cemetery Section	Plot/Marker Number	Original Location	Original Marker/Feature			
Cheesman	234.01	Unknown	No			
IV. MARKER INFORMATION						
Marker Type						
Headstone		Height: 12	Width: 16	Depth: 8		
<input type="checkbox"/> Marble	<input checked="" type="checkbox"/> Granite	<input type="checkbox"/> Sandstone	<input type="checkbox"/> Slate			
<input type="checkbox"/> Brick	<input type="checkbox"/> Iron	<input type="checkbox"/> Other: _____

V. MATERIAL CONDITIONS						
<input type="checkbox"/> Biological - Algae	<input type="checkbox"/> Biological - Lichens	<input type="checkbox"/> Crack	<input type="checkbox"/> Delamination/Exfoliation			
<input type="checkbox"/> Disaggregation/Erosion	<input type="checkbox"/> Graffiti	<input type="checkbox"/> Off base (missing)	<input type="checkbox"/> Off base (adjacent)			
<input type="checkbox"/> Missing Fragment (s)	<input type="checkbox"/> Previous Repair	<input type="checkbox"/> Soiling	<input type="checkbox"/> Sunken			
<input type="checkbox"/> Tilt	<input type="checkbox"/> Corrosion					
<input type="checkbox"/> Other:	_____					
VI. TREATMENT RECOMMENDATIONS						
<input type="checkbox"/> Archaeology	<input type="checkbox"/> Excavate	<input type="checkbox"/> Reset on exist base	<input type="checkbox"/> Reset on salvaged base (if poss)			
<input checked="" type="checkbox"/> Clean/bio removal	<input type="checkbox"/> Consolidate	<input type="checkbox"/> Composite repair	<input type="checkbox"/> Pin/adhesive repair

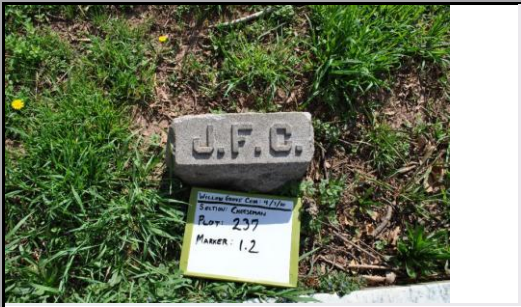
I. BURIAL INFORMATION					II. PRIORITIZATION	
First name	Last name	Birth	Death	Survey date	Condition	Prioritization
J.F.	C	1826	1870	4/7/2010	Excellent	Long term
III. LOCATION						
Cemetery Section	Plot/Marker Number	Original Location	Original Marker/Feature			
Cheesman	237.01.2	Unknown	No			
IV. MARKER INFORMATION						
Marker Type						
Headstone		Height: 9	Width: 15	Depth: 6		
<input type="checkbox"/> Marble	<input checked="" type="checkbox"/> Granite	<input type="checkbox"/> Sandstone	<input type="checkbox"/> Slate			
<input type="checkbox"/> Brick	<input type="checkbox"/> Iron	<input type="checkbox"/> Other: _____

V. MATERIAL CONDITIONS						
<input checked="" type="checkbox"/> Biological - Algae	<input type="checkbox"/> Biological - Lichens	<input type="checkbox"/> Crack	<input type="checkbox"/> Delamination/Exfoliation			
<input type="checkbox"/> Disaggregation/Erosion	<input type="checkbox"/> Graffiti	<input type="checkbox"/> Off base (missing)	<input type="checkbox"/> Off base (adjacent)			
<input type="checkbox"/> Missing Fragment (s)	<input type="checkbox"/> Previous Repair	<input type="checkbox"/> Soiling	<input type="checkbox"/> Sunken			
<input type="checkbox"/> Tilt	<input type="checkbox"/> Corrosion					
<input type="checkbox"/> Other:	_____					
VI. TREATMENT RECOMMENDATIONS						
<input type="checkbox"/> Archaeology	<input type="checkbox"/> Excavate	<input type="checkbox"/> Reset on exist base	<input type="checkbox"/> Reset on salvaged base (if poss)			
<input checked="" type="checkbox"/> Clean/bio removal	<input type="checkbox"/> Consolidate	<input type="checkbox"/> Composite repair	<input type="checkbox"/> Pin/adhesive repair

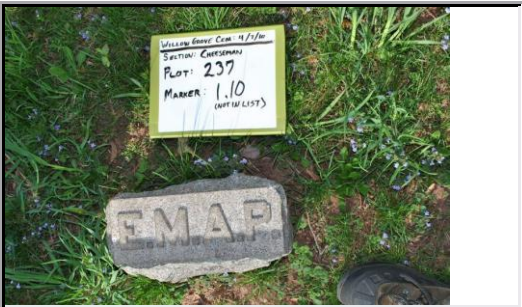
I. BURIAL INFORMATION					II. PRIORITIZATION	
First name	Last name	Birth	Death	Survey date	Condition	Prioritization
E.M.A.	P.			4/7/2010	Excellent	Long term
III. LOCATION						
Cemetery Section	Plot/Marker Number	Original Location	Original Marker/Feature			
Cheesman	237.01.10	Unknown	No			
IV. MARKER INFORMATION						
Marker Type						
Headstone		Height: 9	Width: 15	Depth: 6		
<input type="checkbox"/> Marble	<input checked="" type="checkbox"/> Granite	<input type="checkbox"/> Sandstone	<input type="checkbox"/> Slate			
<input type="checkbox"/> Brick	<input type="checkbox"/> Iron	<input type="checkbox"/> Other: _____

V. MATERIAL CONDITIONS						
<input checked="" type="checkbox"/> Biological - Algae	<input type="checkbox"/> Biological - Lichens	<input type="checkbox"/> Crack	<input type="checkbox"/> Delamination/Exfoliation			
<input type="checkbox"/> Disaggregation/Erosion	<input type="checkbox"/> Graffiti	<input type="checkbox"/> Off base (missing)	<input type="checkbox"/> Off base (adjacent)			
<input type="checkbox"/> Missing Fragment (s)	<input type="checkbox"/> Previous Repair	<input type="checkbox"/> Soiling	<input type="checkbox"/> Sunken			
<input type="checkbox"/> Tilt	<input type="checkbox"/> Corrosion					
<input type="checkbox"/> Other:	_____					
VI. TREATMENT RECOMMENDATIONS						
<input type="checkbox"/> Archaeology	<input type="checkbox"/> Excavate	<input type="checkbox"/> Reset on exist base	<input type="checkbox"/> Reset on salvaged base (if poss)			
<input checked="" type="checkbox"/> Clean/bio removal	<input type="checkbox"/> Consolidate	<input type="checkbox"/> Composite repair	<input type="checkbox"/> Pin/adhesive repair

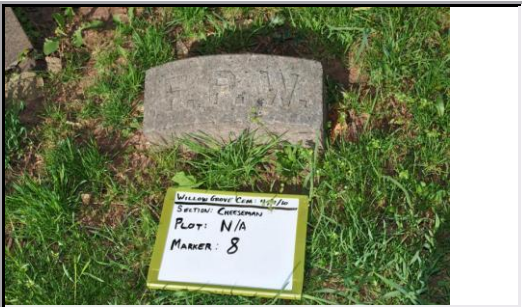
I. BURIAL INFORMATION					II. PRIORITIZATION	
First name	Last name	Birth	Death	Survey date	Condition	Prioritization
F.P.	W.			4/7/2010	Excellent	Long term
III. LOCATION						
Cemetery Section	Plot/Marker Number	Original Location	Original Marker/Feature			
Cheesman	250.08	Unknown	No			
IV. MARKER INFORMATION						
Marker Type						
Headstone		Height: 10	Width: 16	Depth: 5		
<input type="checkbox"/> Marble	<input checked="" type="checkbox"/> Granite	<input type="checkbox"/> Sandstone	<input type="checkbox"/> Slate			
<input type="checkbox"/> Brick	<input type="checkbox"/> Iron	<input type="checkbox"/> Other: _____

V. MATERIAL CONDITIONS						
<input checked="" type="checkbox"/> Biological - Algae	<input type="checkbox"/> Biological - Lichens	<input type="checkbox"/> Crack	<input type="checkbox"/> Delamination/Exfoliation			
<input type="checkbox"/> Disaggregation/Erosion	<input type="checkbox"/> Graffiti	<input type="checkbox"/> Off base (missing)	<input type="checkbox"/> Off base (adjacent)			
<input type="checkbox"/> Missing Fragment (s)	<input type="checkbox"/> Previous Repair	<input checked="" type="checkbox"/> Soiling	<input type="checkbox"/> Sunken			
<input type="checkbox"/> Tilt	<input type="checkbox"/> Corrosion					
<input type="checkbox"/> Other:	_____					
VI. TREATMENT RECOMMENDATIONS						
<input type="checkbox"/> Archaeology	<input type="checkbox"/> Excavate	<input type="checkbox"/> Reset on exist base	<input type="checkbox"/> Reset on salvaged base (if poss)			
<input checked="" type="checkbox"/> Clean/bio removal	<input type="checkbox"/> Consolidate	<input type="checkbox"/> Composite repair	<input type="checkbox"/> Pin/adhesive repair

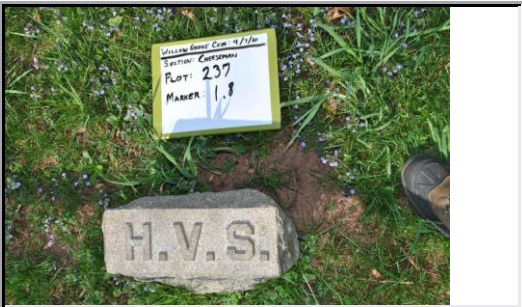
VI. PHOTOGRAPHS	
<p>Photo 1:</p>

I. BURIAL INFORMATION					II. PRIORITIZATION	
First name	Last name	Birth	Death	Survey date	Condition	Prioritization
H.V.	S.	1856	1878	4/7/2010	Excellent	Long term

V. MATERIAL CONDITIONS			
<input checked="" type="checkbox"/> Biological - Algae	<input type="checkbox"/> Biological - Lichens	<input type="checkbox"/> Crack	<input type="checkbox"/> Delamination/Exfoliation
<input type="checkbox"/> Disaggregation/Erosion	<input type="checkbox"/> Graffiti	<input type="checkbox"/> Off base (missing)	<input type="checkbox"/> Off base (adjacent)
<input type="checkbox"/> Missing Fragment (s)	<input type="checkbox"/> Previous Repair	<input type="checkbox"/> Soiling	<input type="checkbox"/> Sunken
<input type="checkbox"/> Tilt	<input type="checkbox"/> Corrosion		
<input type="checkbox"/> Other:	_____

VI. TREATMENT RECOMMENDATIONS			
<input type="checkbox"/> Archaeology	<input type="checkbox"/> Excavate	<input type="checkbox"/> Reset on exist base	<input type="checkbox"/> Reset on salvaged base (if poss)
<input checked="" type="checkbox"/> Clean/bio removal	<input type="checkbox"/> Consolidate	<input type="checkbox"/> Composite repair	<input type="checkbox"/> Pin/adhesive repair
<input type="checkbox"/> Other:	_____

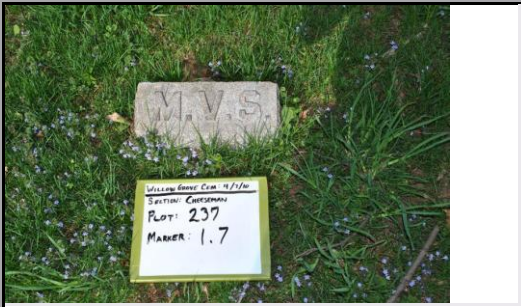
I. BURIAL INFORMATION					II. PRIORITIZATION	
First name	Last name	Birth	Death	Survey date	Condition	Prioritization
M.V	S.	1818	1894	4/7/2010	Excellent	Long term
III. LOCATION						
Cemetery Section	Plot/Marker Number	Original Location	Original Marker/Feature			
Cheesman	237.01.7	Unknown	No			
IV. MARKER INFORMATION						
Marker Type						
Headstone		Height: 9	Width: 15	Depth: 6		
<input type="checkbox"/> Marble	<input checked="" type="checkbox"/> Granite	<input type="checkbox"/> Sandstone	<input type="checkbox"/> Slate			
<input type="checkbox"/> Brick	<input type="checkbox"/> Iron	<input type="checkbox"/> Other: _____

V. MATERIAL CONDITIONS						
<input checked="" type="checkbox"/> Biological - Algae	<input type="checkbox"/> Biological - Lichens	<input type="checkbox"/> Crack	<input type="checkbox"/> Delamination/Exfoliation			
<input type="checkbox"/> Disaggregation/Erosion	<input type="checkbox"/> Graffiti	<input type="checkbox"/> Off base (missing)	<input type="checkbox"/> Off base (adjacent)			
<input type="checkbox"/> Missing Fragment (s)	<input type="checkbox"/> Previous Repair	<input type="checkbox"/> Soiling	<input type="checkbox"/> Sunken			
<input type="checkbox"/> Tilt	<input type="checkbox"/> Corrosion					
<input type="checkbox"/> Other:	_____					
VI. TREATMENT RECOMMENDATIONS						
<input type="checkbox"/> Archaeology	<input type="checkbox"/> Excavate	<input type="checkbox"/> Reset on exist base	<input type="checkbox"/> Reset on salvaged base (if poss)			
<input checked="" type="checkbox"/> Clean/bio removal	<input type="checkbox"/> Consolidate	<input type="checkbox"/> Composite repair	<input type="checkbox"/> Pin/adhesive repair

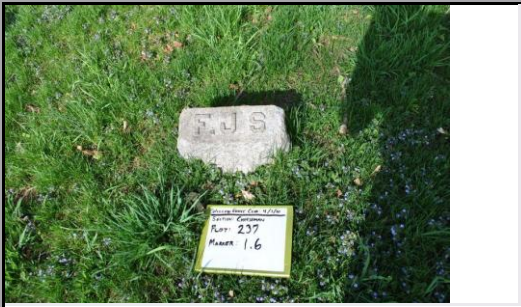
I. BURIAL INFORMATION					II. PRIORITIZATION	
First name	Last name	Birth	Death	Survey date	Condition	Prioritization
F.J.	S.	1819	1871	4/7/2010	Excellent	Long term
III. LOCATION						
Cemetery Section	Plot/Marker Number	Original Location	Original Marker/Feature			
Cheesman	237.01.6	Unknown	No			
IV. MARKER INFORMATION						
Marker Type						
Headstone		Height: 9	Width: 15	Depth: 6		
<input type="checkbox"/> Marble	<input checked="" type="checkbox"/> Granite	<input type="checkbox"/> Sandstone	<input type="checkbox"/> Slate			
<input type="checkbox"/> Brick	<input type="checkbox"/> Iron	<input type="checkbox"/> Other: _____

V. MATERIAL CONDITIONS						
<input checked="" type="checkbox"/> Biological - Algae	<input type="checkbox"/> Biological - Lichens	<input type="checkbox"/> Crack	<input type="checkbox"/> Delamination/Exfoliation			
<input type="checkbox"/> Disaggregation/Erosion	<input type="checkbox"/> Graffiti	<input type="checkbox"/> Off base (missing)	<input type="checkbox"/> Off base (adjacent)			
<input type="checkbox"/> Missing Fragment (s)	<input type="checkbox"/> Previous Repair	<input type="checkbox"/> Soiling	<input type="checkbox"/> Sunken			
<input type="checkbox"/> Tilt	<input type="checkbox"/> Corrosion					
<input type="checkbox"/> Other:	_____					
VI. TREATMENT RECOMMENDATIONS						
<input type="checkbox"/> Archaeology	<input type="checkbox"/> Excavate	<input type="checkbox"/> Reset on exist base	<input type="checkbox"/> Reset on salvaged base (if poss)			
<input checked="" type="checkbox"/> Clean/bio removal	<input type="checkbox"/> Consolidate	<input type="checkbox"/> Composite repair	<input type="checkbox"/> Pin/adhesive repair
