HISTORIC PRESERVATION PLAN

WILLOW GROVE CEMETERY

New Brunswick, Middlesex County, New Jersey

DATE: 4 October 2010

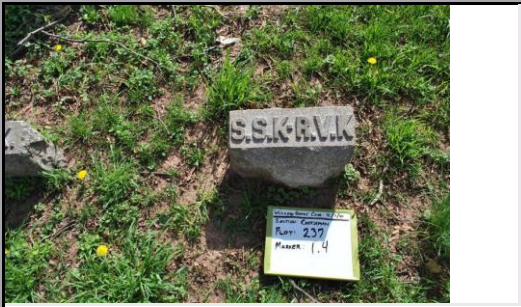
I. BURIAL INFORMATION					II. PRIORITIZATION	
First name	Last name	Birth	Death	Survey date	Condition	Prioritization
R.V.	K.	1831	1871	4/7/2010	Excellent	Long term
III. LOCATION						
Cemetery Section	Plot/Marker Number	Original Location	Original Marker/Feature			
Cheesman	237.01.5	Unknown	No			
IV. MARKER INFORMATION						
Marker Type						
Headstone		Height: 9	Width: 16	Depth: 5		
<input type="checkbox"/> Marble	<input checked="" type="checkbox"/> Granite	<input type="checkbox"/> Sandstone	<input type="checkbox"/> Slate			
<input type="checkbox"/> Brick	<input type="checkbox"/> Iron	<input type="checkbox"/> Other: _____

V. MATERIAL CONDITIONS						
<input checked="" type="checkbox"/> Biological - Algae	<input type="checkbox"/> Biological - Lichens	<input type="checkbox"/> Crack	<input type="checkbox"/> Delamination/Exfoliation			
<input type="checkbox"/> Disaggregation/Erosion	<input type="checkbox"/> Graffiti	<input type="checkbox"/> Off base (missing)	<input type="checkbox"/> Off base (adjacent)			
<input type="checkbox"/> Missing Fragment (s)	<input type="checkbox"/> Previous Repair	<input type="checkbox"/> Soiling	<input type="checkbox"/> Sunken			
<input type="checkbox"/> Tilt	<input type="checkbox"/> Corrosion					
<input type="checkbox"/> Other:	_____					
VI. TREATMENT RECOMMENDATIONS						
<input type="checkbox"/> Archaeology	<input type="checkbox"/> Excavate	<input type="checkbox"/> Reset on exist base	<input type="checkbox"/> Reset on salvaged base (if poss)			
<input checked="" type="checkbox"/> Clean/bio removal	<input type="checkbox"/> Consolidate	<input type="checkbox"/> Composite repair	<input type="checkbox"/> Pin/adhesive repair

VII. ADDITIONAL INFORMATION						
Two burials marked here: S.S.K (237.1.4). And R.V.K. (237.1.5).

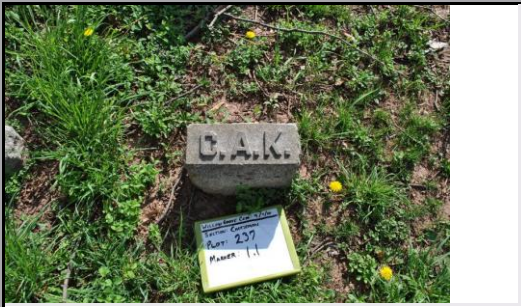
I. BURIAL INFORMATION					II. PRIORITIZATION	
First name	Last name	Birth	Death	Survey date	Condition	Prioritization
C.A.	K.	1799	1887	4/7/2010	Excellent	Long term
III. LOCATION						
Cemetery Section	Plot/Marker Number	Original Location	Original Marker/Feature			
Cheesman	237.01.1	Unknown	No			
IV. MARKER INFORMATION						
Marker Type						
Headstone		Height: 9	Width: 15	Depth: 6		
<input type="checkbox"/> Marble	<input checked="" type="checkbox"/> Granite	<input type="checkbox"/> Sandstone	<input type="checkbox"/> Slate			
<input type="checkbox"/> Brick	<input type="checkbox"/> Iron	<input type="checkbox"/> Other: _____

V. MATERIAL CONDITIONS						
<input checked="" type="checkbox"/> Biological - Algae	<input type="checkbox"/> Biological - Lichens	<input type="checkbox"/> Crack	<input type="checkbox"/> Delamination/Exfoliation			
<input type="checkbox"/> Disaggregation/Erosion	<input type="checkbox"/> Graffiti	<input type="checkbox"/> Off base (missing)	<input type="checkbox"/> Off base (adjacent)			
<input type="checkbox"/> Missing Fragment (s)	<input type="checkbox"/> Previous Repair	<input type="checkbox"/> Soiling	<input type="checkbox"/> Sunken			
<input type="checkbox"/> Tilt	<input type="checkbox"/> Corrosion					
<input type="checkbox"/> Other:	_____					
VI. TREATMENT RECOMMENDATIONS						
<input type="checkbox"/> Archaeology	<input type="checkbox"/> Excavate	<input type="checkbox"/> Reset on exist base	<input type="checkbox"/> Reset on salvaged base (if poss)			
<input checked="" type="checkbox"/> Clean/bio removal	<input type="checkbox"/> Consolidate	<input type="checkbox"/> Composite repair	<input type="checkbox"/> Pin/adhesive repair

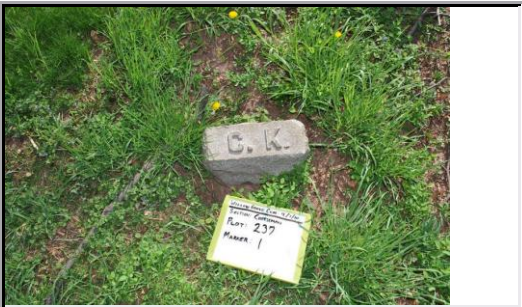
I. BURIAL INFORMATION					II. PRIORITIZATION	
First name	Last name	Birth	Death	Survey date	Condition	Prioritization
C.	K.	1794	1884	4/7/2010	Excellent	Long term
III. LOCATION						
Cemetery Section	Plot/Marker Number	Original Location	Original Marker/Feature			
Cheesman	237.01.0	Unknown	No			
IV. MARKER INFORMATION						
Marker Type						
Headstone		Height: 9	Width: 15	Depth: 6		
<input type="checkbox"/> Marble	<input checked="" type="checkbox"/> Granite	<input type="checkbox"/> Sandstone	<input type="checkbox"/> Slate			
<input type="checkbox"/> Brick	<input type="checkbox"/> Iron	<input type="checkbox"/> Other: _____

V. MATERIAL CONDITIONS						
<input checked="" type="checkbox"/> Biological - Algae	<input type="checkbox"/> Biological - Lichens	<input type="checkbox"/> Crack	<input type="checkbox"/> Delamination/Exfoliation			
<input type="checkbox"/> Disaggregation/Erosion	<input type="checkbox"/> Graffiti	<input type="checkbox"/> Off base (missing)	<input type="checkbox"/> Off base (adjacent)			
<input type="checkbox"/> Missing Fragment (s)	<input type="checkbox"/> Previous Repair	<input type="checkbox"/> Soiling	<input type="checkbox"/> Sunken			
<input type="checkbox"/> Tilt	<input type="checkbox"/> Corrosion					
<input type="checkbox"/> Other:	_____					
VI. TREATMENT RECOMMENDATIONS						
<input type="checkbox"/> Archaeology	<input type="checkbox"/> Excavate	<input type="checkbox"/> Reset on exist base	<input type="checkbox"/> Reset on salvaged base (if poss)			
<input checked="" type="checkbox"/> Clean/bio removal	<input type="checkbox"/> Consolidate	<input type="checkbox"/> Composite repair	<input type="checkbox"/> Pin/adhesive repair

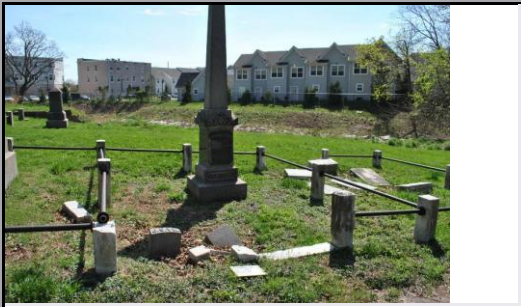
I. BURIAL INFORMATION					II. PRIORITIZATION	
First name	Last name	Birth	Death	Survey date	Condition	Prioritization
	Van Marten			4/7/2010	Excellent	Long term
III. LOCATION						
Cemetery Section	Plot/Marker Number	Original Location	Original Marker/Feature			
Cheesman	229.00.F	Yes	No			
IV. MARKER INFORMATION						
Marker Type						
Obelisk		Height:	Width:	Depth:		
<input type="checkbox"/> Marble	<input checked="" type="checkbox"/> Granite	<input type="checkbox"/> Sandstone	<input type="checkbox"/> Slate			
<input type="checkbox"/> Brick	<input type="checkbox"/> Iron	<input type="checkbox"/> Other: _____

V. MATERIAL CONDITIONS						
<input type="checkbox"/> Biological - Algae	<input type="checkbox"/> Biological - Lichens	<input type="checkbox"/> Crack	<input type="checkbox"/> Delamination/Exfoliation			
<input type="checkbox"/> Disaggregation/Erosion	<input type="checkbox"/> Graffiti	<input type="checkbox"/> Off base (missing)	<input type="checkbox"/> Off base (adjacent)			
<input type="checkbox"/> Missing Fragment (s)	<input type="checkbox"/> Previous Repair	<input type="checkbox"/> Soiling	<input type="checkbox"/> Sunken			
<input type="checkbox"/> Tilt	<input type="checkbox"/> Corrosion					
<input type="checkbox"/> Other:	_____					
VI. TREATMENT RECOMMENDATIONS						
<input type="checkbox"/> Archaeology	<input type="checkbox"/> Excavate	<input type="checkbox"/> Reset on exist base	<input type="checkbox"/> Reset on salvaged base (if poss)			
<input type="checkbox"/> Clean/bio removal	<input type="checkbox"/> Consolidate	<input type="checkbox"/> Composite repair	<input type="checkbox"/> Pin/adhesive repair

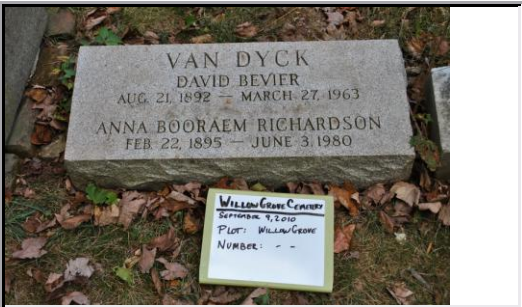
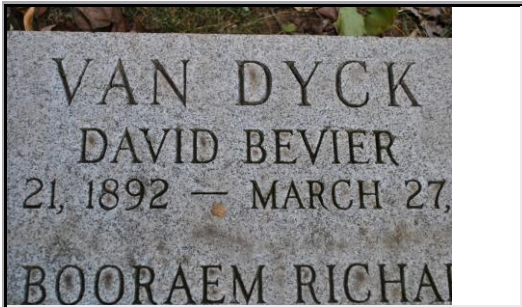
I. BURIAL INFORMATION					II. PRIORITIZATION	
First name	Last name	Birth	Death	Survey date	Condition	Prioritization
David	Van Dyck	1892	1963	9/9/2010	Excellent	Long term
III. LOCATION						
Cemetery Section	Plot/Marker Number	Original Location	Original Marker/Feature			
Willow Grove	133.09	Unknown	No			
IV. MARKER INFORMATION						
Marker Type						
Headstone						
Height: 7		Width: 30		Depth: 13		
<input type="checkbox"/> Marble	<input checked="" type="checkbox"/> Granite	<input type="checkbox"/> Sandstone	<input type="checkbox"/> Slate			
<input type="checkbox"/> Brick	<input type="checkbox"/> Iron	<input type="checkbox"/> Other: _____

V. MATERIAL CONDITIONS						
<input type="checkbox"/> Biological - Algae	<input type="checkbox"/> Biological - Lichens	<input type="checkbox"/> Crack	<input type="checkbox"/> Delamination/Exfoliation			
<input type="checkbox"/> Disaggregation/Erosion	<input type="checkbox"/> Graffiti	<input type="checkbox"/> Off base (missing)	<input type="checkbox"/> Off base (adjacent)			
<input type="checkbox"/> Missing Fragment (s)	<input type="checkbox"/> Previous Repair	<input checked="" type="checkbox"/> Soiling	<input type="checkbox"/> Sunken			
<input type="checkbox"/> Tilt	<input type="checkbox"/> Corrosion					
<input type="checkbox"/> Other:	_____					
VI. TREATMENT RECOMMENDATIONS						
<input type="checkbox"/> Archaeology	<input type="checkbox"/> Excavate	<input type="checkbox"/> Reset on exist base	<input type="checkbox"/> Reset on salvaged base (if poss)			
<input checked="" type="checkbox"/> Clean/bio removal	<input type="checkbox"/> Consolidate	<input type="checkbox"/> Composite repair	<input type="checkbox"/> Pin/adhesive repair

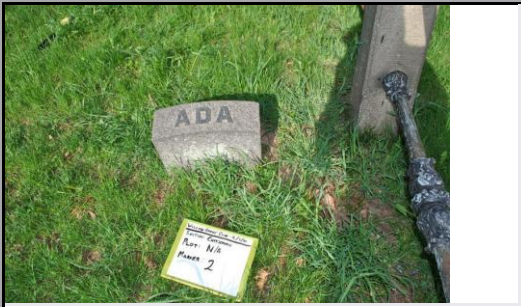
I. BURIAL INFORMATION					II. PRIORITIZATION	
First name	Last name	Birth	Death	Survey date	Condition	Prioritization
Ada	Meyers			4/7/2010	Excellent	Long term
III. LOCATION						
Cemetery Section	Plot/Marker Number	Original Location	Original Marker/Feature			
Cheesman	250.02	Yes	No			
IV. MARKER INFORMATION						
Marker Type						
Headstone		Height: 10	Width: 16	Depth: 5		
<input type="checkbox"/> Marble	<input checked="" type="checkbox"/> Granite	<input type="checkbox"/> Sandstone	<input type="checkbox"/> Slate			
<input type="checkbox"/> Brick	<input type="checkbox"/> Iron	<input type="checkbox"/> Other: _____

V. MATERIAL CONDITIONS						
<input checked="" type="checkbox"/> Biological - Algae	<input type="checkbox"/> Biological - Lichens	<input type="checkbox"/> Crack	<input type="checkbox"/> Delamination/Exfoliation			
<input type="checkbox"/> Disaggregation/Erosion	<input type="checkbox"/> Graffiti	<input type="checkbox"/> Off base (missing)	<input type="checkbox"/> Off base (adjacent)			
<input type="checkbox"/> Missing Fragment (s)	<input type="checkbox"/> Previous Repair	<input checked="" type="checkbox"/> Soiling	<input type="checkbox"/> Sunken			
<input type="checkbox"/> Tilt	<input type="checkbox"/> Corrosion					
<input type="checkbox"/> Other:	_____					
VI. TREATMENT RECOMMENDATIONS						
<input type="checkbox"/> Archaeology	<input type="checkbox"/> Excavate	<input type="checkbox"/> Reset on exist base	<input type="checkbox"/> Reset on salvaged base (if poss)			
<input checked="" type="checkbox"/> Clean/bio removal	<input type="checkbox"/> Consolidate	<input type="checkbox"/> Composite repair	<input type="checkbox"/> Pin/adhesive repair

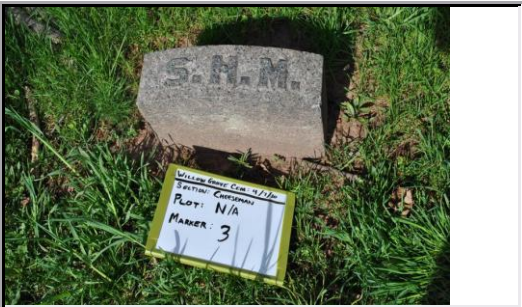
I. BURIAL INFORMATION					II. PRIORITIZATION	
First name	Last name	Birth	Death	Survey date	Condition	Prioritization
Susan H. Brokaw	Meyers	1838	1904	4/7/2010	Excellent	Long term
III. LOCATION						
Cemetery Section	Plot/Marker Number	Original Location	Original Marker/Feature			
Cheesman	250.03	Unknown	No			
IV. MARKER INFORMATION						
Marker Type						
Headstone		Height: 10	Width: 16	Depth: 5		
<input type="checkbox"/> Marble	<input checked="" type="checkbox"/> Granite	<input type="checkbox"/> Sandstone	<input type="checkbox"/> Slate			
<input type="checkbox"/> Brick	<input type="checkbox"/> Iron	<input type="checkbox"/> Other: _____

V. MATERIAL CONDITIONS						
<input checked="" type="checkbox"/> Biological - Algae	<input type="checkbox"/> Biological - Lichens	<input type="checkbox"/> Crack	<input type="checkbox"/> Delamination/Exfoliation			
<input type="checkbox"/> Disaggregation/Erosion	<input type="checkbox"/> Graffiti	<input type="checkbox"/> Off base (missing)	<input type="checkbox"/> Off base (adjacent)			
<input type="checkbox"/> Missing Fragment (s)	<input type="checkbox"/> Previous Repair	<input checked="" type="checkbox"/> Soiling	<input type="checkbox"/> Sunken			
<input type="checkbox"/> Tilt	<input type="checkbox"/> Corrosion					
<input type="checkbox"/> Other:	_____					
VI. TREATMENT RECOMMENDATIONS						
<input type="checkbox"/> Archaeology	<input type="checkbox"/> Excavate	<input type="checkbox"/> Reset on exist base	<input type="checkbox"/> Reset on salvaged base (if poss)			
<input checked="" type="checkbox"/> Clean/bio removal	<input type="checkbox"/> Consolidate	<input type="checkbox"/> Composite repair	<input type="checkbox"/> Pin/adhesive repair

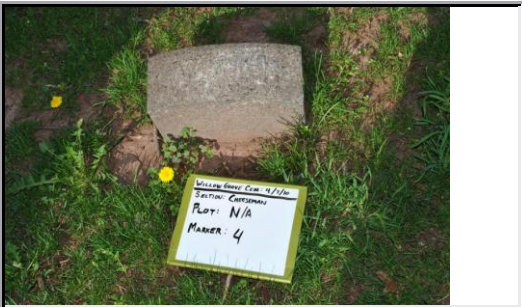
I. BURIAL INFORMATION					II. PRIORITIZATION	
First name	Last name	Birth	Death	Survey date	Condition	Prioritization
V.	H.			4/7/2010	Excellent	Long term
III. LOCATION						
Cemetery Section	Plot/Marker Number	Original Location	Original Marker/Feature			
Cheesman	250.04	Unknown	No			
IV. MARKER INFORMATION						
Marker Type						
Headstone		Height: 10	Width: 16	Depth: 5		
<input type="checkbox"/> Marble	<input checked="" type="checkbox"/> Granite	<input type="checkbox"/> Sandstone	<input type="checkbox"/> Slate			
<input type="checkbox"/> Brick	<input type="checkbox"/> Iron	<input type="checkbox"/> Other: _____

V. MATERIAL CONDITIONS						
<input checked="" type="checkbox"/> Biological - Algae	<input type="checkbox"/> Biological - Lichens	<input type="checkbox"/> Crack	<input type="checkbox"/> Delamination/Exfoliation			
<input type="checkbox"/> Disaggregation/Erosion	<input type="checkbox"/> Graffiti	<input type="checkbox"/> Off base (missing)	<input type="checkbox"/> Off base (adjacent)			
<input type="checkbox"/> Missing Fragment (s)	<input type="checkbox"/> Previous Repair	<input type="checkbox"/> Soiling	<input type="checkbox"/> Sunken			
<input type="checkbox"/> Tilt	<input type="checkbox"/> Corrosion					
<input type="checkbox"/> Other:	_____					
VI. TREATMENT RECOMMENDATIONS						
<input type="checkbox"/> Archaeology	<input type="checkbox"/> Excavate	<input type="checkbox"/> Reset on exist base	<input type="checkbox"/> Reset on salvaged base (if poss)			
<input checked="" type="checkbox"/> Clean/bio removal	<input type="checkbox"/> Consolidate	<input type="checkbox"/> Composite repair	<input type="checkbox"/> Pin/adhesive repair

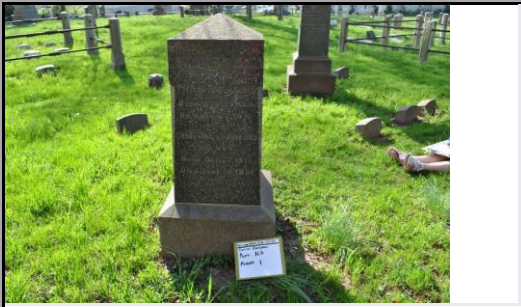
I. BURIAL INFORMATION					II. PRIORITIZATION	
First name	Last name	Birth	Death	Survey date	Condition	Prioritization
Meyers	Mary	1841	1862	4/7/2010	Excellent	Long term
III. LOCATION						
Cemetery Section	Plot/Marker Number	Original Location	Original Marker/Feature			
Cheesman	250.00.F	Unknown	No			
IV. MARKER INFORMATION						
Marker Type						
Family Marker		Height: 56	Width: 27	Depth: 27		
<input type="checkbox"/> Marble	<input checked="" type="checkbox"/> Granite	<input type="checkbox"/> Sandstone	<input type="checkbox"/> Slate			
<input type="checkbox"/> Brick	<input type="checkbox"/> Iron	<input type="checkbox"/> Other: _____

V. MATERIAL CONDITIONS						
<input checked="" type="checkbox"/> Biological - Algae	<input type="checkbox"/> Biological - Lichens	<input type="checkbox"/> Crack	<input type="checkbox"/> Delamination/Exfoliation			
<input type="checkbox"/> Disaggregation/Erosion	<input type="checkbox"/> Graffiti	<input type="checkbox"/> Off base (missing)	<input type="checkbox"/> Off base (adjacent)			
<input type="checkbox"/> Missing Fragment (s)	<input type="checkbox"/> Previous Repair	<input type="checkbox"/> Soiling	<input type="checkbox"/> Sunken			
<input type="checkbox"/> Tilt	<input type="checkbox"/> Corrosion					
<input type="checkbox"/> Other:	_____					
VI. TREATMENT RECOMMENDATIONS						
<input type="checkbox"/> Archaeology	<input type="checkbox"/> Excavate	<input type="checkbox"/> Reset on exist base	<input type="checkbox"/> Reset on salvaged base (if poss)			
<input checked="" type="checkbox"/> Clean/bio removal	<input type="checkbox"/> Consolidate	<input type="checkbox"/> Composite repair	<input type="checkbox"/> Pin/adhesive repair

VII. ADDITIONAL INFORMATION						
Family marker with multiple names: Mary (1841-1862), Philip (1811-1872), Christine (1819-1891), Ada (1863-1895), Susan (1838-1904), Michael (1843-1844), William (1852-1857).

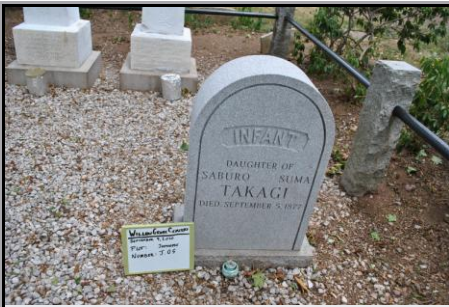
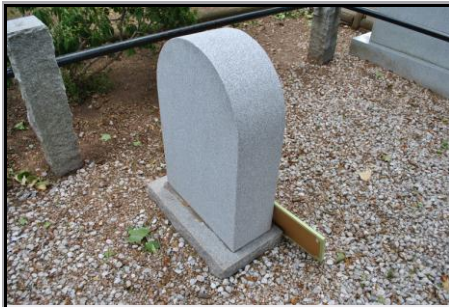
I. BURIAL INFORMATION					II. PRIORITIZATION	
First name	Last name	Birth	Death	Survey date	Condition	Prioritization
Infant	Tagaki	0	1877	9/9/2010	Excellent	Long term
III. LOCATION						
Cemetery Section	Plot/Marker Number	Original Location	Original Marker/Feature			
Willow Grove	J.05	Unknown	No			
IV. MARKER INFORMATION						
Marker Type						
Headstone w/ base		Height: 34	Width: 24	Depth: 13		
<input type="checkbox"/> Marble	<input checked="" type="checkbox"/> Granite	<input type="checkbox"/> Sandstone	<input type="checkbox"/> Slate			
<input type="checkbox"/> Brick	<input type="checkbox"/> Iron	<input type="checkbox"/> Other: _____

V. MATERIAL CONDITIONS						
<input type="checkbox"/> Biological - Algae	<input type="checkbox"/> Biological - Lichens	<input type="checkbox"/> Crack	<input type="checkbox"/> Delamination/Exfoliation			
<input type="checkbox"/> Disaggregation/Erosion	<input type="checkbox"/> Graffiti	<input type="checkbox"/> Off base (missing)	<input type="checkbox"/> Off base (adjacent)			
<input type="checkbox"/> Missing Fragment (s)	<input type="checkbox"/> Previous Repair	<input type="checkbox"/> Soiling	<input type="checkbox"/> Sunken			
<input type="checkbox"/> Tilt	<input type="checkbox"/> Corrosion					
<input type="checkbox"/> Other:	_____					
VI. TREATMENT RECOMMENDATIONS						
<input type="checkbox"/> Archaeology	<input type="checkbox"/> Excavate	<input type="checkbox"/> Reset on exist base	<input type="checkbox"/> Reset on salvaged base (if poss)			
<input type="checkbox"/> Clean/bio removal	<input type="checkbox"/> Consolidate	<input type="checkbox"/> Composite repair	<input type="checkbox"/> Pin/adhesive repair

<input checked="" type="checkbox"/> Other:	Marker was restored in 2010. No immediate action required.					
VI. PHOTOGRAPHS						
Photo 1:			Photo 2:

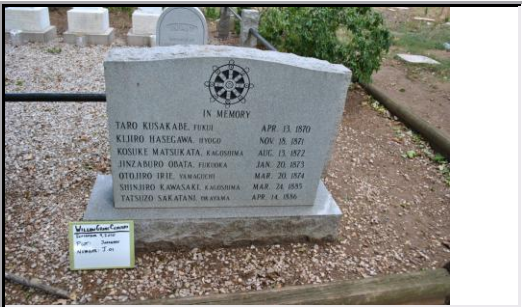
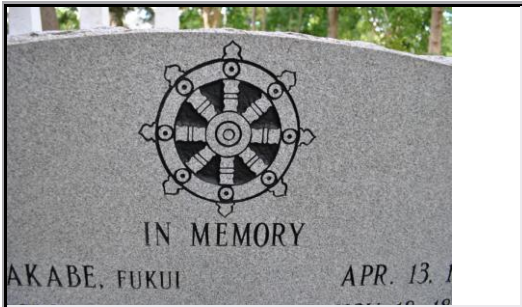
I. BURIAL INFORMATION					II. PRIORITIZATION	
First name	Last name	Birth	Death	Survey date	Condition	Prioritization
		0		9/9/2010	Excellent	Long term
III. LOCATION						
Cemetery Section	Plot/Marker Number	Original Location	Original Marker/Feature			
Willow Grove	J.01	Unknown	No			
IV. MARKER INFORMATION						
Marker Type						
Family Marker		Height: 36	Width: 48	Depth: 14		
<input type="checkbox"/> Marble	<input checked="" type="checkbox"/> Granite	<input type="checkbox"/> Sandstone	<input type="checkbox"/> Slate			
<input type="checkbox"/> Brick	<input type="checkbox"/> Iron	<input type="checkbox"/> Other: _____

V. MATERIAL CONDITIONS						
<input type="checkbox"/> Biological - Algae	<input type="checkbox"/> Biological - Lichens	<input type="checkbox"/> Crack	<input type="checkbox"/> Delamination/Exfoliation			
<input type="checkbox"/> Disaggregation/Erosion	<input type="checkbox"/> Graffiti	<input type="checkbox"/> Off base (missing)	<input type="checkbox"/> Off base (adjacent)			
<input type="checkbox"/> Missing Fragment (s)	<input type="checkbox"/> Previous Repair	<input type="checkbox"/> Soiling	<input type="checkbox"/> Sunken			
<input type="checkbox"/> Tilt	<input type="checkbox"/> Corrosion					
<input type="checkbox"/> Other:	_____					
VI. TREATMENT RECOMMENDATIONS						
<input type="checkbox"/> Archaeology	<input type="checkbox"/> Excavate	<input type="checkbox"/> Reset on exist base	<input type="checkbox"/> Reset on salvaged base (if poss)			
<input type="checkbox"/> Clean/bio removal	<input type="checkbox"/> Consolidate	<input type="checkbox"/> Composite repair	<input type="checkbox"/> Pin/adhesive repair

<input checked="" type="checkbox"/> Other:	No immediate action required.					
VI. PHOTOGRAPHS						
Photo 1:			Photo 2:

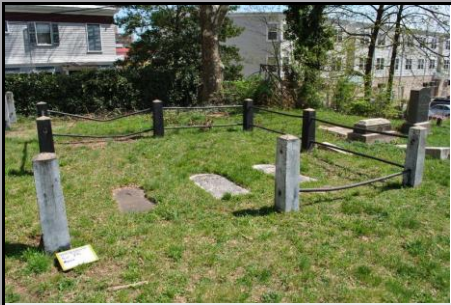
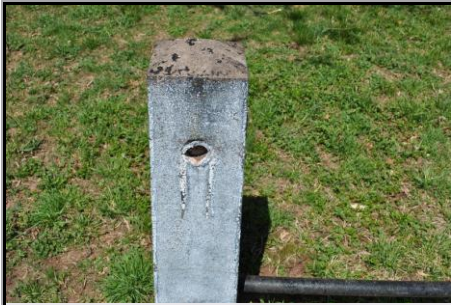
I. BURIAL INFORMATION					II. PRIORITIZATION	
First name	Last name	Birth	Death	Survey date	Condition	Prioritization
				4/7/2010	Fair	Long term
III. LOCATION						
Cemetery Section	Plot/Marker Number	Original Location	Original Marker/Feature			
Presbyterian	295.00	Yes	Yes			
IV. MARKER INFORMATION						
Marker Type	Site Feature	Height:	Width:	Depth:		
<input type="checkbox"/> Marble	<input checked="" type="checkbox"/> Granite	<input type="checkbox"/> Sandstone	<input type="checkbox"/> Slate			
<input type="checkbox"/> Brick	<input checked="" type="checkbox"/> Iron	<input type="checkbox"/> Other: <input style="width: 100%;" type="text"/>

V. MATERIAL CONDITIONS						
<input checked="" type="checkbox"/> Biological - Algae	<input type="checkbox"/> Biological - Lichens	<input type="checkbox"/> Crack	<input type="checkbox"/> Delamination/Exfoliation			
<input type="checkbox"/> Disaggregation/Erosion	<input type="checkbox"/> Graffiti	<input type="checkbox"/> Off base (missing)	<input type="checkbox"/> Off base (adjacent)			
<input checked="" type="checkbox"/> Missing Fragment (s)	<input type="checkbox"/> Previous Repair	<input checked="" type="checkbox"/> Soiling	<input type="checkbox"/> Sunken			
<input type="checkbox"/> Tilt	<input checked="" type="checkbox"/> Corrosion					
<input checked="" type="checkbox"/> Other:	Granite fence with iron rails, several of which are missing and several of which have also been bent by vandals.. One missing post Multiple rails and original gate (presumed) are missing.					
VI. TREATMENT RECOMMENDATIONS

<input type="checkbox"/> Archaeology	<input type="checkbox"/> Excavate	<input type="checkbox"/> Reset on exist base	<input type="checkbox"/> Reset on salvaged base (if poss)			
<input checked="" type="checkbox"/> Clean/bio removal	<input type="checkbox"/> Consolidate	<input type="checkbox"/> Composite repair	<input type="checkbox"/> Pin/adhesive repair			
<input checked="" type="checkbox"/> Other:	Repair and repaint surviving rails. Replace missing posts, rails and gate.					
VI. PHOTOGRAPHS						
Photo 1:			Photo 2:

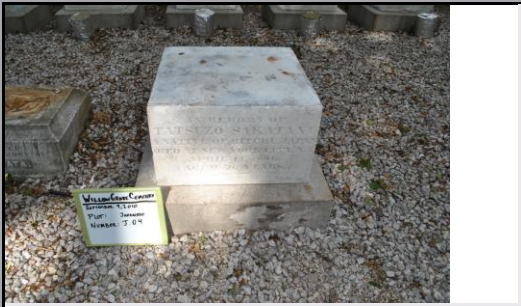
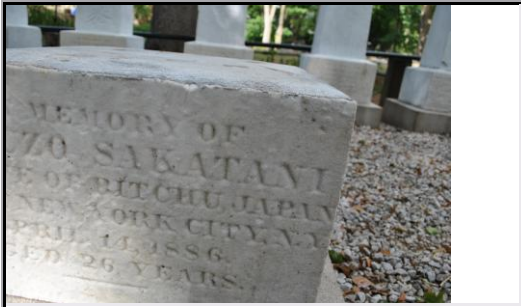
I. BURIAL INFORMATION					II. PRIORITIZATION	
First name	Last name	Birth	Death	Survey date	Condition	Prioritization
Sakatani	Tatsuzo	0	1886	9/9/2010	Fair	Long term
III. LOCATION						
Cemetery Section	Plot/Marker Number	Original Location	Original Marker/Feature			
Willow Grove	J.04	Yes	Yes			
IV. MARKER INFORMATION						
Marker Type						
Obelisk		Height: 18	Width: 26	Depth: 26		
<input checked="" type="checkbox"/> Marble	<input checked="" type="checkbox"/> Granite	<input type="checkbox"/> Sandstone	<input type="checkbox"/> Slate			
<input type="checkbox"/> Brick	<input type="checkbox"/> Iron	<input type="checkbox"/> Other: _____

V. MATERIAL CONDITIONS						
<input type="checkbox"/> Biological - Algae	<input type="checkbox"/> Biological - Lichens	<input type="checkbox"/> Crack	<input type="checkbox"/> Delamination/Exfoliation			
<input type="checkbox"/> Disaggregation/Erosion	<input type="checkbox"/> Graffiti	<input type="checkbox"/> Off base (missing)	<input type="checkbox"/> Off base (adjacent)			
<input checked="" type="checkbox"/> Missing Fragment (s)	<input type="checkbox"/> Previous Repair	<input type="checkbox"/> Soiling	<input type="checkbox"/> Sunken			
<input type="checkbox"/> Tilt	<input type="checkbox"/> Corrosion					
<input type="checkbox"/> Other:	_____					
VI. TREATMENT RECOMMENDATIONS						
<input type="checkbox"/> Archaeology	<input type="checkbox"/> Excavate	<input type="checkbox"/> Reset on exist base	<input type="checkbox"/> Reset on salvaged base (if poss)			
<input checked="" type="checkbox"/> Clean/bio removal	<input type="checkbox"/> Consolidate	<input type="checkbox"/> Composite repair	<input type="checkbox"/> Pin/adhesive repair

<input type="checkbox"/> Other:	_____					
VI. PHOTOGRAPHS						
Photo 1:			Photo 2:

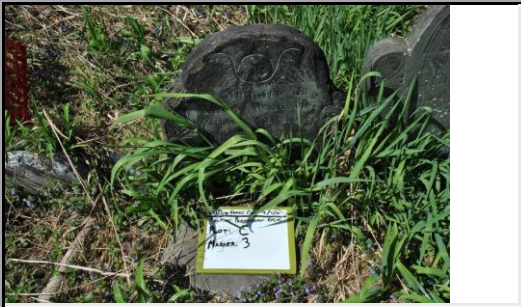
I. BURIAL INFORMATION					II. PRIORITIZATION	
First name	Last name	Birth	Death	Survey date	Condition	Prioritization
Ann	Nixon		1746	4/7/2010	Fair	Long term
III. LOCATION						
Cemetery Section	Plot/Marker Number	Original Location	Original Marker/Feature			
Presbyterian	C.3	No	Yes			
IV. MARKER INFORMATION						
Marker Type						
Headstone	Height: 25	Width: 22	Depth: 4			
<input type="checkbox"/> Marble	<input type="checkbox"/> Granite	<input type="checkbox"/> Sandstone	<input checked="" type="checkbox"/> Slate			
<input type="checkbox"/> Brick	<input type="checkbox"/> Iron	<input type="checkbox"/> Other: _____

V. MATERIAL CONDITIONS						
<input checked="" type="checkbox"/> Biological - Algae	<input type="checkbox"/> Biological - Lichens	<input type="checkbox"/> Crack	<input checked="" type="checkbox"/> Delamination/Exfoliation			
<input type="checkbox"/> Disaggregation/Erosion	<input type="checkbox"/> Graffiti	<input type="checkbox"/> Off base (missing)	<input type="checkbox"/> Off base (adjacent)			
<input type="checkbox"/> Missing Fragment (s)	<input type="checkbox"/> Previous Repair	<input type="checkbox"/> Soiling	<input checked="" type="checkbox"/> Sunken			
<input type="checkbox"/> Tilt	<input type="checkbox"/> Corrosion					
<input type="checkbox"/> Other:	_____					
VI. TREATMENT RECOMMENDATIONS						
<input type="checkbox"/> Archaeology	<input type="checkbox"/> Excavate	<input type="checkbox"/> Reset on exist base	<input type="checkbox"/> Reset on salvaged base (if poss)			
<input checked="" type="checkbox"/> Clean/bio removal	<input type="checkbox"/> Consolidate	<input checked="" type="checkbox"/> Composite repair	<input type="checkbox"/> Pin/adhesive repair

VII. ADDITIONAL INFORMATION						
The use of slate is exceptionally rare within this cemetery. Slate markers were noted only within the Presbyterian portion of the site. Marker is located in an area with poor drainage and will be susceptible to water related deterioration.

<input checked="" type="checkbox"/> Other:	Injection or adhesive to stabilize cracks and minimize additional exfoliation. Lead cap for top of marker.					
VI. PHOTOGRAPHS						
Photo 1:			Photo 2:

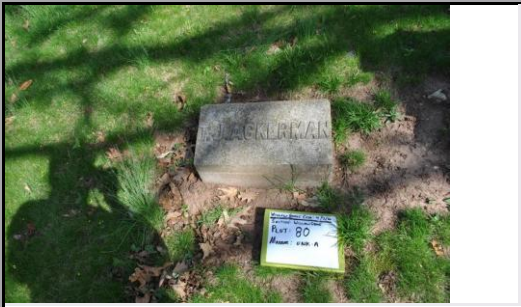
I. BURIAL INFORMATION					II. PRIORITIZATION	
First name	Last name	Birth	Death	Survey date	Condition	Prioritization
T.J.	Ackerman			4/7/2010	Fair	Long term
III. LOCATION						
Cemetery Section	Plot/Marker Number	Original Location	Original Marker/Feature			
Willow Grove	080.A	Unknown	No			
IV. MARKER INFORMATION						
Marker Type						
Headstone		Height: 8	Width: 20	Depth: 10		
<input type="checkbox"/> Marble	<input checked="" type="checkbox"/> Granite	<input type="checkbox"/> Sandstone	<input type="checkbox"/> Slate			
<input type="checkbox"/> Brick	<input type="checkbox"/> Iron	<input type="checkbox"/> Other: _____

V. MATERIAL CONDITIONS						
<input checked="" type="checkbox"/> Biological - Algae	<input type="checkbox"/> Biological - Lichens	<input type="checkbox"/> Crack	<input type="checkbox"/> Delamination/Exfoliation			
<input type="checkbox"/> Disaggregation/Erosion	<input type="checkbox"/> Graffiti	<input type="checkbox"/> Off base (missing)	<input type="checkbox"/> Off base (adjacent)			
<input type="checkbox"/> Missing Fragment (s)	<input type="checkbox"/> Previous Repair	<input checked="" type="checkbox"/> Soiling	<input checked="" type="checkbox"/> Sunken			
<input type="checkbox"/> Tilt	<input type="checkbox"/> Corrosion					
<input type="checkbox"/> Other:	_____					
VI. TREATMENT RECOMMENDATIONS						
<input type="checkbox"/> Archaeology	<input checked="" type="checkbox"/> Excavate	<input type="checkbox"/> Reset on exist base	<input type="checkbox"/> Reset on salvaged base (if poss)			
<input checked="" type="checkbox"/> Clean/bio removal	<input type="checkbox"/> Consolidate	<input type="checkbox"/> Composite repair	<input type="checkbox"/> Pin/adhesive repair

<input checked="" type="checkbox"/> Other:	Reset on new mortar pad.					
VI. PHOTOGRAPHS						
Photo 1:			Photo 2:

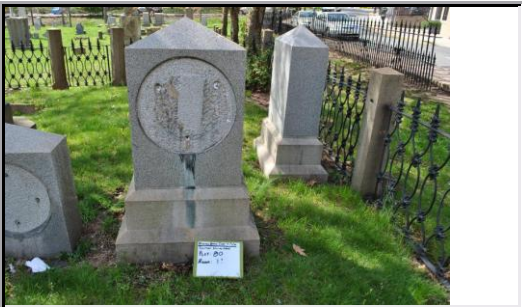
I. BURIAL INFORMATION					II. PRIORITIZATION	
First name	Last name	Birth	Death	Survey date	Condition	Prioritization
				4/7/2010	Fair	Long term
III. LOCATION						
Cemetery Section	Plot/Marker Number	Original Location	Original Marker/Feature			
Willow Grove	080.01	Yes	Unknown			
IV. MARKER INFORMATION						
Marker Type						
Headstone w/ base		Height: 56	Width: 34	Depth: 20		
<input type="checkbox"/> Marble	<input checked="" type="checkbox"/> Granite	<input type="checkbox"/> Sandstone	<input type="checkbox"/> Slate			
<input type="checkbox"/> Brick	<input type="checkbox"/> Iron	<input type="checkbox"/> Other: _____

V. MATERIAL CONDITIONS						
<input type="checkbox"/> Biological - Algae	<input type="checkbox"/> Biological - Lichens	<input type="checkbox"/> Crack	<input type="checkbox"/> Delamination/Exfoliation			
<input type="checkbox"/> Disaggregation/Erosion	<input type="checkbox"/> Graffiti	<input type="checkbox"/> Off base (missing)	<input type="checkbox"/> Off base (adjacent)			
<input checked="" type="checkbox"/> Missing Fragment (s)	<input type="checkbox"/> Previous Repair	<input checked="" type="checkbox"/> Soiling	<input type="checkbox"/> Sunken			
<input type="checkbox"/> Tilt	<input type="checkbox"/> Corrosion					
<input checked="" type="checkbox"/> Other:	Metallic staining. Missing plaque which identifies burial.					
VI. TREATMENT RECOMMENDATIONS						
<input type="checkbox"/> Archaeology	<input type="checkbox"/> Excavate	<input type="checkbox"/> Reset on exist base	<input type="checkbox"/> Reset on salvaged base (if poss)

<input type="checkbox"/> Clean/bio removal	<input type="checkbox"/> Consolidate	<input type="checkbox"/> Composite repair	<input type="checkbox"/> Pin/adhesive repair			
<input checked="" type="checkbox"/> Other:	Historic photos or research to identify burial or provide insight into missing plaque?					
VI. PHOTOGRAPHS						
Photo 1:			Photo 2:

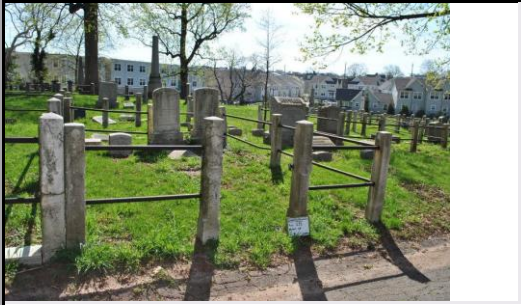
I. BURIAL INFORMATION					II. PRIORITIZATION	
First name	Last name	Birth	Death	Survey date	Condition	Prioritization
				4/7/2010	Fair	Long term
III. LOCATION						
Cemetery Section	Plot/Marker Number	Original Location	Original Marker/Feature			
Cheesman	235.00	Yes	Yes			
IV. MARKER INFORMATION						
Marker Type	Site Feature	Height:	Width:	Depth:		
<input checked="" type="checkbox"/> Marble	<input type="checkbox"/> Granite	<input type="checkbox"/> Sandstone	<input type="checkbox"/> Slate			
<input type="checkbox"/> Brick	<input checked="" type="checkbox"/> Iron	<input type="checkbox"/> Other: _____

V. MATERIAL CONDITIONS						
<input type="checkbox"/> Biological - Algae	<input type="checkbox"/> Biological - Lichens	<input type="checkbox"/> Crack	<input type="checkbox"/> Delamination/Exfoliation			
<input checked="" type="checkbox"/> Disaggregation/Erosion	<input type="checkbox"/> Graffiti	<input type="checkbox"/> Off base (missing)	<input type="checkbox"/> Off base (adjacent)			
<input checked="" type="checkbox"/> Missing Fragment (s)	<input checked="" type="checkbox"/> Previous Repair	<input checked="" type="checkbox"/> Soiling	<input type="checkbox"/> Sunken			
<input type="checkbox"/> Tilt	<input checked="" type="checkbox"/> Corrosion					
<input checked="" type="checkbox"/> Other:	Missing gate.					
VI. TREATMENT RECOMMENDATIONS						
<input type="checkbox"/> Archaeology	<input type="checkbox"/> Excavate	<input type="checkbox"/> Reset on exist base	<input type="checkbox"/> Reset on salvaged base (if poss)

VII. ADDITIONAL INFORMATION						
Inscribed plaque on post reads "1872."

<input checked="" type="checkbox"/> Clean/bio removal	<input type="checkbox"/> Consolidate	<input type="checkbox"/> Composite repair	<input type="checkbox"/> Pin/adhesive repair			
<input checked="" type="checkbox"/> Other:	Repair and repaint surviving rails. Replace missing gate.					
VI. PHOTOGRAPHS						
Photo 1:			Photo 2:

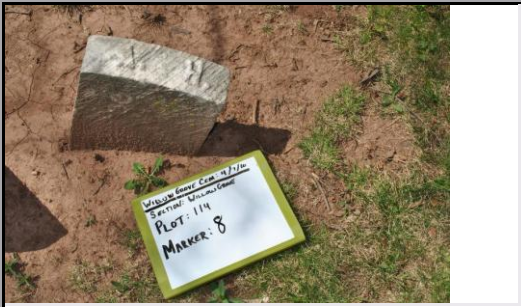
I. BURIAL INFORMATION					II. PRIORITIZATION	
First name	Last name	Birth	Death	Survey date	Condition	Prioritization
A.	H.	1842	1873	4/7/2010	Fair	Long term
III. LOCATION						
Cemetery Section	Plot/Marker Number	Original Location	Original Marker/Feature			
Willow Grove	114.08	Unknown	No			
IV. MARKER INFORMATION						
Marker Type	Height:	Width:	Depth:			
Headstone	13	10	3			
<input checked="" type="checkbox"/> Marble	<input type="checkbox"/> Granite	<input type="checkbox"/> Sandstone	<input type="checkbox"/> Slate			
<input type="checkbox"/> Brick	<input type="checkbox"/> Iron	<input type="checkbox"/> Other: _____

V. MATERIAL CONDITIONS						
<input checked="" type="checkbox"/> Biological - Algae	<input type="checkbox"/> Biological - Lichens	<input type="checkbox"/> Crack	<input type="checkbox"/> Delamination/Exfoliation			
<input type="checkbox"/> Disaggregation/Erosion	<input type="checkbox"/> Graffiti	<input type="checkbox"/> Off base (missing)	<input type="checkbox"/> Off base (adjacent)			
<input type="checkbox"/> Missing Fragment (s)	<input type="checkbox"/> Previous Repair	<input checked="" type="checkbox"/> Soiling	<input checked="" type="checkbox"/> Sunken			
<input checked="" type="checkbox"/> Tilt	<input type="checkbox"/> Corrosion					
<input checked="" type="checkbox"/> Other:	Raised letters on top surface: A.H.					
VI. TREATMENT RECOMMENDATIONS						
<input type="checkbox"/> Archaeology	<input checked="" type="checkbox"/> Excavate	<input type="checkbox"/> Reset on exist base	<input type="checkbox"/> Reset on salvaged base (if poss)

<input checked="" type="checkbox"/> Clean/bio removal	<input type="checkbox"/> Consolidate	<input type="checkbox"/> Composite repair	<input type="checkbox"/> Pin/adhesive repair			
<input checked="" type="checkbox"/> Other:	Reset on new pea gravel base.					
VI. PHOTOGRAPHS						
Photo 1:			Photo 2:

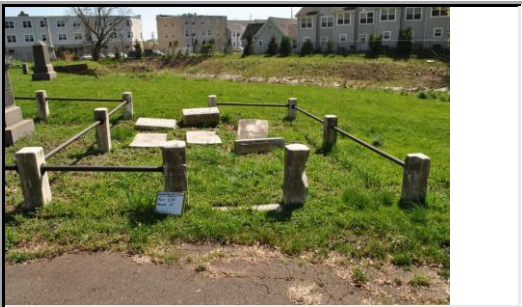
I. BURIAL INFORMATION					II. PRIORITIZATION	
First name	Last name	Birth	Death	Survey date	Condition	Prioritization
				4/7/2010	Fair	Long term
III. LOCATION						
Cemetery Section	Plot/Marker Number	Original Location	Original Marker/Feature			
Cheesman	239.00	Yes	Yes			
IV. MARKER INFORMATION						
Marker Type	Site Feature	Height:	Width:	Depth:		
<input checked="" type="checkbox"/> Marble	<input type="checkbox"/> Granite	<input type="checkbox"/> Sandstone	<input type="checkbox"/> Slate			
<input type="checkbox"/> Brick	<input checked="" type="checkbox"/> Iron	<input type="checkbox"/> Other: _____

V. MATERIAL CONDITIONS						
<input checked="" type="checkbox"/> Biological - Algae	<input type="checkbox"/> Biological - Lichens	<input type="checkbox"/> Crack	<input type="checkbox"/> Delamination/Exfoliation			
<input type="checkbox"/> Disaggregation/Erosion	<input type="checkbox"/> Graffiti	<input type="checkbox"/> Off base (missing)	<input type="checkbox"/> Off base (adjacent)			
<input checked="" type="checkbox"/> Missing Fragment (s)	<input type="checkbox"/> Previous Repair	<input checked="" type="checkbox"/> Soiling	<input type="checkbox"/> Sunken			
<input type="checkbox"/> Tilt	<input checked="" type="checkbox"/> Corrosion					
<input checked="" type="checkbox"/> Other:	Missing rails and gate. Paint failure for surviving rails.					
VI. TREATMENT RECOMMENDATIONS						
<input type="checkbox"/> Archaeology	<input type="checkbox"/> Excavate	<input type="checkbox"/> Reset on exist base	<input type="checkbox"/> Reset on salvaged base (if poss)

<input checked="" type="checkbox"/> Clean/bio removal	<input type="checkbox"/> Consolidate	<input checked="" type="checkbox"/> Composite repair	<input type="checkbox"/> Pin/adhesive repair			
<input checked="" type="checkbox"/> Other:	Repair and repaint surviving rails. Replace missing posts, rails and gate.					
VI. PHOTOGRAPHS						
Photo 1:			Photo 2:

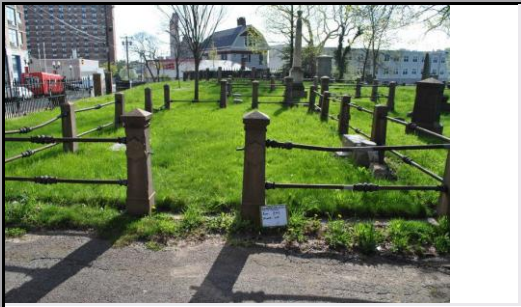
I. BURIAL INFORMATION					II. PRIORITIZATION	
First name	Last name	Birth	Death	Survey date	Condition	Prioritization
				4/7/2010	Fair	Long term
III. LOCATION						
Cemetery Section	Plot/Marker Number	Original Location	Original Marker/Feature			
Presbyterian	245.00	Yes	Yes			
IV. MARKER INFORMATION						
Marker Type	Site Feature	Height:	Width:	Depth:		
<input type="checkbox"/> Marble	<input checked="" type="checkbox"/> Granite	<input type="checkbox"/> Sandstone	<input type="checkbox"/> Slate			
<input type="checkbox"/> Brick	<input checked="" type="checkbox"/> Iron	<input type="checkbox"/> Other: _____

V. MATERIAL CONDITIONS						
<input type="checkbox"/> Biological - Algae	<input type="checkbox"/> Biological - Lichens	<input type="checkbox"/> Crack	<input type="checkbox"/> Delamination/Exfoliation			
<input type="checkbox"/> Disaggregation/Erosion	<input type="checkbox"/> Graffiti	<input type="checkbox"/> Off base (missing)	<input type="checkbox"/> Off base (adjacent)			
<input checked="" type="checkbox"/> Missing Fragment (s)	<input type="checkbox"/> Previous Repair	<input checked="" type="checkbox"/> Soiling	<input type="checkbox"/> Sunken			
<input type="checkbox"/> Tilt	<input checked="" type="checkbox"/> Corrosion					
<input checked="" type="checkbox"/> Other:	Damaged and missing rails. Missing gate.					
VI. TREATMENT RECOMMENDATIONS						
<input type="checkbox"/> Archaeology	<input type="checkbox"/> Excavate	<input type="checkbox"/> Reset on exist base	<input type="checkbox"/> Reset on salvaged base (if poss)

<input type="checkbox"/> Clean/bio removal	<input type="checkbox"/> Consolidate	<input type="checkbox"/> Composite repair	<input type="checkbox"/> Pin/adhesive repair			
<input checked="" type="checkbox"/> Other:	Repair and repaint surviving rails. Replace missing rails and missing gate.					
VI. PHOTOGRAPHS						
Photo 1:			Photo 2:

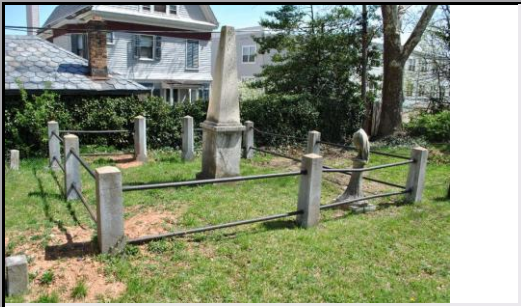
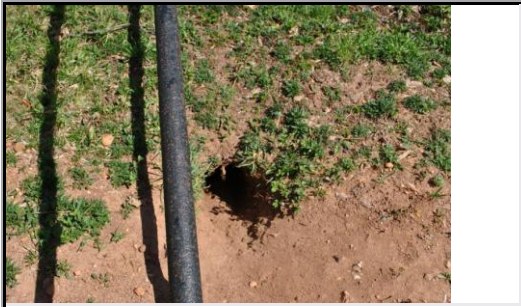
I. BURIAL INFORMATION					II. PRIORITIZATION	
First name	Last name	Birth	Death	Survey date	Condition	Prioritization
				4/7/2010	Fair	Long term
III. LOCATION						
Cemetery Section	Plot/Marker Number	Original Location	Original Marker/Feature			
Presbyterian	292.00	Yes	Yes			
IV. MARKER INFORMATION						
Marker Type	Site Feature	Height:	Width:	Depth:		
<input type="checkbox"/> Marble	<input checked="" type="checkbox"/> Granite	<input type="checkbox"/> Sandstone	<input type="checkbox"/> Slate			
<input type="checkbox"/> Brick	<input checked="" type="checkbox"/> Iron	<input type="checkbox"/> Other: _____

V. MATERIAL CONDITIONS						
<input checked="" type="checkbox"/> Biological - Algae	<input type="checkbox"/> Biological - Lichens	<input type="checkbox"/> Crack	<input type="checkbox"/> Delamination/Exfoliation			
<input type="checkbox"/> Disaggregation/Erosion	<input type="checkbox"/> Graffiti	<input type="checkbox"/> Off base (missing)	<input type="checkbox"/> Off base (adjacent)			
<input type="checkbox"/> Missing Fragment (s)	<input type="checkbox"/> Previous Repair	<input checked="" type="checkbox"/> Soiling	<input type="checkbox"/> Sunken			
<input type="checkbox"/> Tilt	<input checked="" type="checkbox"/> Corrosion					
<input checked="" type="checkbox"/> Other:	_____					
VI. TREATMENT RECOMMENDATIONS						
<input type="checkbox"/> Archaeology	<input type="checkbox"/> Excavate	<input type="checkbox"/> Reset on exist base	<input type="checkbox"/> Reset on salvaged base (if poss)			
<input type="checkbox"/> Clean/bio removal	<input type="checkbox"/> Consolidate	<input type="checkbox"/> Composite repair	<input type="checkbox"/> Pin/adhesive repair

<input checked="" type="checkbox"/> Other:	Replace missing gate.					
VI. PHOTOGRAPHS						
Photo 1:			Photo 2:

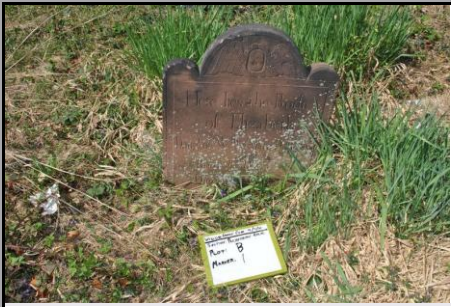
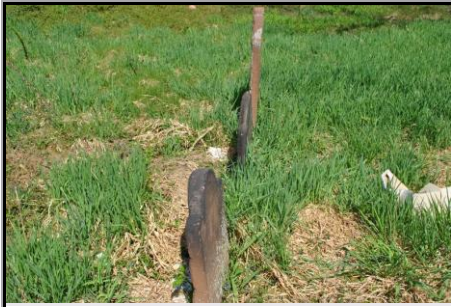
I. BURIAL INFORMATION					II. PRIORITIZATION	
First name	Last name	Birth	Death	Survey date	Condition	Prioritization
Elizabeth	Donaldson		1757	4/7/2010	Fair	Long term
III. LOCATION						
Cemetery Section	Plot/Marker Number	Original Location	Original Marker/Feature			
Presbyterian	B.1	No	Yes			
IV. MARKER INFORMATION						
Marker Type						
Headstone		Height: 25	Width: 25	Depth: 4		
<input type="checkbox"/> Marble	<input type="checkbox"/> Granite	<input checked="" type="checkbox"/> Sandstone	<input type="checkbox"/> Slate			
<input type="checkbox"/> Brick	<input type="checkbox"/> Iron	<input type="checkbox"/> Other: _____

V. MATERIAL CONDITIONS						
<input checked="" type="checkbox"/> Biological - Algae	<input checked="" type="checkbox"/> Biological - Lichens	<input type="checkbox"/> Crack	<input type="checkbox"/> Delamination/Exfoliation			
<input type="checkbox"/> Disaggregation/Erosion	<input type="checkbox"/> Graffiti	<input type="checkbox"/> Off base (missing)	<input type="checkbox"/> Off base (adjacent)			
<input type="checkbox"/> Missing Fragment (s)	<input type="checkbox"/> Previous Repair	<input type="checkbox"/> Soiling	<input type="checkbox"/> Sunken			
<input checked="" type="checkbox"/> Tilt	<input type="checkbox"/> Corrosion					
<input type="checkbox"/> Other:	_____					
VI. TREATMENT RECOMMENDATIONS						
<input type="checkbox"/> Archaeology	<input type="checkbox"/> Excavate	<input type="checkbox"/> Reset on exist base	<input checked="" type="checkbox"/> Reset on salvaged base (if poss)			
<input checked="" type="checkbox"/> Clean/bio removal	<input type="checkbox"/> Consolidate	<input type="checkbox"/> Composite repair	<input type="checkbox"/> Pin/adhesive repair

VII. ADDITIONAL INFORMATION						
Marker is located in an area with poor drainage and will be susceptible to water related deterioration.

<input type="checkbox"/> Other:	_____					
VI. PHOTOGRAPHS						
Photo 1:			Photo 2:

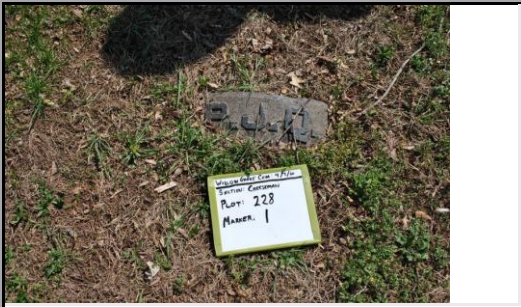
I. BURIAL INFORMATION					II. PRIORITIZATION	
First name	Last name	Birth	Death	Survey date	Condition	Prioritization
Peter	Quick	1806	1886	4/7/2010	Fair	Long term
III. LOCATION						
Cemetery Section	Plot/Marker Number	Original Location	Original Marker/Feature			
Cheesman	228.01	Unknown	No			
IV. MARKER INFORMATION						
Marker Type						
Headstone		Height: 14	Width: 16	Depth: 6		
<input type="checkbox"/> Marble	<input checked="" type="checkbox"/> Granite	<input type="checkbox"/> Sandstone	<input type="checkbox"/> Slate			
<input type="checkbox"/> Brick	<input type="checkbox"/> Iron	<input type="checkbox"/> Other: _____

V. MATERIAL CONDITIONS						
<input type="checkbox"/> Biological - Algae	<input type="checkbox"/> Biological - Lichens	<input type="checkbox"/> Crack	<input type="checkbox"/> Delamination/Exfoliation			
<input type="checkbox"/> Disaggregation/Erosion	<input type="checkbox"/> Graffiti	<input type="checkbox"/> Off base (missing)	<input type="checkbox"/> Off base (adjacent)			
<input type="checkbox"/> Missing Fragment (s)	<input type="checkbox"/> Previous Repair	<input type="checkbox"/> Soiling	<input checked="" type="checkbox"/> Sunken			
<input type="checkbox"/> Tilt	<input type="checkbox"/> Corrosion					
<input type="checkbox"/> Other:	_____					
VI. TREATMENT RECOMMENDATIONS						
<input type="checkbox"/> Archaeology	<input checked="" type="checkbox"/> Excavate	<input type="checkbox"/> Reset on exist base	<input checked="" type="checkbox"/> Reset on salvaged base (if poss)			
<input checked="" type="checkbox"/> Clean/bio removal	<input type="checkbox"/> Consolidate	<input type="checkbox"/> Composite repair	<input type="checkbox"/> Pin/adhesive repair

VII. ADDITIONAL INFORMATION						
Marker inscription with raised letters: P.J.Q.

<input type="checkbox"/> Other:	_____					
VI. PHOTOGRAPHS						
Photo 1:			Photo 2:

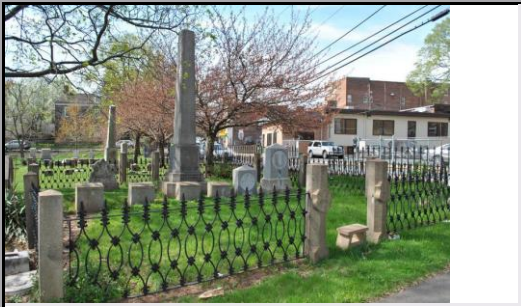
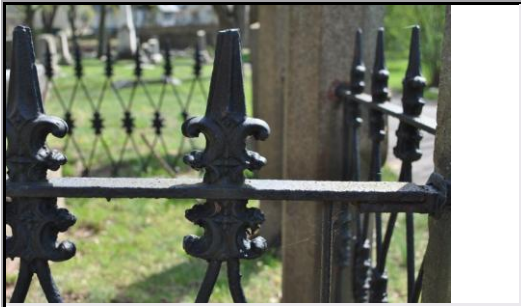
I. BURIAL INFORMATION					II. PRIORITIZATION	
First name	Last name	Birth	Death	Survey date	Condition	Prioritization
				4/7/2010	Good	Long term
III. LOCATION						
Cemetery Section	Plot/Marker Number	Original Location	Original Marker/Feature			
Willow Grove	080.00	Yes	Yes			
IV. MARKER INFORMATION						
Marker Type	Height:	Width:	Depth:			
Site Feature						
<input type="checkbox"/> Marble	<input checked="" type="checkbox"/> Granite	<input type="checkbox"/> Sandstone	<input type="checkbox"/> Slate			
<input type="checkbox"/> Brick	<input checked="" type="checkbox"/> Iron	<input type="checkbox"/> Other: _____

V. MATERIAL CONDITIONS						
<input checked="" type="checkbox"/> Biological - Algae	<input type="checkbox"/> Biological - Lichens	<input type="checkbox"/> Crack	<input type="checkbox"/> Delamination/Exfoliation			
<input type="checkbox"/> Disaggregation/Erosion	<input type="checkbox"/> Graffiti	<input type="checkbox"/> Off base (missing)	<input type="checkbox"/> Off base (adjacent)			
<input checked="" type="checkbox"/> Missing Fragment (s)	<input type="checkbox"/> Previous Repair	<input checked="" type="checkbox"/> Soiling	<input type="checkbox"/> Sunken			
<input type="checkbox"/> Tilt	<input type="checkbox"/> Corrosion					
<input checked="" type="checkbox"/> Other:	Missing gate.					
VI. TREATMENT RECOMMENDATIONS						
<input type="checkbox"/> Archaeology	<input type="checkbox"/> Excavate	<input type="checkbox"/> Reset on exist base	<input type="checkbox"/> Reset on salvaged base (if poss)

VII. ADDITIONAL INFORMATION						
Plot is less susceptible to vandalism due to high visibility at front of cemetery. Shields at entrance to plot read "I.C. Voorhees" and "A.D. 1853."

<input checked="" type="checkbox"/> Clean/bio removal	<input type="checkbox"/> Consolidate	<input type="checkbox"/> Composite repair	<input type="checkbox"/> Pin/adhesive repair			
<input checked="" type="checkbox"/> Other:	Remove minor corrosion from plot fence. Repaint as required.					
VI. PHOTOGRAPHS						
Photo 1:			Photo 2:

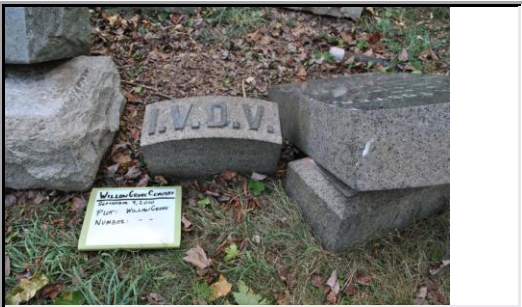
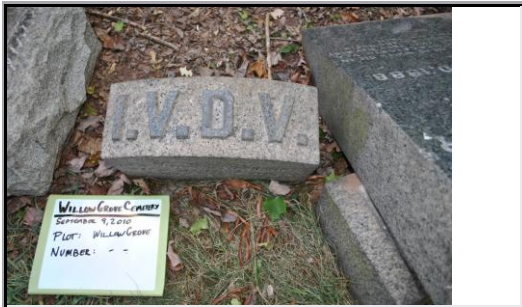
I. BURIAL INFORMATION					II. PRIORITIZATION	
First name	Last name	Birth	Death	Survey date	Condition	Prioritization
I.V.D.	V. (Voorhees)	1885	1895	9/9/2010	Good	Long term
III. LOCATION						
Cemetery Section	Plot/Marker Number	Original Location	Original Marker/Feature			
Willow Grove	132.04	Unknown	No			
IV. MARKER INFORMATION						
Marker Type						
Headstone		Height: 10	Width: 16	Depth: 6		
<input type="checkbox"/> Marble	<input checked="" type="checkbox"/> Granite	<input type="checkbox"/> Sandstone	<input type="checkbox"/> Slate			
<input type="checkbox"/> Brick	<input type="checkbox"/> Iron	<input type="checkbox"/> Other: _____

V. MATERIAL CONDITIONS						
<input type="checkbox"/> Biological - Algae	<input type="checkbox"/> Biological - Lichens	<input type="checkbox"/> Crack	<input type="checkbox"/> Delamination/Exfoliation			
<input type="checkbox"/> Disaggregation/Erosion	<input type="checkbox"/> Graffiti	<input type="checkbox"/> Off base (missing)	<input type="checkbox"/> Off base (adjacent)			
<input type="checkbox"/> Missing Fragment (s)	<input type="checkbox"/> Previous Repair	<input checked="" type="checkbox"/> Soiling	<input checked="" type="checkbox"/> Sunken			
<input checked="" type="checkbox"/> Tilt	<input type="checkbox"/> Corrosion					
<input type="checkbox"/> Other:	_____					
VI. TREATMENT RECOMMENDATIONS						
<input type="checkbox"/> Archaeology	<input checked="" type="checkbox"/> Excavate	<input type="checkbox"/> Reset on exist base	<input type="checkbox"/> Reset on salvaged base (if poss)			
<input checked="" type="checkbox"/> Clean/bio removal	<input type="checkbox"/> Consolidate	<input type="checkbox"/> Composite repair	<input type="checkbox"/> Pin/adhesive repair

<input type="checkbox"/> Other:	_____					
VI. PHOTOGRAPHS						
Photo 1:			Photo 2:

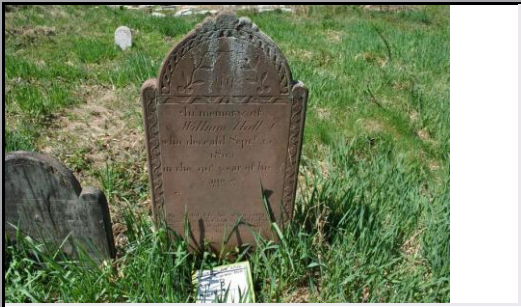
I. BURIAL INFORMATION					II. PRIORITIZATION	
First name	Last name	Birth	Death	Survey date	Condition	Prioritization
William	Hall		1803	4/7/2010	Good	Long term
III. LOCATION						
Cemetery Section	Plot/Marker Number	Original Location	Original Marker/Feature			
Presbyterian	B.3	No	Yes			
IV. MARKER INFORMATION						
Marker Type						
Headstone		Height: 51	Width: 25	Depth: 4		
<input type="checkbox"/> Marble	<input type="checkbox"/> Granite	<input checked="" type="checkbox"/> Sandstone	<input type="checkbox"/> Slate			
<input type="checkbox"/> Brick	<input type="checkbox"/> Iron	<input type="checkbox"/> Other: _____

V. MATERIAL CONDITIONS						
<input checked="" type="checkbox"/> Biological - Algae	<input checked="" type="checkbox"/> Biological - Lichens	<input type="checkbox"/> Crack	<input checked="" type="checkbox"/> Delamination/Exfoliation			
<input type="checkbox"/> Disaggregation/Erosion	<input type="checkbox"/> Graffiti	<input type="checkbox"/> Off base (missing)	<input type="checkbox"/> Off base (adjacent)			
<input type="checkbox"/> Missing Fragment (s)	<input type="checkbox"/> Previous Repair	<input type="checkbox"/> Soiling	<input type="checkbox"/> Sunken			
<input type="checkbox"/> Tilt	<input type="checkbox"/> Corrosion					
<input checked="" type="checkbox"/> Other:	Delamination is very minor.					
VI. TREATMENT RECOMMENDATIONS						
<input type="checkbox"/> Archaeology	<input type="checkbox"/> Excavate	<input type="checkbox"/> Reset on exist base	<input type="checkbox"/> Reset on salvaged base (if poss)

VII. ADDITIONAL INFORMATION						
The use of slate is exceptionally rare within this cemetery. Slate markers were noted only within the Presbyterian portion of the site. Marker is located in an area with poor drainage and will be susceptible to water related deterioration.

<input checked="" type="checkbox"/> Clean/bio removal	<input type="checkbox"/> Consolidate	<input checked="" type="checkbox"/> Composite repair	<input type="checkbox"/> Pin/adhesive repair			
<input checked="" type="checkbox"/> Other:	Monitor delamination. Injection grout and composite repair to minimize additional delamination.					
VI. PHOTOGRAPHS						
Photo 1:			Photo 2:

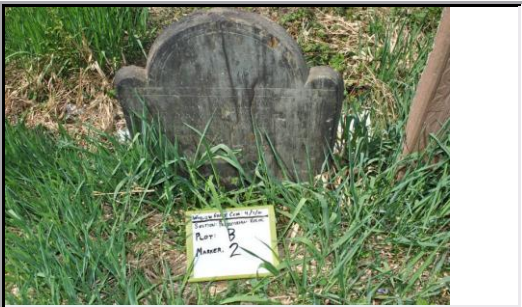
I. BURIAL INFORMATION					II. PRIORITIZATION	
First name	Last name	Birth	Death	Survey date	Condition	Prioritization
Mary	Hall		1761	4/7/2010	Good	Long term
III. LOCATION						
Cemetery Section	Plot/Marker Number	Original Location	Original Marker/Feature			
Presbyterian	B.2	No	Yes			
IV. MARKER INFORMATION						
Marker Type						
Headstone	Height: 29	Width: 25	Depth: 3			
<input type="checkbox"/> Marble	<input type="checkbox"/> Granite	<input type="checkbox"/> Sandstone	<input checked="" type="checkbox"/> Slate			
<input type="checkbox"/> Brick	<input type="checkbox"/> Iron	<input type="checkbox"/> Other: _____

V. MATERIAL CONDITIONS						
<input checked="" type="checkbox"/> Biological - Algae	<input type="checkbox"/> Biological - Lichens	<input checked="" type="checkbox"/> Crack	<input checked="" type="checkbox"/> Delamination/Exfoliation			
<input type="checkbox"/> Disaggregation/Erosion	<input type="checkbox"/> Graffiti	<input type="checkbox"/> Off base (missing)	<input type="checkbox"/> Off base (adjacent)			
<input type="checkbox"/> Missing Fragment (s)	<input type="checkbox"/> Previous Repair	<input type="checkbox"/> Soiling	<input type="checkbox"/> Sunken			
<input type="checkbox"/> Tilt	<input type="checkbox"/> Corrosion					
<input type="checkbox"/> Other:	_____					
VI. TREATMENT RECOMMENDATIONS						
<input type="checkbox"/> Archaeology	<input type="checkbox"/> Excavate	<input type="checkbox"/> Reset on exist base	<input type="checkbox"/> Reset on salvaged base (if poss)			
<input checked="" type="checkbox"/> Clean/bio removal	<input type="checkbox"/> Consolidate	<input type="checkbox"/> Composite repair	<input type="checkbox"/> Pin/adhesive repair

VII. ADDITIONAL INFORMATION						
The use of slate is exceptionally rare within this cemetery. Slate markers were noted only within the Presbyterian portion of the site. Marker is located in an area with poor drainage and will be susceptible to water related deterioration.

<input checked="" type="checkbox"/> Other:	Injection or adhesive to stabilize cracks and minimize additional exfoliation. Lead cap for top of marker.					
VI. PHOTOGRAPHS						
Photo 1:			Photo 2:

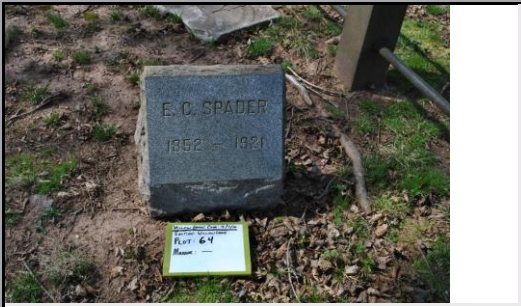
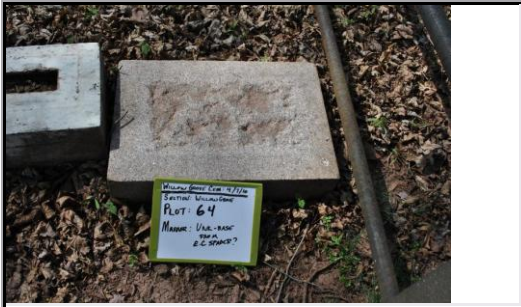
I. BURIAL INFORMATION					II. PRIORITIZATION	
First name	Last name	Birth	Death	Survey date	Condition	Prioritization
E.C.	Spader	1852	1921	4/7/2010	Good	Long term
III. LOCATION						
Cemetery Section	Plot/Marker Number	Original Location	Original Marker/Feature			
Willow Grove	064.1	No	No			
IV. MARKER INFORMATION						
Marker Type						
Headstone w/ base		Height: 19	Width: 19	Depth: 10		
<input type="checkbox"/> Marble	<input checked="" type="checkbox"/> Granite	<input type="checkbox"/> Sandstone	<input type="checkbox"/> Slate			
<input type="checkbox"/> Brick	<input type="checkbox"/> Iron	<input type="checkbox"/> Other: _____

V. MATERIAL CONDITIONS						
<input type="checkbox"/> Biological - Algae	<input type="checkbox"/> Biological - Lichens	<input type="checkbox"/> Crack	<input type="checkbox"/> Delamination/Exfoliation			
<input type="checkbox"/> Disaggregation/Erosion	<input type="checkbox"/> Graffiti	<input type="checkbox"/> Off base (missing)	<input checked="" type="checkbox"/> Off base (adjacent)			
<input type="checkbox"/> Missing Fragment (s)	<input type="checkbox"/> Previous Repair	<input type="checkbox"/> Soiling	<input type="checkbox"/> Sunken			
<input type="checkbox"/> Tilt	<input type="checkbox"/> Corrosion					
<input checked="" type="checkbox"/> Other:	Marker has been removed from base, and moved from original location.					
VI. TREATMENT RECOMMENDATIONS						
<input checked="" type="checkbox"/> Archaeology	<input type="checkbox"/> Excavate	<input checked="" type="checkbox"/> Reset on exist base	<input type="checkbox"/> Reset on salvaged base (if poss)

<input type="checkbox"/> Clean/bio removal	<input type="checkbox"/> Consolidate	<input type="checkbox"/> Composite repair	<input type="checkbox"/> Pin/adhesive repair			
<input checked="" type="checkbox"/> Other:	Locate proper burial location. Re-set existing base on pea gravel/mortar pad. Reinstall headstone on mortar bed between base and headstone.					
VI. PHOTOGRAPHS						
Photo 1:			Photo 2:

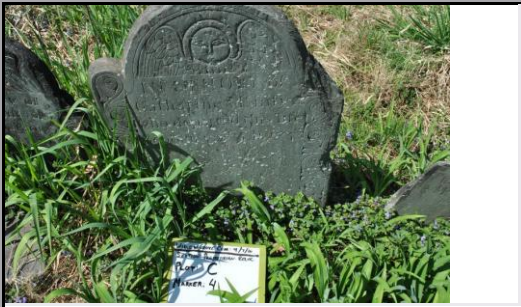
VI. PHOTOGRAPHS	
<p>Photo 1:</p>

I. BURIAL INFORMATION					II. PRIORITIZATION	
First name	Last name	Birth	Death	Survey date	Condition	Prioritization
Catharine	McIntyre		1863	4/7/2010	Good	Long term

V. MATERIAL CONDITIONS			
<input checked="" type="checkbox"/> Biological - Algae	<input type="checkbox"/> Biological - Lichens	<input type="checkbox"/> Crack	<input checked="" type="checkbox"/> Delamination/Exfoliation
<input type="checkbox"/> Disaggregation/Erosion	<input type="checkbox"/> Graffiti	<input type="checkbox"/> Off base (missing)	<input type="checkbox"/> Off base (adjacent)
<input type="checkbox"/> Missing Fragment (s)	<input type="checkbox"/> Previous Repair	<input type="checkbox"/> Soiling	<input type="checkbox"/> Sunken
<input type="checkbox"/> Tilt	<input type="checkbox"/> Corrosion		
<input type="checkbox"/> Other:

VII. ADDITIONAL INFORMATION
<p>The use of slate is exceptionally rare within this cemetery. Slate markers were noted only within the Presbyterian portion of the site. Marker is located in an area with poor drainage and will be susceptible to water related deterioration.</p>

VI. TREATMENT RECOMMENDATIONS			
<input type="checkbox"/> Archaeology	<input type="checkbox"/> Excavate	<input type="checkbox"/> Reset on exist base	<input type="checkbox"/> Reset on salvaged base (if poss)
<input checked="" type="checkbox"/> Clean/bio removal	<input type="checkbox"/> Consolidate	<input type="checkbox"/> Composite repair	<input type="checkbox"/> Pin/adhesive repair
<input checked="" type="checkbox"/> Other:	Monitor delamination. Injection grout and composite repair to minimize additional delamination.
