HISTORIC PRESERVATION PLAN

WILLOW GROVE CEMETERY

New Brunswick, Middlesex County, New Jersey

DATE: 4 October 2010

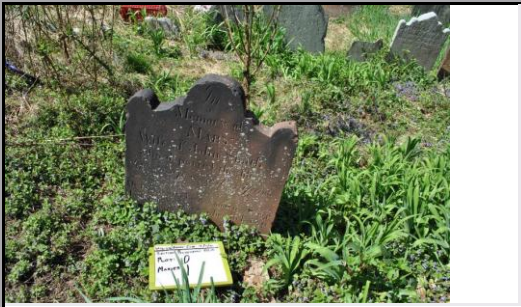
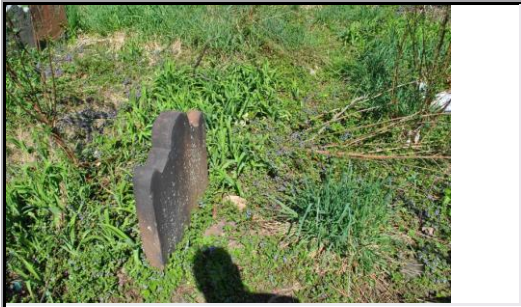
I. BURIAL INFORMATION					II. PRIORITIZATION	
First name	Last name	Birth	Death	Survey date	Condition	Prioritization
Mary	Smith		1791	4/7/2010	Good	Long term
III. LOCATION						
Cemetery Section	Plot/Marker Number	Original Location	Original Marker/Feature			
Presbyterian	D.1	No	Yes			
IV. MARKER INFORMATION						
Marker Type						
Headstone		Height: 27	Width: 24	Depth: 4		
<input type="checkbox"/> Marble	<input type="checkbox"/> Granite	<input checked="" type="checkbox"/> Sandstone	<input type="checkbox"/> Slate			
<input type="checkbox"/> Brick	<input type="checkbox"/> Iron	<input type="checkbox"/> Other: _____

V. MATERIAL CONDITIONS						
<input checked="" type="checkbox"/> Biological - Algae	<input checked="" type="checkbox"/> Biological - Lichens	<input type="checkbox"/> Crack	<input checked="" type="checkbox"/> Delamination/Exfoliation			
<input type="checkbox"/> Disaggregation/Erosion	<input type="checkbox"/> Graffiti	<input type="checkbox"/> Off base (missing)	<input type="checkbox"/> Off base (adjacent)			
<input type="checkbox"/> Missing Fragment (s)	<input type="checkbox"/> Previous Repair	<input type="checkbox"/> Soiling	<input type="checkbox"/> Sunken			
<input type="checkbox"/> Tilt	<input type="checkbox"/> Corrosion					
<input type="checkbox"/> Other:	_____					
VI. TREATMENT RECOMMENDATIONS						
<input type="checkbox"/> Archaeology	<input type="checkbox"/> Excavate	<input type="checkbox"/> Reset on exist base	<input type="checkbox"/> Reset on salvaged base (if poss)			
<input checked="" type="checkbox"/> Clean/bio removal	<input type="checkbox"/> Consolidate	<input type="checkbox"/> Composite repair	<input type="checkbox"/> Pin/adhesive repair

<input checked="" type="checkbox"/> Other:	Monitor minor delamination. Stabilize with injection grout and composite repair if necessary.					
VI. PHOTOGRAPHS						
Photo 1:			Photo 2:

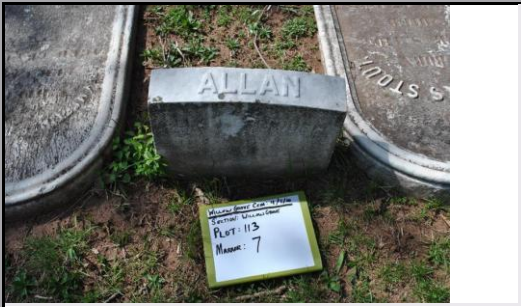
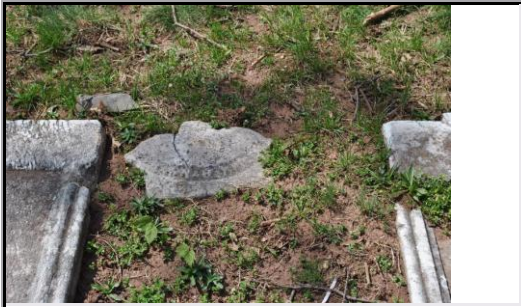
I. BURIAL INFORMATION					II. PRIORITIZATION	
First name	Last name	Birth	Death	Survey date	Condition	Prioritization
Allan	Riddell			4/7/2010	Good	Long term
III. LOCATION						
Cemetery Section	Plot/Marker Number	Original Location	Original Marker/Feature			
Willow Grove	113.07	Unknown	No			
IV. MARKER INFORMATION						
Marker Type						
Headstone		Height: 16	Width: 18	Depth: 4		
<input checked="" type="checkbox"/> Marble	<input type="checkbox"/> Granite	<input type="checkbox"/> Sandstone	<input type="checkbox"/> Slate			
<input type="checkbox"/> Brick	<input type="checkbox"/> Iron	<input type="checkbox"/> Other: _____

V. MATERIAL CONDITIONS						
<input checked="" type="checkbox"/> Biological - Algae	<input type="checkbox"/> Biological - Lichens	<input type="checkbox"/> Crack	<input type="checkbox"/> Delamination/Exfoliation			
<input checked="" type="checkbox"/> Disaggregation/Erosion	<input type="checkbox"/> Graffiti	<input type="checkbox"/> Off base (missing)	<input type="checkbox"/> Off base (adjacent)			
<input type="checkbox"/> Missing Fragment (s)	<input type="checkbox"/> Previous Repair	<input checked="" type="checkbox"/> Soiling	<input type="checkbox"/> Sunken			
<input type="checkbox"/> Tilt	<input type="checkbox"/> Corrosion					
<input checked="" type="checkbox"/> Other:	Other fragments of what appear to be an older stone nearby.					
VI. TREATMENT RECOMMENDATIONS						
<input checked="" type="checkbox"/> Archaeology	<input type="checkbox"/> Excavate	<input type="checkbox"/> Reset on exist base	<input type="checkbox"/> Reset on salvaged base (if poss)

<input checked="" type="checkbox"/> Clean/bio removal	<input type="checkbox"/> Consolidate	<input type="checkbox"/> Composite repair	<input type="checkbox"/> Pin/adhesive repair			
<input checked="" type="checkbox"/> Other:	Archaeology to investigate and identify nearby fragments.					
VI. PHOTOGRAPHS						
Photo 1:			Photo 2:

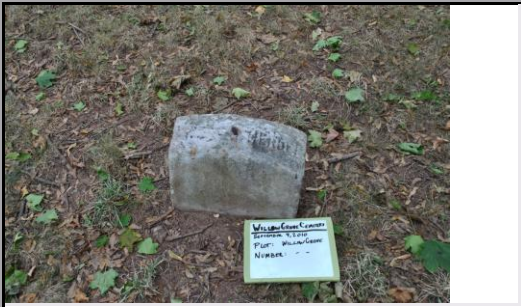
I. BURIAL INFORMATION					II. PRIORITIZATION	
First name	Last name	Birth	Death	Survey date	Condition	Prioritization
	...herdet?	0		9/9/2010	Good	Long term
III. LOCATION						
Cemetery Section	Plot/Marker Number	Original Location	Original Marker/Feature			
Willow Grove	068.00	Yes	Yes			
IV. MARKER INFORMATION						
Marker Type						
Headstone		Height: 12	Width: 16	Depth: 7		
<input checked="" type="checkbox"/> Marble	<input type="checkbox"/> Granite	<input type="checkbox"/> Sandstone	<input type="checkbox"/> Slate			
<input type="checkbox"/> Brick	<input type="checkbox"/> Iron	<input type="checkbox"/> Other: _____

V. MATERIAL CONDITIONS						
<input checked="" type="checkbox"/> Biological - Algae	<input type="checkbox"/> Biological - Lichens	<input type="checkbox"/> Crack	<input type="checkbox"/> Delamination/Exfoliation			
<input checked="" type="checkbox"/> Disaggregation/Erosion	<input type="checkbox"/> Graffiti	<input type="checkbox"/> Off base (missing)	<input type="checkbox"/> Off base (adjacent)			
<input type="checkbox"/> Missing Fragment (s)	<input type="checkbox"/> Previous Repair	<input checked="" type="checkbox"/> Soiling	<input type="checkbox"/> Sunken			
<input type="checkbox"/> Tilt	<input type="checkbox"/> Corrosion					
<input checked="" type="checkbox"/> Other:	Inscription is illegible due to erosion.					
VI. TREATMENT RECOMMENDATIONS						
<input type="checkbox"/> Archaeology	<input type="checkbox"/> Excavate	<input type="checkbox"/> Reset on exist base	<input type="checkbox"/> Reset on salvaged base (if poss)

<input checked="" type="checkbox"/> Clean/bio removal	<input type="checkbox"/> Consolidate	<input type="checkbox"/> Composite repair	<input type="checkbox"/> Pin/adhesive repair			
<input type="checkbox"/> Other:	_____					
VI. PHOTOGRAPHS						
Photo 1:			Photo 2:

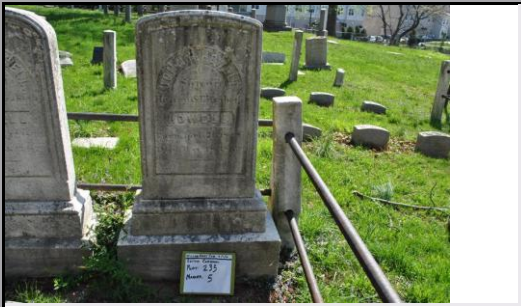
I. BURIAL INFORMATION					II. PRIORITIZATION	
First name	Last name	Birth	Death	Survey date	Condition	Prioritization
John	Howell	1848	1869	4/7/2010	Good	Long term
III. LOCATION						
Cemetery Section	Plot/Marker Number	Original Location	Original Marker/Feature			
Cheesman	235.05	Yes	Yes			
IV. MARKER INFORMATION						
Marker Type						
Headstone w/ base		Height: 54	Width: 34	Depth: 14		
<input checked="" type="checkbox"/> Marble	<input type="checkbox"/> Granite	<input type="checkbox"/> Sandstone	<input type="checkbox"/> Slate			
<input type="checkbox"/> Brick	<input type="checkbox"/> Iron	<input type="checkbox"/> Other: _____

V. MATERIAL CONDITIONS						
<input checked="" type="checkbox"/> Biological - Algae	<input type="checkbox"/> Biological - Lichens	<input type="checkbox"/> Crack	<input type="checkbox"/> Delamination/Exfoliation			
<input checked="" type="checkbox"/> Disaggregation/Erosion	<input type="checkbox"/> Graffiti	<input type="checkbox"/> Off base (missing)	<input type="checkbox"/> Off base (adjacent)			
<input type="checkbox"/> Missing Fragment (s)	<input type="checkbox"/> Previous Repair	<input type="checkbox"/> Soiling	<input type="checkbox"/> Sunken			
<input checked="" type="checkbox"/> Tilt	<input type="checkbox"/> Corrosion					
<input type="checkbox"/> Other:	_____					
VI. TREATMENT RECOMMENDATIONS						
<input type="checkbox"/> Archaeology	<input type="checkbox"/> Excavate	<input type="checkbox"/> Reset on exist base	<input type="checkbox"/> Reset on salvaged base (if poss)			
<input checked="" type="checkbox"/> Clean/bio removal	<input type="checkbox"/> Consolidate	<input type="checkbox"/> Composite repair	<input type="checkbox"/> Pin/adhesive repair

<input checked="" type="checkbox"/> Other:	Monitor tilt and correct when required.					
VI. PHOTOGRAPHS						
Photo 1:			Photo 2:

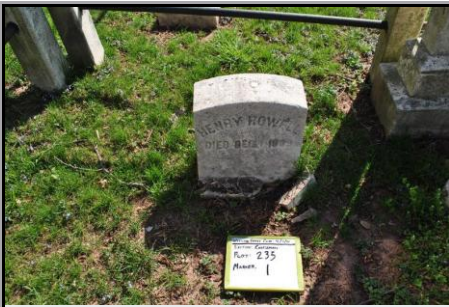
I. BURIAL INFORMATION					II. PRIORITIZATION	
First name	Last name	Birth	Death	Survey date	Condition	Prioritization
Henry	Howell		1889	4/7/2010	Good	Long term
III. LOCATION						
Cemetery Section	Plot/Marker Number	Original Location	Original Marker/Feature			
Cheesman	235.01	Yes	Yes			
IV. MARKER INFORMATION						
Marker Type						
Headstone		Height: 20	Width: 17	Depth: 6		
<input checked="" type="checkbox"/> Marble	<input type="checkbox"/> Granite	<input type="checkbox"/> Sandstone	<input type="checkbox"/> Slate			
<input type="checkbox"/> Brick	<input type="checkbox"/> Iron	<input type="checkbox"/> Other: _____

V. MATERIAL CONDITIONS						
<input checked="" type="checkbox"/> Biological - Algae	<input type="checkbox"/> Biological - Lichens	<input type="checkbox"/> Crack	<input type="checkbox"/> Delamination/Exfoliation			
<input checked="" type="checkbox"/> Disaggregation/Erosion	<input type="checkbox"/> Graffiti	<input type="checkbox"/> Off base (missing)	<input type="checkbox"/> Off base (adjacent)			
<input type="checkbox"/> Missing Fragment (s)	<input type="checkbox"/> Previous Repair	<input type="checkbox"/> Soiling	<input type="checkbox"/> Sunken			
<input type="checkbox"/> Tilt	<input type="checkbox"/> Corrosion					
<input type="checkbox"/> Other:	_____					
VI. TREATMENT RECOMMENDATIONS						
<input type="checkbox"/> Archaeology	<input type="checkbox"/> Excavate	<input type="checkbox"/> Reset on exist base	<input type="checkbox"/> Reset on salvaged base (if poss)			
<input checked="" type="checkbox"/> Clean/bio removal	<input type="checkbox"/> Consolidate	<input type="checkbox"/> Composite repair	<input type="checkbox"/> Pin/adhesive repair

VII. ADDITIONAL INFORMATION						
Fragments of concrete around base.

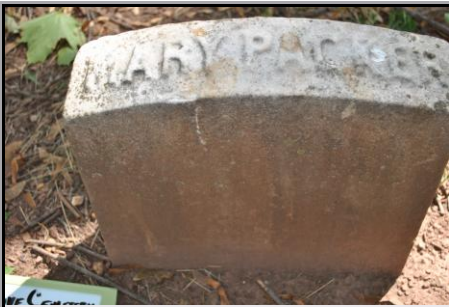
VI. PHOTOGRAPHS	
Photo 1:

I. BURIAL INFORMATION					II. PRIORITIZATION	
First name	Last name	Birth	Death	Survey date	Condition	Prioritization
Mary	Packer	1798	1887	9/9/2010	Good	Long term

V. MATERIAL CONDITIONS			
<input checked="" type="checkbox"/> Biological - Algae	<input checked="" type="checkbox"/> Biological - Lichens	<input type="checkbox"/> Crack	<input type="checkbox"/> Delamination/Exfoliation
<input checked="" type="checkbox"/> Disaggregation/Erosion	<input type="checkbox"/> Graffiti	<input type="checkbox"/> Off base (missing)	<input type="checkbox"/> Off base (adjacent)
<input type="checkbox"/> Missing Fragment (s)	<input type="checkbox"/> Previous Repair	<input checked="" type="checkbox"/> Soiling	<input type="checkbox"/> Sunken
<input checked="" type="checkbox"/> Tilt	<input type="checkbox"/> Corrosion		
<input type="checkbox"/> Other:	_____

VI. TREATMENT RECOMMENDATIONS			
<input type="checkbox"/> Archaeology	<input type="checkbox"/> Excavate	<input type="checkbox"/> Reset on exist base	<input type="checkbox"/> Reset on salvaged base (if poss)
<input checked="" type="checkbox"/> Clean/bio removal	<input type="checkbox"/> Consolidate	<input type="checkbox"/> Composite repair	<input type="checkbox"/> Pin/adhesive repair
<input type="checkbox"/> Other:	_____

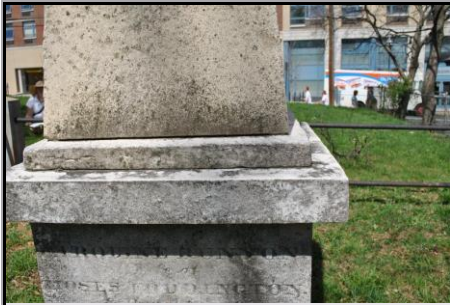
I. BURIAL INFORMATION					II. PRIORITIZATION	
First name	Last name	Birth	Death	Survey date	Condition	Prioritization
				4/7/2010	Good	Long term
III. LOCATION						
Cemetery Section	Plot/Marker Number	Original Location	Original Marker/Feature			
Presbyterian	292.01	Yes	Yes			
IV. MARKER INFORMATION						
Marker Type						
Obelisk	Height: 96	Width: 24	Depth: 24			
<input checked="" type="checkbox"/> Marble	<input type="checkbox"/> Granite	<input type="checkbox"/> Sandstone	<input type="checkbox"/> Slate			
<input type="checkbox"/> Brick	<input type="checkbox"/> Iron	<input type="checkbox"/> Other: _____

V. MATERIAL CONDITIONS						
<input checked="" type="checkbox"/> Biological - Algae	<input checked="" type="checkbox"/> Biological - Lichens	<input type="checkbox"/> Crack	<input type="checkbox"/> Delamination/Exfoliation			
<input type="checkbox"/> Disaggregation/Erosion	<input type="checkbox"/> Graffiti	<input type="checkbox"/> Off base (missing)	<input type="checkbox"/> Off base (adjacent)			
<input type="checkbox"/> Missing Fragment (s)	<input type="checkbox"/> Previous Repair	<input checked="" type="checkbox"/> Soiling	<input type="checkbox"/> Sunken			
<input type="checkbox"/> Tilt	<input type="checkbox"/> Corrosion					
<input checked="" type="checkbox"/> Other:	Open joints between obelisk and base. Ground surrounding plot has been disturbed by groundhog activity.					
VI. TREATMENT RECOMMENDATIONS						
<input type="checkbox"/> Archaeology	<input type="checkbox"/> Excavate	<input type="checkbox"/> Reset on exist base	<input type="checkbox"/> Reset on salvaged base (if poss)

<input checked="" type="checkbox"/> Clean/bio removal	<input type="checkbox"/> Consolidate	<input type="checkbox"/> Composite repair	<input type="checkbox"/> Pin/adhesive repair			
<input checked="" type="checkbox"/> Other:	Monitor for soil shift and associated tilt. Repoint joint between obelisk shaft and base.					
VI. PHOTOGRAPHS						
Photo 1:			Photo 2:

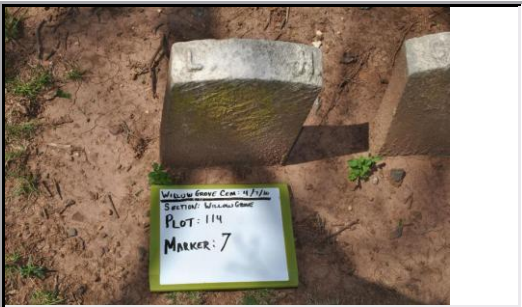
VI. PHOTOGRAPHS	
<p>Photo 1:</p>

I. BURIAL INFORMATION					II. PRIORITIZATION	
First name	Last name	Birth	Death	Survey date	Condition	Prioritization
L.	H.	1851	1852	4/7/2010	Good	Long term

V. MATERIAL CONDITIONS			
<input checked="" type="checkbox"/> Biological - Algae	<input type="checkbox"/> Biological - Lichens	<input type="checkbox"/> Crack	<input type="checkbox"/> Delamination/Exfoliation
<input type="checkbox"/> Disaggregation/Erosion	<input type="checkbox"/> Graffiti	<input type="checkbox"/> Off base (missing)	<input type="checkbox"/> Off base (adjacent)
<input type="checkbox"/> Missing Fragment (s)	<input type="checkbox"/> Previous Repair	<input checked="" type="checkbox"/> Soiling	<input type="checkbox"/> Sunken
<input type="checkbox"/> Tilt	<input type="checkbox"/> Corrosion		
<input checked="" type="checkbox"/> Other:	Raised letters on top surface: H.V.H.

VI. TREATMENT RECOMMENDATIONS			
<input type="checkbox"/> Archaeology	<input type="checkbox"/> Excavate	<input type="checkbox"/> Reset on exist base	<input type="checkbox"/> Reset on salvaged base (if poss)
<input checked="" type="checkbox"/> Clean/bio removal	<input type="checkbox"/> Consolidate	<input type="checkbox"/> Composite repair	<input type="checkbox"/> Pin/adhesive repair
<input type="checkbox"/> Other:	_____

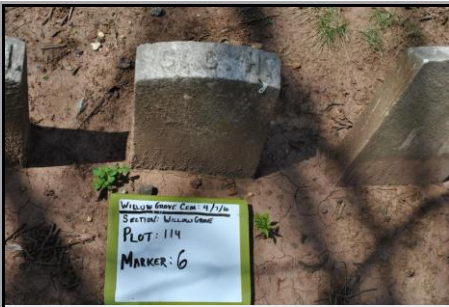
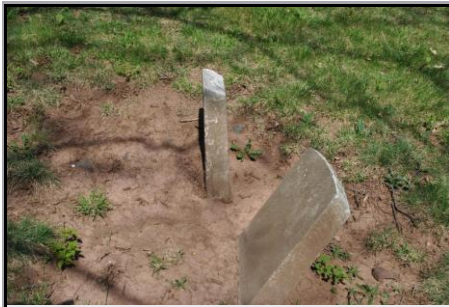
I. BURIAL INFORMATION					II. PRIORITIZATION	
First name	Last name	Birth	Death	Survey date	Condition	Prioritization
C.C.	H	1849	1850	4/7/2010	Good	Long term

V. MATERIAL CONDITIONS			
<input checked="" type="checkbox"/> Biological - Algae	<input type="checkbox"/> Biological - Lichens	<input type="checkbox"/> Crack	<input type="checkbox"/> Delamination/Exfoliation
<input checked="" type="checkbox"/> Disaggregation/Erosion	<input type="checkbox"/> Graffiti	<input type="checkbox"/> Off base (missing)	<input type="checkbox"/> Off base (adjacent)
<input type="checkbox"/> Missing Fragment (s)	<input type="checkbox"/> Previous Repair	<input checked="" type="checkbox"/> Soiling	<input type="checkbox"/> Sunken
<input checked="" type="checkbox"/> Tilt	<input type="checkbox"/> Corrosion		
<input checked="" type="checkbox"/> Other:	Raised letters on top surface: C.C.H.

VI. TREATMENT RECOMMENDATIONS			
<input type="checkbox"/> Archaeology	<input checked="" type="checkbox"/> Excavate	<input type="checkbox"/> Reset on exist base	<input type="checkbox"/> Reset on salvaged base (if poss)
<input checked="" type="checkbox"/> Clean/bio removal	<input type="checkbox"/> Consolidate	<input type="checkbox"/> Composite repair	<input type="checkbox"/> Pin/adhesive repair
<input checked="" type="checkbox"/> Other:	Reset on new pea gravel base.

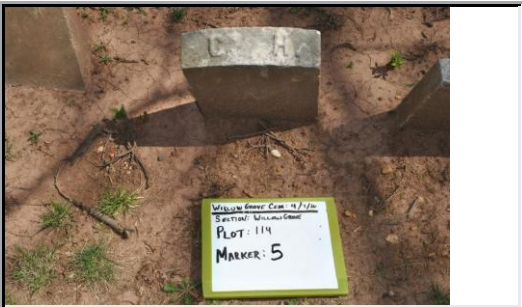
I. BURIAL INFORMATION					II. PRIORITIZATION	
First name	Last name	Birth	Death	Survey date	Condition	Prioritization
C.	H.		1848	4/7/2010	Good	Long term
III. LOCATION						
Cemetery Section	Plot/Marker Number	Original Location	Original Marker/Feature			
Willow Grove	114.05	Unknown	No			
IV. MARKER INFORMATION						
Marker Type						
Headstone		Height: 13	Width: 10	Depth: 3		
<input checked="" type="checkbox"/> Marble	<input type="checkbox"/> Granite	<input type="checkbox"/> Sandstone	<input type="checkbox"/> Slate			
<input type="checkbox"/> Brick	<input type="checkbox"/> Iron	<input type="checkbox"/> Other: _____

V. MATERIAL CONDITIONS						
<input checked="" type="checkbox"/> Biological - Algae	<input type="checkbox"/> Biological - Lichens	<input type="checkbox"/> Crack	<input type="checkbox"/> Delamination/Exfoliation			
<input checked="" type="checkbox"/> Disaggregation/Erosion	<input type="checkbox"/> Graffiti	<input type="checkbox"/> Off base (missing)	<input type="checkbox"/> Off base (adjacent)			
<input type="checkbox"/> Missing Fragment (s)	<input type="checkbox"/> Previous Repair	<input checked="" type="checkbox"/> Soiling	<input type="checkbox"/> Sunken			
<input type="checkbox"/> Tilt	<input type="checkbox"/> Corrosion					
<input checked="" type="checkbox"/> Other:	Raised letters on top surface: C.H.					
VI. TREATMENT RECOMMENDATIONS						
<input type="checkbox"/> Archaeology	<input type="checkbox"/> Excavate	<input type="checkbox"/> Reset on exist base	<input type="checkbox"/> Reset on salvaged base (if poss)

<input checked="" type="checkbox"/> Clean/bio removal	<input type="checkbox"/> Consolidate	<input type="checkbox"/> Composite repair	<input type="checkbox"/> Pin/adhesive repair			
<input type="checkbox"/> Other:	_____					
VI. PHOTOGRAPHS						
Photo 1:			Photo 2:

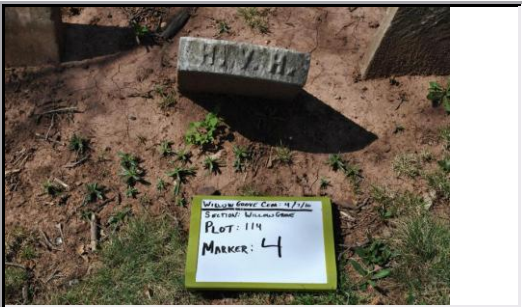
VI. PHOTOGRAPHS	
Photo 1:

I. BURIAL INFORMATION					II. PRIORITIZATION	
First name	Last name	Birth	Death	Survey date	Condition	Prioritization
H.V.	Hoagland	1839	1841	4/7/2010	Good	Long term

V. MATERIAL CONDITIONS			
<input checked="" type="checkbox"/> Biological - Algae	<input type="checkbox"/> Biological - Lichens	<input type="checkbox"/> Crack	<input type="checkbox"/> Delamination/Exfoliation
<input checked="" type="checkbox"/> Disaggregation/Erosion	<input type="checkbox"/> Graffiti	<input type="checkbox"/> Off base (missing)	<input type="checkbox"/> Off base (adjacent)
<input type="checkbox"/> Missing Fragment (s)	<input type="checkbox"/> Previous Repair	<input type="checkbox"/> Soiling	<input type="checkbox"/> Sunken
<input checked="" type="checkbox"/> Tilt	<input type="checkbox"/> Corrosion		
<input checked="" type="checkbox"/> Other:	Raised letters on top surface: H.V.H.

VI. TREATMENT RECOMMENDATIONS			
<input checked="" type="checkbox"/> Archaeology	<input checked="" type="checkbox"/> Excavate	<input type="checkbox"/> Reset on exist base	<input type="checkbox"/> Reset on salvaged base (if poss)
<input checked="" type="checkbox"/> Clean/bio removal	<input type="checkbox"/> Consolidate	<input type="checkbox"/> Composite repair	<input type="checkbox"/> Pin/adhesive repair
<input checked="" type="checkbox"/> Other:	Reset on new pea gravel base. Archaeology may be required.

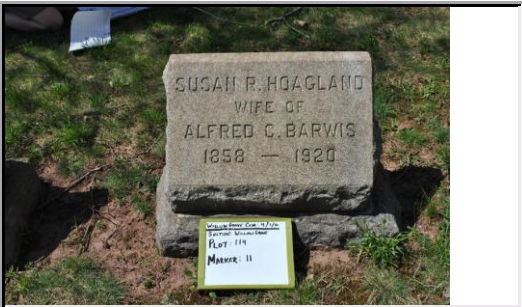
I. BURIAL INFORMATION					II. PRIORITIZATION	
First name	Last name	Birth	Death	Survey date	Condition	Prioritization
Susan	Barwis	1858	1920	4/7/2010	Good	Long term
III. LOCATION						
Cemetery Section	Plot/Marker Number	Original Location	Original Marker/Feature			
Willow Grove	114.11	Unknown	Unknown			
IV. MARKER INFORMATION						
Marker Type						
Headstone w/ base		Height: 22	Width: 28	Depth: 16		
<input type="checkbox"/> Marble	<input checked="" type="checkbox"/> Granite	<input type="checkbox"/> Sandstone	<input type="checkbox"/> Slate			
<input type="checkbox"/> Brick	<input type="checkbox"/> Iron	<input type="checkbox"/> Other: _____

V. MATERIAL CONDITIONS						
<input type="checkbox"/> Biological - Algae	<input type="checkbox"/> Biological - Lichens	<input type="checkbox"/> Crack	<input type="checkbox"/> Delamination/Exfoliation			
<input type="checkbox"/> Disaggregation/Erosion	<input type="checkbox"/> Graffiti	<input type="checkbox"/> Off base (missing)	<input type="checkbox"/> Off base (adjacent)			
<input type="checkbox"/> Missing Fragment (s)	<input type="checkbox"/> Previous Repair	<input type="checkbox"/> Soiling	<input type="checkbox"/> Sunken			
<input type="checkbox"/> Tilt	<input type="checkbox"/> Corrosion					
<input checked="" type="checkbox"/> Other:	Headstone has shifted slightly on base.					
VI. TREATMENT RECOMMENDATIONS						
<input type="checkbox"/> Archaeology	<input type="checkbox"/> Excavate	<input type="checkbox"/> Reset on exist base	<input type="checkbox"/> Reset on salvaged base (if poss)			
<input checked="" type="checkbox"/> Clean/bio removal	<input type="checkbox"/> Consolidate	<input type="checkbox"/> Composite repair	<input type="checkbox"/> Pin/adhesive repair

<input checked="" type="checkbox"/> Other:	Center marker on base. Point as required.					
VI. PHOTOGRAPHS						
Photo 1:			Photo 2:

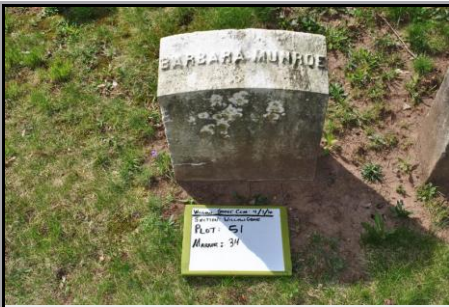
I. BURIAL INFORMATION					II. PRIORITIZATION	
First name	Last name	Birth	Death	Survey date	Condition	Prioritization
Barbara H.	Munroe			4/7/2010	Good	Long term
III. LOCATION						
Cemetery Section	Plot/Marker Number	Original Location	Original Marker/Feature			
Willow Grove	080.03	Unknown	No			
IV. MARKER INFORMATION						
Marker Type						
Headstone		Height: 19	Width: 16	Depth: 6		
<input checked="" type="checkbox"/> Marble	<input type="checkbox"/> Granite	<input type="checkbox"/> Sandstone	<input type="checkbox"/> Slate			
<input type="checkbox"/> Brick	<input type="checkbox"/> Iron	<input type="checkbox"/> Other: _____

V. MATERIAL CONDITIONS						
<input checked="" type="checkbox"/> Biological - Algae	<input type="checkbox"/> Biological - Lichens	<input type="checkbox"/> Crack	<input type="checkbox"/> Delamination/Exfoliation			
<input checked="" type="checkbox"/> Disaggregation/Erosion	<input type="checkbox"/> Graffiti	<input type="checkbox"/> Off base (missing)	<input type="checkbox"/> Off base (adjacent)			
<input type="checkbox"/> Missing Fragment (s)	<input type="checkbox"/> Previous Repair	<input type="checkbox"/> Soiling	<input type="checkbox"/> Sunken			
<input type="checkbox"/> Tilt	<input type="checkbox"/> Corrosion					
<input type="checkbox"/> Other:	_____					
VI. TREATMENT RECOMMENDATIONS						
<input type="checkbox"/> Archaeology	<input type="checkbox"/> Excavate	<input type="checkbox"/> Reset on exist base	<input type="checkbox"/> Reset on salvaged base (if poss)			
<input checked="" type="checkbox"/> Clean/bio removal	<input type="checkbox"/> Consolidate	<input type="checkbox"/> Composite repair	<input type="checkbox"/> Pin/adhesive repair

VII. ADDITIONAL INFORMATION						
Accompanies footstone also losted for this plot.

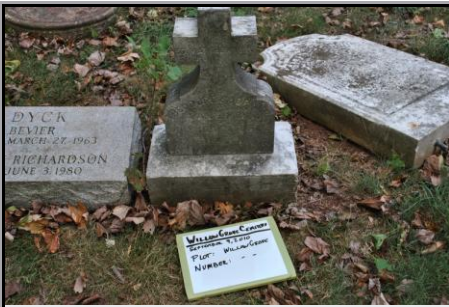
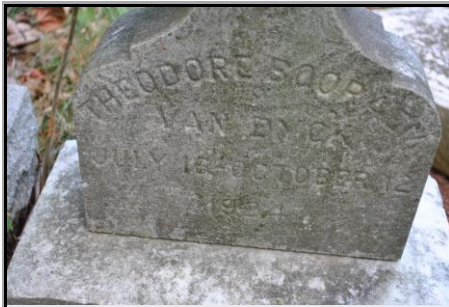
I. BURIAL INFORMATION					II. PRIORITIZATION	
First name	Last name	Birth	Death	Survey date	Condition	Prioritization
Theodore Booraem	Van Dyck	1924	1924	9/9/2010	Good	Long term

V. MATERIAL CONDITIONS			
<input checked="" type="checkbox"/> Biological - Algae	<input checked="" type="checkbox"/> Biological - Lichens	<input type="checkbox"/> Crack	<input type="checkbox"/> Delamination/Exfoliation
<input checked="" type="checkbox"/> Disaggregation/Erosion	<input type="checkbox"/> Graffiti	<input type="checkbox"/> Off base (missing)	<input type="checkbox"/> Off base (adjacent)
<input type="checkbox"/> Missing Fragment (s)	<input type="checkbox"/> Previous Repair	<input checked="" type="checkbox"/> Soiling	<input type="checkbox"/> Sunken
<input type="checkbox"/> Tilt	<input type="checkbox"/> Corrosion		
<input type="checkbox"/> Other:	_____

VI. TREATMENT RECOMMENDATIONS			
<input type="checkbox"/> Archaeology	<input type="checkbox"/> Excavate	<input type="checkbox"/> Reset on exist base	<input type="checkbox"/> Reset on salvaged base (if poss)
<input checked="" type="checkbox"/> Clean/bio removal	<input type="checkbox"/> Consolidate	<input type="checkbox"/> Composite repair	<input type="checkbox"/> Pin/adhesive repair
<input type="checkbox"/> Other:	_____

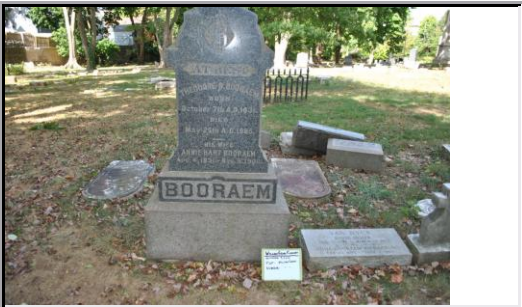
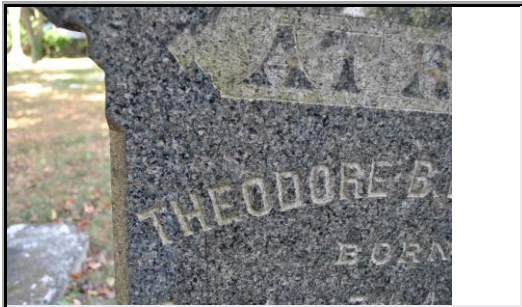
I. BURIAL INFORMATION					II. PRIORITIZATION	
First name	Last name	Birth	Death	Survey date	Condition	Prioritization
Theodore	Booraem	1831	1885	9/9/2010	Good	Long term
III. LOCATION						
Cemetery Section	Plot/Marker Number	Original Location	Original Marker/Feature			
Willow Grove	133.05	Unknown	No			
IV. MARKER INFORMATION						
Marker Type						
Headstone w/ base		Height: 72	Width: 39	Depth: 21		
<input type="checkbox"/> Marble	<input checked="" type="checkbox"/> Granite	<input type="checkbox"/> Sandstone	<input type="checkbox"/> Slate			
<input checked="" type="checkbox"/> Brick	<input type="checkbox"/> Iron	<input type="checkbox"/> Other: _____

V. MATERIAL CONDITIONS						
<input checked="" type="checkbox"/> Biological - Algae	<input type="checkbox"/> Biological - Lichens	<input type="checkbox"/> Crack	<input type="checkbox"/> Delamination/Exfoliation			
<input type="checkbox"/> Disaggregation/Erosion	<input type="checkbox"/> Graffiti	<input type="checkbox"/> Off base (missing)	<input type="checkbox"/> Off base (adjacent)			
<input type="checkbox"/> Missing Fragment (s)	<input type="checkbox"/> Previous Repair	<input type="checkbox"/> Soiling	<input type="checkbox"/> Sunken			
<input type="checkbox"/> Tilt	<input type="checkbox"/> Corrosion					
<input checked="" type="checkbox"/> Other:	Open joints at brick base.					
VI. TREATMENT RECOMMENDATIONS						
<input type="checkbox"/> Archaeology	<input type="checkbox"/> Excavate	<input type="checkbox"/> Reset on exist base	<input type="checkbox"/> Reset on salvaged base (if poss)			
<input checked="" type="checkbox"/> Clean/bio removal	<input type="checkbox"/> Consolidate	<input type="checkbox"/> Composite repair	<input type="checkbox"/> Pin/adhesive repair

<input checked="" type="checkbox"/> Other:	Repoint and parge brick base.					
VI. PHOTOGRAPHS						
Photo 1:			Photo 2:

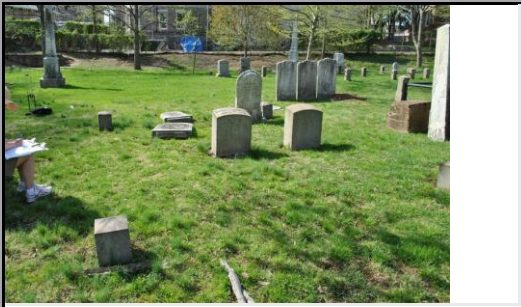
I. BURIAL INFORMATION					II. PRIORITIZATION	
First name	Last name	Birth	Death	Survey date	Condition	Prioritization
				4/7/2010	Good	Long term
III. LOCATION						
Cemetery Section	Plot/Marker Number	Original Location	Original Marker/Feature			
Willow Grove	025.00	Yes	Yes			
IV. MARKER INFORMATION						
Marker Type	Height:	Width:	Depth:			
Site Feature						
<input type="checkbox"/> Marble	<input checked="" type="checkbox"/> Granite	<input type="checkbox"/> Sandstone	<input type="checkbox"/> Slate			
<input type="checkbox"/> Brick	<input type="checkbox"/> Iron	<input type="checkbox"/> Other: _____

V. MATERIAL CONDITIONS						
<input type="checkbox"/> Biological - Algae	<input type="checkbox"/> Biological - Lichens	<input type="checkbox"/> Crack	<input type="checkbox"/> Delamination/Exfoliation			
<input type="checkbox"/> Disaggregation/Erosion	<input type="checkbox"/> Graffiti	<input type="checkbox"/> Off base (missing)	<input type="checkbox"/> Off base (adjacent)			
<input checked="" type="checkbox"/> Missing Fragment (s)	<input type="checkbox"/> Previous Repair	<input type="checkbox"/> Soiling	<input type="checkbox"/> Sunken			
<input type="checkbox"/> Tilt	<input type="checkbox"/> Corrosion					
<input type="checkbox"/> Other:	_____					
VI. TREATMENT RECOMMENDATIONS						
<input type="checkbox"/> Archaeology	<input type="checkbox"/> Excavate	<input type="checkbox"/> Reset on exist base	<input type="checkbox"/> Reset on salvaged base (if poss)			
<input checked="" type="checkbox"/> Clean/bio removal	<input type="checkbox"/> Consolidate	<input type="checkbox"/> Composite repair	<input type="checkbox"/> Pin/adhesive repair

VII. ADDITIONAL INFORMATION						
Unclear whether curbing or fencing was associated with this plot, or whether four corner blocks marked perimeter only.

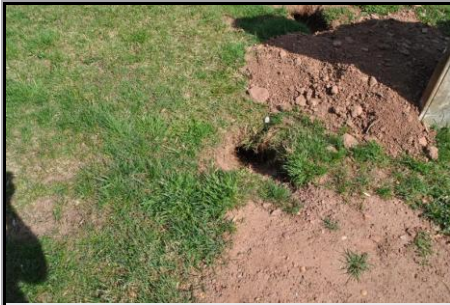
I. BURIAL INFORMATION					II. PRIORITIZATION	
First name	Last name	Birth	Death	Survey date	Condition	Prioritization
Ephraim	Dunn		1841	4/7/2010	Good	Long term
III. LOCATION						
Cemetery Section	Plot/Marker Number	Original Location	Original Marker/Feature			
Willow Grove	014.04	Yes	Yes			
IV. MARKER INFORMATION						
Marker Type						
Headstone		Height: 48	Width: 24	Depth: 2		
<input checked="" type="checkbox"/> Marble	<input type="checkbox"/> Granite	<input type="checkbox"/> Sandstone	<input type="checkbox"/> Slate			
<input type="checkbox"/> Brick	<input type="checkbox"/> Iron	<input type="checkbox"/> Other: _____

V. MATERIAL CONDITIONS						
<input checked="" type="checkbox"/> Biological - Algae	<input checked="" type="checkbox"/> Biological - Lichens	<input type="checkbox"/> Crack	<input type="checkbox"/> Delamination/Exfoliation			
<input type="checkbox"/> Disaggregation/Erosion	<input type="checkbox"/> Graffiti	<input type="checkbox"/> Off base (missing)	<input type="checkbox"/> Off base (adjacent)			
<input type="checkbox"/> Missing Fragment (s)	<input type="checkbox"/> Previous Repair	<input checked="" type="checkbox"/> Soiling	<input type="checkbox"/> Sunken			
<input type="checkbox"/> Tilt	<input type="checkbox"/> Corrosion					
<input checked="" type="checkbox"/> Other:	Adjacent groundhog activity.					
VI. TREATMENT RECOMMENDATIONS						
<input type="checkbox"/> Archaeology	<input type="checkbox"/> Excavate	<input type="checkbox"/> Reset on exist base	<input type="checkbox"/> Reset on salvaged base (if poss)

<input checked="" type="checkbox"/> Clean/bio removal	<input type="checkbox"/> Consolidate	<input type="checkbox"/> Composite repair	<input type="checkbox"/> Pin/adhesive repair			
<input checked="" type="checkbox"/> Other:	Monitor for tilt/instability from nearby groundhog activity.					
VI. PHOTOGRAPHS						
Photo 1:			Photo 2:

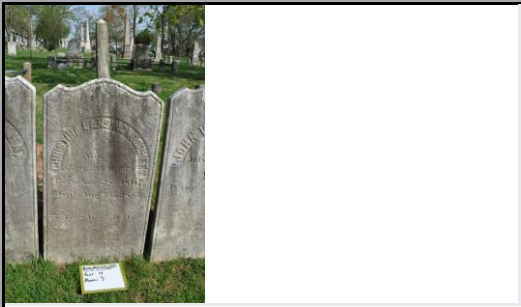
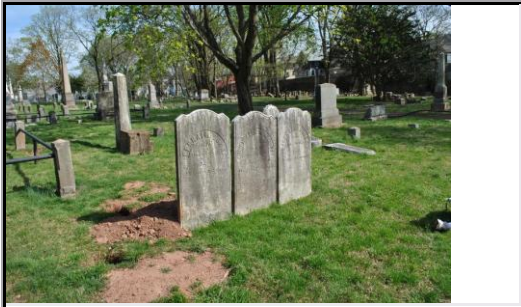
I. BURIAL INFORMATION					II. PRIORITIZATION	
First name	Last name	Birth	Death	Survey date	Condition	Prioritization
Christian	Van Norden		1885	4/7/2010	Good	Long term
III. LOCATION						
Cemetery Section	Plot/Marker Number	Original Location	Original Marker/Feature			
Willow Grove	014.03	Yes	Yes			
IV. MARKER INFORMATION						
Marker Type						
Headstone		Height: 48	Width: 24	Depth: 2		
<input checked="" type="checkbox"/> Marble	<input type="checkbox"/> Granite	<input type="checkbox"/> Sandstone	<input type="checkbox"/> Slate			
<input type="checkbox"/> Brick	<input type="checkbox"/> Iron	<input type="checkbox"/> Other: _____

V. MATERIAL CONDITIONS						
<input checked="" type="checkbox"/> Biological - Algae	<input checked="" type="checkbox"/> Biological - Lichens	<input type="checkbox"/> Crack	<input type="checkbox"/> Delamination/Exfoliation			
<input type="checkbox"/> Disaggregation/Erosion	<input type="checkbox"/> Graffiti	<input type="checkbox"/> Off base (missing)	<input type="checkbox"/> Off base (adjacent)			
<input type="checkbox"/> Missing Fragment (s)	<input type="checkbox"/> Previous Repair	<input checked="" type="checkbox"/> Soiling	<input type="checkbox"/> Sunken			
<input type="checkbox"/> Tilt	<input type="checkbox"/> Corrosion					
<input type="checkbox"/> Other:	_____					
VI. TREATMENT RECOMMENDATIONS						
<input type="checkbox"/> Archaeology	<input type="checkbox"/> Excavate	<input type="checkbox"/> Reset on exist base	<input type="checkbox"/> Reset on salvaged base (if poss)			
<input checked="" type="checkbox"/> Clean/bio removal	<input type="checkbox"/> Consolidate	<input type="checkbox"/> Composite repair	<input type="checkbox"/> Pin/adhesive repair

<input checked="" type="checkbox"/> Other:	Monitor for tilt which might be associated with nearby groundhog activity.					
VI. PHOTOGRAPHS						
Photo 1:			Photo 2:

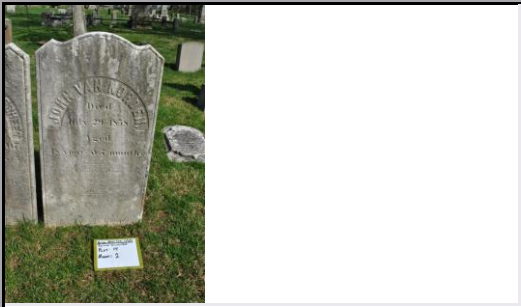
I. BURIAL INFORMATION					II. PRIORITIZATION	
First name	Last name	Birth	Death	Survey date	Condition	Prioritization
John	Van Norden		1858	4/7/2010	Good	Long term
III. LOCATION						
Cemetery Section	Plot/Marker Number	Original Location	Original Marker/Feature			
Willow Grove	014.02	Yes	Yes			
IV. MARKER INFORMATION						
Marker Type						
Headstone		Height: 48	Width: 24	Depth: 2		
<input checked="" type="checkbox"/> Marble	<input type="checkbox"/> Granite	<input type="checkbox"/> Sandstone	<input type="checkbox"/> Slate			
<input type="checkbox"/> Brick	<input type="checkbox"/> Iron	<input type="checkbox"/> Other: _____

V. MATERIAL CONDITIONS						
<input checked="" type="checkbox"/> Biological - Algae	<input checked="" type="checkbox"/> Biological - Lichens	<input type="checkbox"/> Crack	<input type="checkbox"/> Delamination/Exfoliation			
<input type="checkbox"/> Disaggregation/Erosion	<input type="checkbox"/> Graffiti	<input type="checkbox"/> Off base (missing)	<input type="checkbox"/> Off base (adjacent)			
<input type="checkbox"/> Missing Fragment (s)	<input type="checkbox"/> Previous Repair	<input checked="" type="checkbox"/> Soiling	<input type="checkbox"/> Sunken			
<input type="checkbox"/> Tilt	<input type="checkbox"/> Corrosion					
<input type="checkbox"/> Other:	_____					
VI. TREATMENT RECOMMENDATIONS						
<input type="checkbox"/> Archaeology	<input type="checkbox"/> Excavate	<input type="checkbox"/> Reset on exist base	<input type="checkbox"/> Reset on salvaged base (if poss)			
<input checked="" type="checkbox"/> Clean/bio removal	<input type="checkbox"/> Consolidate	<input type="checkbox"/> Composite repair	<input type="checkbox"/> Pin/adhesive repair

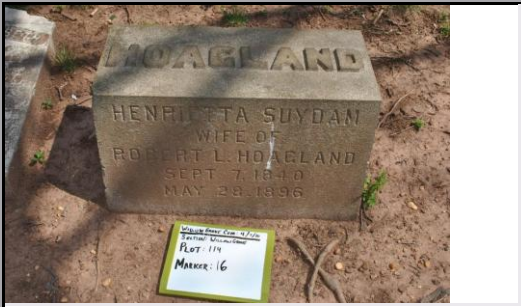
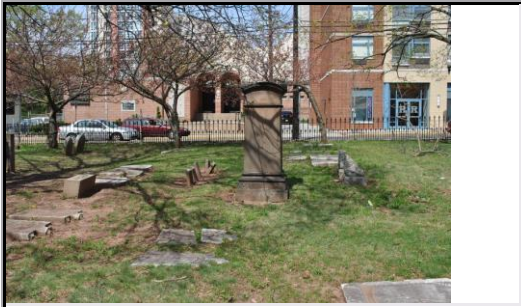
I. BURIAL INFORMATION					II. PRIORITIZATION	
First name	Last name	Birth	Death	Survey date	Condition	Prioritization
Henrietta	Hoagland	1840	1896	4/7/2010	Good	Long term
III. LOCATION						
Cemetery Section	Plot/Marker Number	Original Location	Original Marker/Feature			
Willow Grove	114.16	Unknown	No			
IV. MARKER INFORMATION						
Marker Type						
Headstone		Height: 16	Width: 28	Depth: 14		
<input type="checkbox"/> Marble	<input checked="" type="checkbox"/> Granite	<input type="checkbox"/> Sandstone	<input type="checkbox"/> Slate			
<input type="checkbox"/> Brick	<input type="checkbox"/> Iron	<input type="checkbox"/> Other: _____

V. MATERIAL CONDITIONS						
<input checked="" type="checkbox"/> Biological - Algae	<input type="checkbox"/> Biological - Lichens	<input type="checkbox"/> Crack	<input type="checkbox"/> Delamination/Exfoliation			
<input type="checkbox"/> Disaggregation/Erosion	<input type="checkbox"/> Graffiti	<input type="checkbox"/> Off base (missing)	<input type="checkbox"/> Off base (adjacent)			
<input type="checkbox"/> Missing Fragment (s)	<input type="checkbox"/> Previous Repair	<input type="checkbox"/> Soiling	<input type="checkbox"/> Sunken			
<input type="checkbox"/> Tilt	<input type="checkbox"/> Corrosion					
<input type="checkbox"/> Other:	_____					
VI. TREATMENT RECOMMENDATIONS						
<input type="checkbox"/> Archaeology	<input type="checkbox"/> Excavate	<input type="checkbox"/> Reset on exist base	<input type="checkbox"/> Reset on salvaged base (if poss)			
<input checked="" type="checkbox"/> Clean/bio removal	<input type="checkbox"/> Consolidate	<input type="checkbox"/> Composite repair	<input type="checkbox"/> Pin/adhesive repair

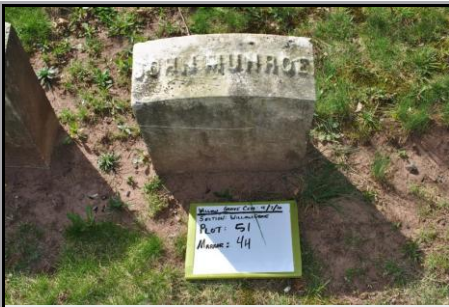
I. BURIAL INFORMATION					II. PRIORITIZATION	
First name	Last name	Birth	Death	Survey date	Condition	Prioritization
John	Munroe			4/7/2010	Good	Long term
III. LOCATION						
Cemetery Section	Plot/Marker Number	Original Location	Original Marker/Feature			
Willow Grove	080.04	Unknown	No			
IV. MARKER INFORMATION						
Marker Type						
Headstone		Height: 19	Width: 16	Depth: 6		
<input checked="" type="checkbox"/> Marble	<input type="checkbox"/> Granite	<input type="checkbox"/> Sandstone	<input type="checkbox"/> Slate			
<input type="checkbox"/> Brick	<input type="checkbox"/> Iron	<input type="checkbox"/> Other: _____

V. MATERIAL CONDITIONS						
<input checked="" type="checkbox"/> Biological - Algae	<input type="checkbox"/> Biological - Lichens	<input type="checkbox"/> Crack	<input type="checkbox"/> Delamination/Exfoliation			
<input checked="" type="checkbox"/> Disaggregation/Erosion	<input type="checkbox"/> Graffiti	<input type="checkbox"/> Off base (missing)	<input type="checkbox"/> Off base (adjacent)			
<input type="checkbox"/> Missing Fragment (s)	<input type="checkbox"/> Previous Repair	<input type="checkbox"/> Soiling	<input type="checkbox"/> Sunken			
<input type="checkbox"/> Tilt	<input type="checkbox"/> Corrosion					
<input checked="" type="checkbox"/> Other:	Damage from lawnmowers: scrapes on surface of marker.					
VI. TREATMENT RECOMMENDATIONS						
<input type="checkbox"/> Archaeology	<input type="checkbox"/> Excavate	<input type="checkbox"/> Reset on exist base	<input type="checkbox"/> Reset on salvaged base (if poss)

<input checked="" type="checkbox"/> Clean/bio removal	<input type="checkbox"/> Consolidate	<input type="checkbox"/> Composite repair	<input type="checkbox"/> Pin/adhesive repair			
<input type="checkbox"/> Other:	_____					
VI. PHOTOGRAPHS						
Photo 1:			Photo 2:

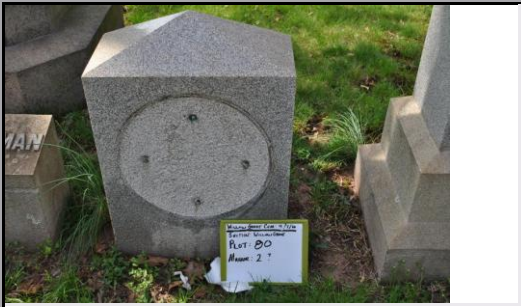
I. BURIAL INFORMATION					II. PRIORITIZATION	
First name	Last name	Birth	Death	Survey date	Condition	Prioritization
				4/7/2010	Good	Long term
III. LOCATION						
Cemetery Section	Plot/Marker Number	Original Location	Original Marker/Feature			
Willow Grove	080.02	Yes	Unknown			
IV. MARKER INFORMATION						
Marker Type						
Headstone w/ base		Height: 56	Width: 22	Depth: 10		
<input type="checkbox"/> Marble	<input checked="" type="checkbox"/> Granite	<input type="checkbox"/> Sandstone	<input type="checkbox"/> Slate			
<input type="checkbox"/> Brick	<input type="checkbox"/> Iron	<input type="checkbox"/> Other: _____

V. MATERIAL CONDITIONS						
<input type="checkbox"/> Biological - Algae	<input type="checkbox"/> Biological - Lichens	<input type="checkbox"/> Crack	<input type="checkbox"/> Delamination/Exfoliation			
<input type="checkbox"/> Disaggregation/Erosion	<input type="checkbox"/> Graffiti	<input checked="" type="checkbox"/> Off base (missing)	<input type="checkbox"/> Off base (adjacent)			
<input checked="" type="checkbox"/> Missing Fragment (s)	<input type="checkbox"/> Previous Repair	<input type="checkbox"/> Soiling	<input type="checkbox"/> Sunken			
<input type="checkbox"/> Tilt	<input type="checkbox"/> Corrosion					
<input checked="" type="checkbox"/> Other:	Metallic staining. Missing plaque which identifies burial.					
VI. TREATMENT RECOMMENDATIONS						
<input type="checkbox"/> Archaeology	<input type="checkbox"/> Excavate	<input type="checkbox"/> Reset on exist base	<input type="checkbox"/> Reset on salvaged base (if poss)

<input type="checkbox"/> Clean/bio removal	<input type="checkbox"/> Consolidate	<input type="checkbox"/> Composite repair	<input type="checkbox"/> Pin/adhesive repair			
<input checked="" type="checkbox"/> Other:	Historic photos or research to identify burial or provide insight into missing plaque?					
VI. PHOTOGRAPHS						
Photo 1:			Photo 2:

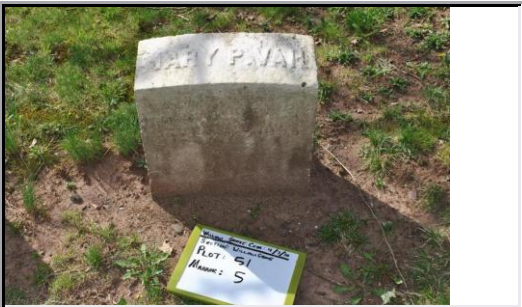
I. BURIAL INFORMATION					II. PRIORITIZATION	
First name	Last name	Birth	Death	Survey date	Condition	Prioritization
Mary P.	Vail	1814	1895	4/7/2010	Good	Long term
III. LOCATION						
Cemetery Section	Plot/Marker Number	Original Location	Original Marker/Feature			
Willow Grove	080.05	Unknown	No			
IV. MARKER INFORMATION						
Marker Type						
Headstone		Height: 19	Width: 16	Depth: 6		
<input checked="" type="checkbox"/> Marble	<input type="checkbox"/> Granite	<input type="checkbox"/> Sandstone	<input type="checkbox"/> Slate			
<input type="checkbox"/> Brick	<input type="checkbox"/> Iron	<input type="checkbox"/> Other: _____

V. MATERIAL CONDITIONS						
<input checked="" type="checkbox"/> Biological - Algae	<input type="checkbox"/> Biological - Lichens	<input type="checkbox"/> Crack	<input type="checkbox"/> Delamination/Exfoliation			
<input checked="" type="checkbox"/> Disaggregation/Erosion	<input type="checkbox"/> Graffiti	<input type="checkbox"/> Off base (missing)	<input type="checkbox"/> Off base (adjacent)			
<input type="checkbox"/> Missing Fragment (s)	<input type="checkbox"/> Previous Repair	<input type="checkbox"/> Soiling	<input type="checkbox"/> Sunken			
<input type="checkbox"/> Tilt	<input type="checkbox"/> Corrosion					
<input type="checkbox"/> Other:	_____					
VI. TREATMENT RECOMMENDATIONS						
<input type="checkbox"/> Archaeology	<input type="checkbox"/> Excavate	<input type="checkbox"/> Reset on exist base	<input type="checkbox"/> Reset on salvaged base (if poss)			
<input checked="" type="checkbox"/> Clean/bio removal	<input type="checkbox"/> Consolidate	<input type="checkbox"/> Composite repair	<input type="checkbox"/> Pin/adhesive repair

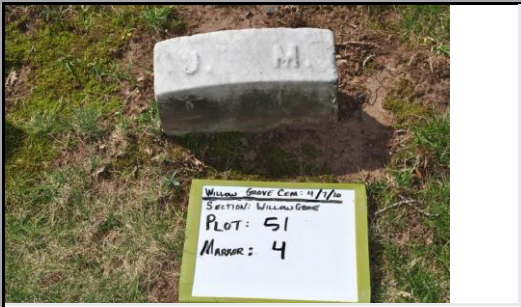
I. BURIAL INFORMATION					II. PRIORITIZATION	
First name	Last name	Birth	Death	Survey date	Condition	Prioritization
J.	M.			4/7/2010	Good	Long term
III. LOCATION						
Cemetery Section	Plot/Marker Number	Original Location	Original Marker/Feature			
Willow Grove	080.04	Unknown	No			
IV. MARKER INFORMATION						
Marker Type						
Footstone		Height: 7	Width: 12	Depth: 4		
<input checked="" type="checkbox"/> Marble	<input type="checkbox"/> Granite	<input type="checkbox"/> Sandstone	<input type="checkbox"/> Slate			
<input type="checkbox"/> Brick	<input type="checkbox"/> Iron	<input type="checkbox"/> Other: _____

V. MATERIAL CONDITIONS						
<input checked="" type="checkbox"/> Biological - Algae	<input type="checkbox"/> Biological - Lichens	<input type="checkbox"/> Crack	<input type="checkbox"/> Delamination/Exfoliation			
<input checked="" type="checkbox"/> Disaggregation/Erosion	<input type="checkbox"/> Graffiti	<input type="checkbox"/> Off base (missing)	<input type="checkbox"/> Off base (adjacent)			
<input type="checkbox"/> Missing Fragment (s)	<input type="checkbox"/> Previous Repair	<input type="checkbox"/> Soiling	<input type="checkbox"/> Sunken			
<input type="checkbox"/> Tilt	<input type="checkbox"/> Corrosion					
<input type="checkbox"/> Other:	_____					
VI. TREATMENT RECOMMENDATIONS						
<input type="checkbox"/> Archaeology	<input type="checkbox"/> Excavate	<input type="checkbox"/> Reset on exist base	<input type="checkbox"/> Reset on salvaged base (if poss)			
<input checked="" type="checkbox"/> Clean/bio removal	<input type="checkbox"/> Consolidate	<input type="checkbox"/> Composite repair	<input type="checkbox"/> Pin/adhesive repair

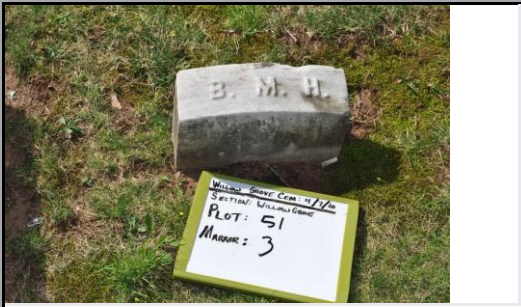
I. BURIAL INFORMATION					II. PRIORITIZATION	
First name	Last name	Birth	Death	Survey date	Condition	Prioritization
B.M.	H.		1868	4/7/2010	Good	Long term
III. LOCATION						
Cemetery Section	Plot/Marker Number	Original Location	Original Marker/Feature			
Willow Grove	080.03	Unknown	No			
IV. MARKER INFORMATION						
Marker Type						
Footstone		Height: 7	Width: 12	Depth: 4		
<input checked="" type="checkbox"/> Marble	<input type="checkbox"/> Granite	<input type="checkbox"/> Sandstone	<input type="checkbox"/> Slate			
<input type="checkbox"/> Brick	<input type="checkbox"/> Iron	<input type="checkbox"/> Other: _____

V. MATERIAL CONDITIONS						
<input checked="" type="checkbox"/> Biological - Algae	<input type="checkbox"/> Biological - Lichens	<input type="checkbox"/> Crack	<input type="checkbox"/> Delamination/Exfoliation			
<input checked="" type="checkbox"/> Disaggregation/Erosion	<input type="checkbox"/> Graffiti	<input type="checkbox"/> Off base (missing)	<input type="checkbox"/> Off base (adjacent)			
<input type="checkbox"/> Missing Fragment (s)	<input type="checkbox"/> Previous Repair	<input type="checkbox"/> Soiling	<input type="checkbox"/> Sunken			
<input type="checkbox"/> Tilt	<input type="checkbox"/> Corrosion					
<input type="checkbox"/> Other:	_____					
VI. TREATMENT RECOMMENDATIONS						
<input type="checkbox"/> Archaeology	<input type="checkbox"/> Excavate	<input type="checkbox"/> Reset on exist base	<input type="checkbox"/> Reset on salvaged base (if poss)			
<input checked="" type="checkbox"/> Clean/bio removal	<input type="checkbox"/> Consolidate	<input type="checkbox"/> Composite repair	<input type="checkbox"/> Pin/adhesive repair

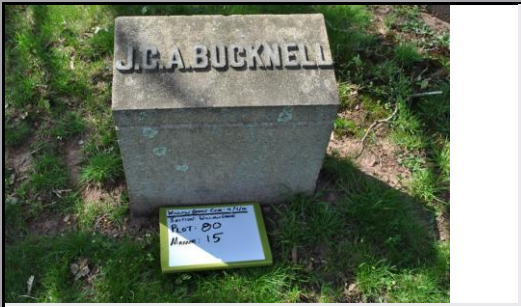
I. BURIAL INFORMATION					II. PRIORITIZATION	
First name	Last name	Birth	Death	Survey date	Condition	Prioritization
J.C.A.	Bucknell			4/7/2010	Good	Long term
III. LOCATION						
Cemetery Section	Plot/Marker Number	Original Location	Original Marker/Feature			
Willow Grove	080.15	Unknown	Unknown			
IV. MARKER INFORMATION						
Marker Type						
Headstone		Height: 16	Width: 20	Depth: 10		
<input type="checkbox"/> Marble	<input checked="" type="checkbox"/> Granite	<input type="checkbox"/> Sandstone	<input type="checkbox"/> Slate			
<input type="checkbox"/> Brick	<input type="checkbox"/> Iron	<input type="checkbox"/> Other: _____

V. MATERIAL CONDITIONS						
<input checked="" type="checkbox"/> Biological - Algae	<input checked="" type="checkbox"/> Biological - Lichens	<input type="checkbox"/> Crack	<input type="checkbox"/> Delamination/Exfoliation			
<input type="checkbox"/> Disaggregation/Erosion	<input type="checkbox"/> Graffiti	<input type="checkbox"/> Off base (missing)	<input type="checkbox"/> Off base (adjacent)			
<input type="checkbox"/> Missing Fragment (s)	<input type="checkbox"/> Previous Repair	<input type="checkbox"/> Soiling	<input type="checkbox"/> Sunken			
<input type="checkbox"/> Tilt	<input type="checkbox"/> Corrosion					
<input type="checkbox"/> Other:	_____					
VI. TREATMENT RECOMMENDATIONS						
<input type="checkbox"/> Archaeology	<input type="checkbox"/> Excavate	<input type="checkbox"/> Reset on exist base	<input type="checkbox"/> Reset on salvaged base (if poss)			
<input checked="" type="checkbox"/> Clean/bio removal	<input type="checkbox"/> Consolidate	<input type="checkbox"/> Composite repair	<input type="checkbox"/> Pin/adhesive repair

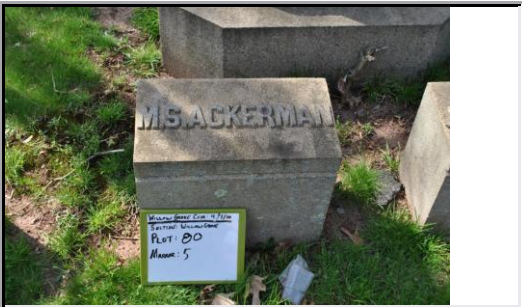
I. BURIAL INFORMATION					II. PRIORITIZATION	
First name	Last name	Birth	Death	Survey date	Condition	Prioritization
M.S.	Ackerman			4/7/2010	Good	Long term
III. LOCATION						
Cemetery Section	Plot/Marker Number	Original Location	Original Marker/Feature			
Willow Grove	080.05	Unknown	Unknown			
IV. MARKER INFORMATION						
Marker Type						
Headstone		Height: 16	Width: 20	Depth: 20		
<input type="checkbox"/> Marble	<input checked="" type="checkbox"/> Granite	<input type="checkbox"/> Sandstone	<input type="checkbox"/> Slate			
<input type="checkbox"/> Brick	<input type="checkbox"/> Iron	<input type="checkbox"/> Other: _____

V. MATERIAL CONDITIONS						
<input checked="" type="checkbox"/> Biological - Algae	<input checked="" type="checkbox"/> Biological - Lichens	<input type="checkbox"/> Crack	<input type="checkbox"/> Delamination/Exfoliation			
<input type="checkbox"/> Disaggregation/Erosion	<input type="checkbox"/> Graffiti	<input type="checkbox"/> Off base (missing)	<input type="checkbox"/> Off base (adjacent)			
<input type="checkbox"/> Missing Fragment (s)	<input type="checkbox"/> Previous Repair	<input type="checkbox"/> Soiling	<input type="checkbox"/> Sunken			
<input type="checkbox"/> Tilt	<input type="checkbox"/> Corrosion					
<input type="checkbox"/> Other:	_____					
VI. TREATMENT RECOMMENDATIONS						
<input type="checkbox"/> Archaeology	<input type="checkbox"/> Excavate	<input type="checkbox"/> Reset on exist base	<input type="checkbox"/> Reset on salvaged base (if poss)			
<input checked="" type="checkbox"/> Clean/bio removal	<input type="checkbox"/> Consolidate	<input type="checkbox"/> Composite repair	<input type="checkbox"/> Pin/adhesive repair

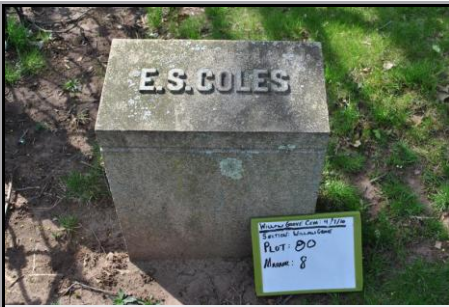
I. BURIAL INFORMATION					II. PRIORITIZATION	
First name	Last name	Birth	Death	Survey date	Condition	Prioritization
E.S	Coles			4/7/2010	Good	Long term
III. LOCATION						
Cemetery Section	Plot/Marker Number	Original Location	Original Marker/Feature			
Willow Grove	080.08	Unknown	Unknown			
IV. MARKER INFORMATION						
Marker Type						
Headstone		Height: 16	Width: 20	Depth: 10		
<input type="checkbox"/> Marble	<input checked="" type="checkbox"/> Granite	<input type="checkbox"/> Sandstone	<input type="checkbox"/> Slate			
<input type="checkbox"/> Brick	<input type="checkbox"/> Iron	<input type="checkbox"/> Other: _____

V. MATERIAL CONDITIONS						
<input checked="" type="checkbox"/> Biological - Algae	<input checked="" type="checkbox"/> Biological - Lichens	<input type="checkbox"/> Crack	<input type="checkbox"/> Delamination/Exfoliation			
<input type="checkbox"/> Disaggregation/Erosion	<input type="checkbox"/> Graffiti	<input type="checkbox"/> Off base (missing)	<input type="checkbox"/> Off base (adjacent)			
<input type="checkbox"/> Missing Fragment (s)	<input type="checkbox"/> Previous Repair	<input type="checkbox"/> Soiling	<input type="checkbox"/> Sunken			
<input type="checkbox"/> Tilt	<input type="checkbox"/> Corrosion					
<input type="checkbox"/> Other:	_____					
VI. TREATMENT RECOMMENDATIONS						
<input type="checkbox"/> Archaeology	<input type="checkbox"/> Excavate	<input type="checkbox"/> Reset on exist base	<input type="checkbox"/> Reset on salvaged base (if poss)			
<input checked="" type="checkbox"/> Clean/bio removal	<input type="checkbox"/> Consolidate	<input type="checkbox"/> Composite repair	<input type="checkbox"/> Pin/adhesive repair

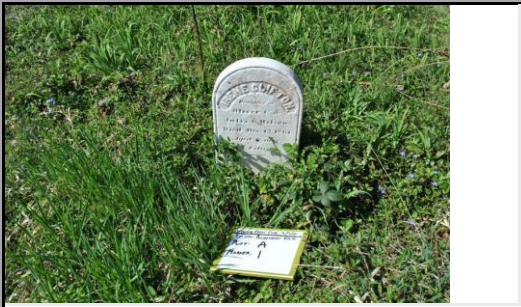
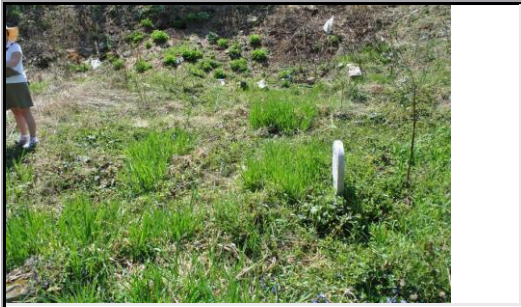
I. BURIAL INFORMATION					II. PRIORITIZATION	
First name	Last name	Birth	Death	Survey date	Condition	Prioritization
Irene	Clifton		1861	4/7/2010	Good	Long term
III. LOCATION						
Cemetery Section	Plot/Marker Number	Original Location	Original Marker/Feature			
Presbyterian	A.1	No	Yes			
IV. MARKER INFORMATION						
Marker Type						
Headstone		Height: 25	Width: 13	Depth: 6		
<input checked="" type="checkbox"/> Marble	<input type="checkbox"/> Granite	<input type="checkbox"/> Sandstone	<input type="checkbox"/> Slate			
<input type="checkbox"/> Brick	<input type="checkbox"/> Iron	<input type="checkbox"/> Other: _____

V. MATERIAL CONDITIONS						
<input type="checkbox"/> Biological - Algae	<input type="checkbox"/> Biological - Lichens	<input type="checkbox"/> Crack	<input type="checkbox"/> Delamination/Exfoliation			
<input checked="" type="checkbox"/> Disaggregation/Erosion	<input type="checkbox"/> Graffiti	<input type="checkbox"/> Off base (missing)	<input type="checkbox"/> Off base (adjacent)			
<input type="checkbox"/> Missing Fragment (s)	<input type="checkbox"/> Previous Repair	<input type="checkbox"/> Soiling	<input type="checkbox"/> Sunken			
<input type="checkbox"/> Tilt	<input type="checkbox"/> Corrosion					
<input type="checkbox"/> Other:	_____					
VI. TREATMENT RECOMMENDATIONS						
<input type="checkbox"/> Archaeology	<input type="checkbox"/> Excavate	<input type="checkbox"/> Reset on exist base	<input type="checkbox"/> Reset on salvaged base (if poss)			
<input checked="" type="checkbox"/> Clean/bio removal	<input type="checkbox"/> Consolidate	<input type="checkbox"/> Composite repair	<input type="checkbox"/> Pin/adhesive repair

VII. ADDITIONAL INFORMATION						
Marker is located in an area with poor drainage and will be susceptible to water related deterioration.

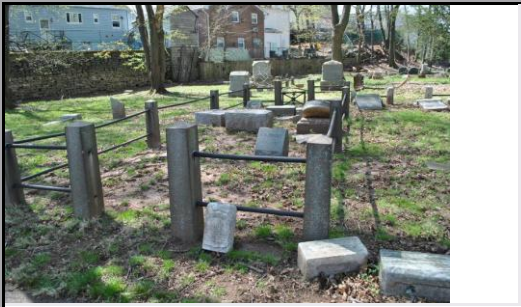
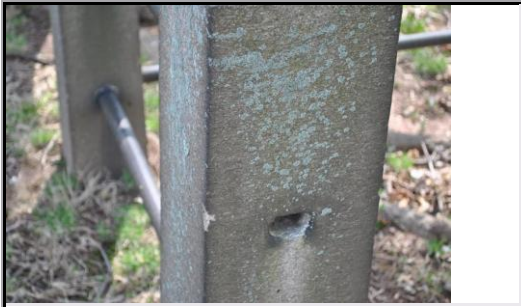
I. BURIAL INFORMATION					II. PRIORITIZATION	
First name	Last name	Birth	Death	Survey date	Condition	Prioritization
				4/7/2010	Poor	Long term
III. LOCATION						
Cemetery Section	Plot/Marker Number	Original Location	Original Marker/Feature			
Willow Grove	064.00	Yes	Yes			
IV. MARKER INFORMATION						
Marker Type	Site Feature	Height:	Width:	Depth:		
<input type="checkbox"/> Marble	<input checked="" type="checkbox"/> Granite	<input type="checkbox"/> Sandstone	<input type="checkbox"/> Slate			
<input type="checkbox"/> Brick	<input checked="" type="checkbox"/> Iron	<input type="checkbox"/> Other: _____

V. MATERIAL CONDITIONS						
<input checked="" type="checkbox"/> Biological - Algae	<input checked="" type="checkbox"/> Biological - Lichens	<input type="checkbox"/> Crack	<input type="checkbox"/> Delamination/Exfoliation			
<input type="checkbox"/> Disaggregation/Erosion	<input type="checkbox"/> Graffiti	<input type="checkbox"/> Off base (missing)	<input type="checkbox"/> Off base (adjacent)			
<input checked="" type="checkbox"/> Missing Fragment (s)	<input type="checkbox"/> Previous Repair	<input type="checkbox"/> Soiling	<input type="checkbox"/> Sunken			
<input type="checkbox"/> Tilt	<input checked="" type="checkbox"/> Corrosion					
<input checked="" type="checkbox"/> Other:	Moderate vandalism. Bent and missing rails, missing gate. Surviving iron rails are corroded.					
VI. TREATMENT RECOMMENDATIONS						
<input type="checkbox"/> Archaeology	<input type="checkbox"/> Excavate	<input type="checkbox"/> Reset on exist base	<input type="checkbox"/> Reset on salvaged base (if poss)

<input checked="" type="checkbox"/> Clean/bio removal	<input type="checkbox"/> Consolidate	<input type="checkbox"/> Composite repair	<input type="checkbox"/> Pin/adhesive repair			
<input checked="" type="checkbox"/> Other:	Repair or replace bent rails. Replace missing rails and missing gate. Remove corrosion from surviving rails and repaint.					
VI. PHOTOGRAPHS						
Photo 1:			Photo 2:

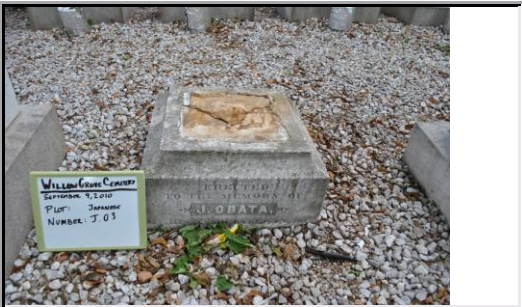
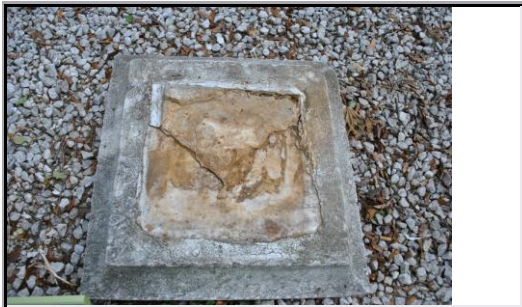
V. MATERIAL CONDITIONS						
<input checked="" type="checkbox"/> Biological - Algae	<input type="checkbox"/> Biological - Lichens	<input type="checkbox"/> Crack	<input type="checkbox"/> Delamination/Exfoliation			
<input type="checkbox"/> Disaggregation/Erosion	<input type="checkbox"/> Graffiti	<input type="checkbox"/> Off base (missing)	<input type="checkbox"/> Off base (adjacent)			
<input checked="" type="checkbox"/> Missing Fragment (s)	<input type="checkbox"/> Previous Repair	<input checked="" type="checkbox"/> Soiling	<input type="checkbox"/> Sunken			
<input type="checkbox"/> Tilt	<input type="checkbox"/> Corrosion					
<input type="checkbox"/> Other:	_____					
VI. TREATMENT RECOMMENDATIONS						
<input type="checkbox"/> Archaeology	<input type="checkbox"/> Excavate	<input type="checkbox"/> Reset on exist base	<input type="checkbox"/> Reset on salvaged base (if poss)			
<input checked="" type="checkbox"/> Clean/bio removal	<input type="checkbox"/> Consolidate	<input type="checkbox"/> Composite repair	<input type="checkbox"/> Pin/adhesive repair

VII. ADDITIONAL INFORMATION						
Obelisk base different size, shape and placement of inscription than others and is also in memory of a person represented by another marker directly behind this one

<input type="checkbox"/> Other:	_____					
VI. PHOTOGRAPHS						
Photo 1:			Photo 2:
