HISTORIC PRESERVATION PLAN

WILLOW GROVE CEMETERY

New Brunswick, Middlesex County, New Jersey

DATE: 4 October 2010

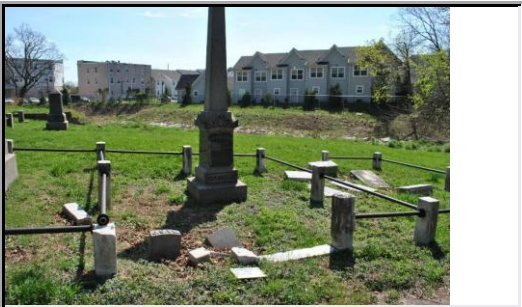
V. MATERIAL CONDITIONS						
<input checked="" type="checkbox"/> Biological - Algae	<input type="checkbox"/> Biological - Lichens	<input checked="" type="checkbox"/> Crack	<input type="checkbox"/> Delamination/Exfoliation			
<input checked="" type="checkbox"/> Disaggregation/Erosion	<input type="checkbox"/> Graffiti	<input type="checkbox"/> Off base (missing)	<input type="checkbox"/> Off base (adjacent)			
<input checked="" type="checkbox"/> Missing Fragment (s)	<input type="checkbox"/> Previous Repair	<input type="checkbox"/> Soiling	<input type="checkbox"/> Sunken			
<input type="checkbox"/> Tilt	<input checked="" type="checkbox"/> Corrosion					
<input checked="" type="checkbox"/> Other:	Posts broken into fragments, missing post, missing rails, missing gate.					
VI. TREATMENT RECOMMENDATIONS						
<input type="checkbox"/> Archaeology	<input type="checkbox"/> Excavate	<input type="checkbox"/> Reset on exist base	<input type="checkbox"/> Reset on salvaged base (if poss)

VII. ADDITIONAL INFORMATION						
Inscription on surviving post reads "1888."

<input type="checkbox"/> Clean/bio removal	<input type="checkbox"/> Consolidate	<input type="checkbox"/> Composite repair	<input type="checkbox"/> Pin/adhesive repair			
<input checked="" type="checkbox"/> Other:	Repair and repaint surviving rails. Replace missing posts, rails and gate.					
VI. PHOTOGRAPHS						
Photo 1:			Photo 2:

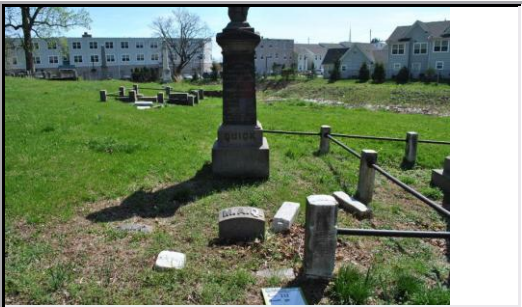
V. MATERIAL CONDITIONS						
<input type="checkbox"/> Biological - Algae	<input type="checkbox"/> Biological - Lichens	<input type="checkbox"/> Crack	<input type="checkbox"/> Delamination/Exfoliation			
<input type="checkbox"/> Disaggregation/Erosion	<input type="checkbox"/> Graffiti	<input type="checkbox"/> Off base (missing)	<input type="checkbox"/> Off base (adjacent)			
<input checked="" type="checkbox"/> Missing Fragment (s)	<input type="checkbox"/> Previous Repair	<input type="checkbox"/> Soiling	<input type="checkbox"/> Sunken			
<input type="checkbox"/> Tilt	<input checked="" type="checkbox"/> Corrosion					
<input type="checkbox"/> Other:	Several missing rails and missing gate. Remaining rails which survive have deteriorated paint finishes and localized corrosion.					
VI. TREATMENT RECOMMENDATIONS						
<input type="checkbox"/> Archaeology	<input type="checkbox"/> Excavate	<input type="checkbox"/> Reset on exist base	<input type="checkbox"/> Reset on salvaged base (if poss)

<input type="checkbox"/> Clean/bio removal	<input type="checkbox"/> Consolidate	<input type="checkbox"/> Composite repair	<input type="checkbox"/> Pin/adhesive repair			
<input checked="" type="checkbox"/> Other:	Repair and repaint surviving rails. Replace missing posts, rails and gate.					
VI. PHOTOGRAPHS						
Photo 1:			Photo 2:

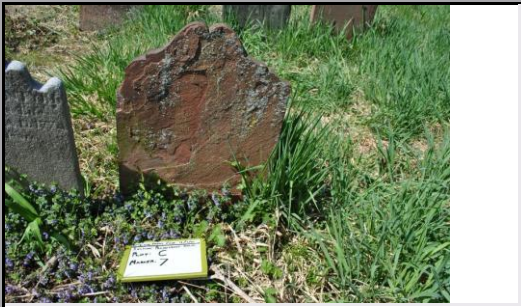
V. MATERIAL CONDITIONS						
<input checked="" type="checkbox"/> Biological - Algae	<input checked="" type="checkbox"/> Biological - Lichens	<input type="checkbox"/> Crack	<input checked="" type="checkbox"/> Delamination/Exfoliation			
<input type="checkbox"/> Disaggregation/Erosion	<input type="checkbox"/> Graffiti	<input type="checkbox"/> Off base (missing)	<input type="checkbox"/> Off base (adjacent)			
<input checked="" type="checkbox"/> Missing Fragment (s)	<input type="checkbox"/> Previous Repair	<input type="checkbox"/> Soiling	<input type="checkbox"/> Sunken			
<input checked="" type="checkbox"/> Tilt	<input type="checkbox"/> Corrosion					
<input checked="" type="checkbox"/> Other:	Marker has lost nearly all material integrity.					
VI. TREATMENT RECOMMENDATIONS						
<input type="checkbox"/> Archaeology	<input type="checkbox"/> Excavate	<input type="checkbox"/> Reset on exist base	<input type="checkbox"/> Reset on salvaged base (if poss)

<input checked="" type="checkbox"/> Clean/bio removal	<input type="checkbox"/> Consolidate	<input checked="" type="checkbox"/> Composite repair	<input type="checkbox"/> Pin/adhesive repair			
<input checked="" type="checkbox"/> Other:	Monitor delamination. Injection grout and composite repair to minimize additional delamination.					
VI. PHOTOGRAPHS						
Photo 1:			Photo 2:

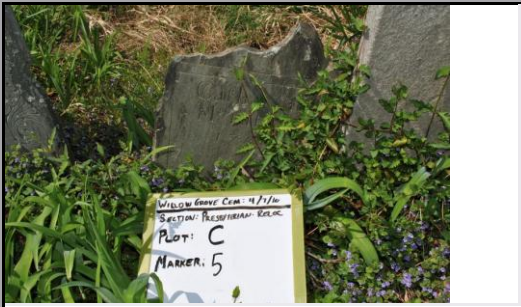
V. MATERIAL CONDITIONS						
<input checked="" type="checkbox"/> Biological - Algae	<input type="checkbox"/> Biological - Lichens	<input type="checkbox"/> Crack	<input type="checkbox"/> Delamination/Exfoliation			
<input type="checkbox"/> Disaggregation/Erosion	<input type="checkbox"/> Graffiti	<input type="checkbox"/> Off base (missing)	<input type="checkbox"/> Off base (adjacent)			
<input type="checkbox"/> Missing Fragment (s)	<input type="checkbox"/> Previous Repair	<input type="checkbox"/> Soiling	<input checked="" type="checkbox"/> Sunken			
<input checked="" type="checkbox"/> Tilt	<input type="checkbox"/> Corrosion					
<input type="checkbox"/> Other:	_____					
VI. TREATMENT RECOMMENDATIONS						
<input type="checkbox"/> Archaeology	<input checked="" type="checkbox"/> Excavate	<input type="checkbox"/> Reset on exist base	<input type="checkbox"/> Reset on salvaged base (if poss)			
<input checked="" type="checkbox"/> Clean/bio removal	<input type="checkbox"/> Consolidate	<input type="checkbox"/> Composite repair	<input type="checkbox"/> Pin/adhesive repair

VII. ADDITIONAL INFORMATION						
<p>The use of slate is exceptionally rare within this cemetery. Slate markers were noted only within the Presbyterian portion of the site. Marker is located in an area with poor drainage and will be susceptible to water related deterioration.</p>

<input type="checkbox"/> Other:	_____					
VI. PHOTOGRAPHS						
Photo 1:			Photo 2:

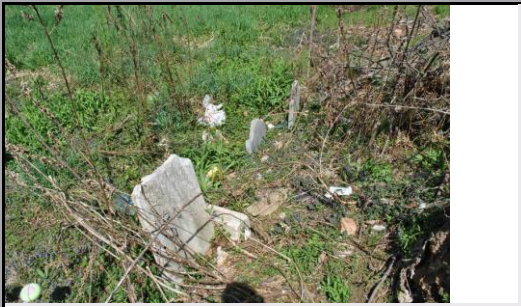
V. MATERIAL CONDITIONS						
<input checked="" type="checkbox"/> Biological - Algae	<input type="checkbox"/> Biological - Lichens	<input type="checkbox"/> Crack	<input checked="" type="checkbox"/> Delamination/Exfoliation			
<input checked="" type="checkbox"/> Disaggregation/Erosion	<input type="checkbox"/> Graffiti	<input type="checkbox"/> Off base (missing)	<input type="checkbox"/> Off base (adjacent)			
<input type="checkbox"/> Missing Fragment (s)	<input type="checkbox"/> Previous Repair	<input type="checkbox"/> Soiling	<input type="checkbox"/> Sunken			
<input type="checkbox"/> Tilt	<input type="checkbox"/> Corrosion					
<input type="checkbox"/> Other:	_____					
VI. TREATMENT RECOMMENDATIONS						
<input type="checkbox"/> Archaeology	<input type="checkbox"/> Excavate	<input type="checkbox"/> Reset on exist base	<input type="checkbox"/> Reset on salvaged base (if poss)			
<input checked="" type="checkbox"/> Clean/bio removal	<input type="checkbox"/> Consolidate	<input type="checkbox"/> Composite repair	<input type="checkbox"/> Pin/adhesive repair

VII. ADDITIONAL INFORMATION						
Three markers present. Illegible due to erosion and loss of inscription. Inaccessible due to site topography.

<input type="checkbox"/> Other:	_____					
VI. PHOTOGRAPHS						
Photo 1:			Photo 2:

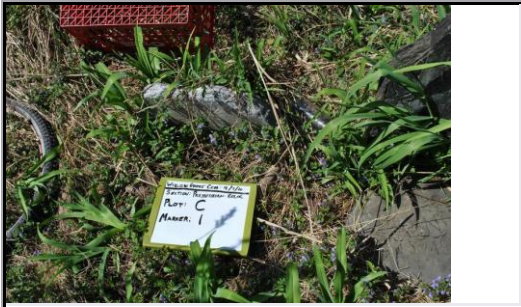
V. MATERIAL CONDITIONS						
<input checked="" type="checkbox"/> Biological - Algae	<input type="checkbox"/> Biological - Lichens	<input type="checkbox"/> Crack	<input type="checkbox"/> Delamination/Exfoliation			
<input type="checkbox"/> Disaggregation/Erosion	<input type="checkbox"/> Graffiti	<input type="checkbox"/> Off base (missing)	<input type="checkbox"/> Off base (adjacent)			
<input checked="" type="checkbox"/> Missing Fragment (s)	<input type="checkbox"/> Previous Repair	<input type="checkbox"/> Soiling	<input type="checkbox"/> Sunken			
<input type="checkbox"/> Tilt	<input type="checkbox"/> Corrosion					
<input checked="" type="checkbox"/> Other:	Fragment only. Marker has suffered a complete loss of integrity.					
VI. TREATMENT RECOMMENDATIONS						
<input type="checkbox"/> Archaeology	<input type="checkbox"/> Excavate	<input type="checkbox"/> Reset on exist base	<input type="checkbox"/> Reset on salvaged base (if poss)

VII. ADDITIONAL INFORMATION						
The use of slate is exceptionally rare within this cemetery. Slate markers were noted only within the Presbyterian portion of the site. Marker is located in an area with poor drainage and will be susceptible to water related deterioration.

<input checked="" type="checkbox"/> Clean/bio removal	<input type="checkbox"/> Consolidate	<input type="checkbox"/> Composite repair	<input type="checkbox"/> Pin/adhesive repair			
<input type="checkbox"/> Other:	_____					
VI. PHOTOGRAPHS						
Photo 1:			Photo 2:

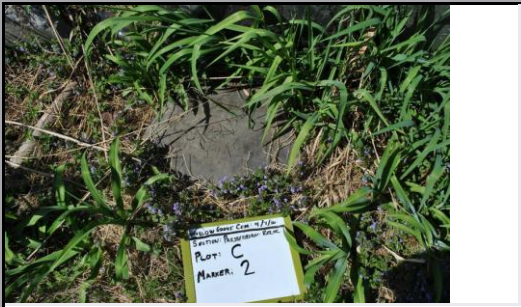
V. MATERIAL CONDITIONS						
<input type="checkbox"/> Biological - Algae	<input type="checkbox"/> Biological - Lichens	<input type="checkbox"/> Crack	<input checked="" type="checkbox"/> Delamination/Exfoliation			
<input type="checkbox"/> Disaggregation/Erosion	<input type="checkbox"/> Graffiti	<input type="checkbox"/> Off base (missing)	<input type="checkbox"/> Off base (adjacent)			
<input type="checkbox"/> Missing Fragment (s)	<input type="checkbox"/> Previous Repair	<input type="checkbox"/> Soiling	<input type="checkbox"/> Sunken			
<input type="checkbox"/> Tilt	<input type="checkbox"/> Corrosion					
<input checked="" type="checkbox"/> Other:	Marker has suffered a complete loss of integrity. Fragment only.					
VI. TREATMENT RECOMMENDATIONS						
<input type="checkbox"/> Archaeology	<input type="checkbox"/> Excavate	<input type="checkbox"/> Reset on exist base	<input type="checkbox"/> Reset on salvaged base (if poss)

VII. ADDITIONAL INFORMATION						
<p>The use of slate is exceptionally rare within this cemetery. Slate markers were noted only within the Presbyterian portion of the site. Marker is located in an area with poor drainage and will be susceptible to water related deterioration.</p>

<input type="checkbox"/> Clean/bio removal	<input type="checkbox"/> Consolidate	<input type="checkbox"/> Composite repair	<input type="checkbox"/> Pin/adhesive repair			
<input type="checkbox"/> Other:	_____					
VI. PHOTOGRAPHS						
Photo 1:			Photo 2:

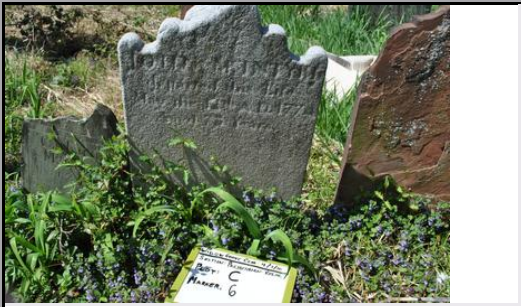
V. MATERIAL CONDITIONS						
<input checked="" type="checkbox"/> Biological - Algae	<input type="checkbox"/> Biological - Lichens	<input type="checkbox"/> Crack	<input type="checkbox"/> Delamination/Exfoliation			
<input checked="" type="checkbox"/> Disaggregation/Erosion	<input type="checkbox"/> Graffiti	<input type="checkbox"/> Off base (missing)	<input type="checkbox"/> Off base (adjacent)			
<input type="checkbox"/> Missing Fragment (s)	<input type="checkbox"/> Previous Repair	<input type="checkbox"/> Soiling	<input type="checkbox"/> Sunken			
<input type="checkbox"/> Tilt	<input type="checkbox"/> Corrosion					
<input type="checkbox"/> Other:	_____					
VI. TREATMENT RECOMMENDATIONS						
<input type="checkbox"/> Archaeology	<input type="checkbox"/> Excavate	<input type="checkbox"/> Reset on exist base	<input type="checkbox"/> Reset on salvaged base (if poss)			
<input checked="" type="checkbox"/> Clean/bio removal	<input checked="" type="checkbox"/> Consolidate	<input type="checkbox"/> Composite repair	<input type="checkbox"/> Pin/adhesive repair

VII. ADDITIONAL INFORMATION						
Marker is located in an area with poor drainage and will be susceptible to water related deterioration.

<input checked="" type="checkbox"/> Other:	Possible candidate for consolidation testing.					
VI. PHOTOGRAPHS						
Photo 1:			Photo 2:

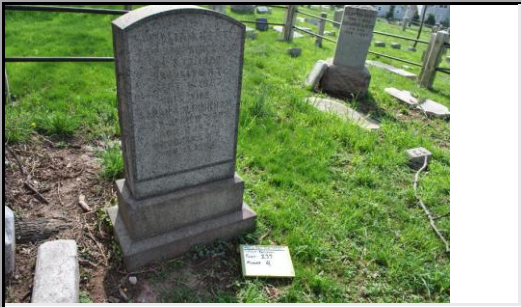
V. MATERIAL CONDITIONS						
<input checked="" type="checkbox"/> Biological - Algae	<input type="checkbox"/> Biological - Lichens	<input type="checkbox"/> Crack	<input type="checkbox"/> Delamination/Exfoliation			
<input type="checkbox"/> Disaggregation/Erosion	<input type="checkbox"/> Graffiti	<input type="checkbox"/> Off base (missing)	<input type="checkbox"/> Off base (adjacent)			
<input type="checkbox"/> Missing Fragment (s)	<input type="checkbox"/> Previous Repair	<input type="checkbox"/> Soiling	<input type="checkbox"/> Sunken			
<input checked="" type="checkbox"/> Tilt	<input type="checkbox"/> Corrosion					
<input type="checkbox"/> Other:	_____					
VI. TREATMENT RECOMMENDATIONS						
<input type="checkbox"/> Archaeology	<input type="checkbox"/> Excavate	<input type="checkbox"/> Reset on exist base	<input type="checkbox"/> Reset on salvaged base (if poss)			
<input checked="" type="checkbox"/> Clean/bio removal	<input type="checkbox"/> Consolidate	<input type="checkbox"/> Composite repair	<input type="checkbox"/> Pin/adhesive repair

<input checked="" type="checkbox"/> Other:	Monitor tilt and correct as required.					
VI. PHOTOGRAPHS						
Photo 1:			Photo 2:

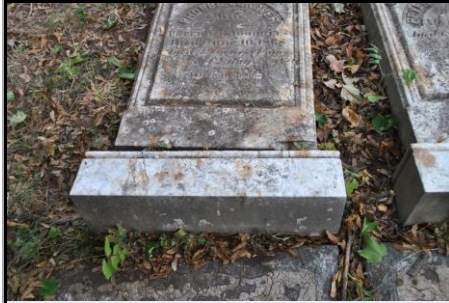
I. BURIAL INFORMATION					II. PRIORITIZATION	
First name	Last name	Birth	Death	Survey date	Condition	Prioritization
Phoebe	Conover (Voorhee	0	1868	9/9/2010	Fair	Moderate term

V. MATERIAL CONDITIONS			
<input checked="" type="checkbox"/> Biological - Algae	<input checked="" type="checkbox"/> Biological - Lichens	<input checked="" type="checkbox"/> Crack	<input type="checkbox"/> Delamination/Exfoliation
<input checked="" type="checkbox"/> Disaggregation/Erosion	<input type="checkbox"/> Graffiti	<input type="checkbox"/> Off base (missing)	<input checked="" type="checkbox"/> Off base (adjacent)
<input type="checkbox"/> Missing Fragment (s)	<input type="checkbox"/> Previous Repair	<input checked="" type="checkbox"/> Soiling	<input type="checkbox"/> Sunken
<input type="checkbox"/> Tilt	<input type="checkbox"/> Corrosion		
<input type="checkbox"/> Other:	_____

VI. TREATMENT RECOMMENDATIONS			
<input checked="" type="checkbox"/> Archaeology	<input type="checkbox"/> Excavate	<input checked="" type="checkbox"/> Reset on exist base	<input type="checkbox"/> Reset on salvaged base (if poss)
<input checked="" type="checkbox"/> Clean/bio removal	<input type="checkbox"/> Consolidate	<input type="checkbox"/> Composite repair	<input type="checkbox"/> Pin/adhesive repair
<input checked="" type="checkbox"/> Other:	Level base as required, installing on pea gravel and mortar pad if required. Reinstall headstone with pins to attach headstone to base.

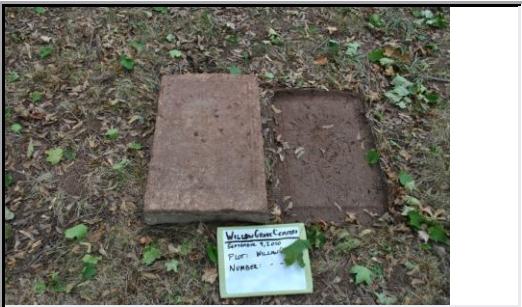
V. MATERIAL CONDITIONS						
<input checked="" type="checkbox"/> Biological - Algae	<input checked="" type="checkbox"/> Biological - Lichens	<input type="checkbox"/> Crack	<input type="checkbox"/> Delamination/Exfoliation			
<input checked="" type="checkbox"/> Disaggregation/Erosion	<input type="checkbox"/> Graffiti	<input checked="" type="checkbox"/> Off base (missing)	<input type="checkbox"/> Off base (adjacent)			
<input type="checkbox"/> Missing Fragment (s)	<input type="checkbox"/> Previous Repair	<input checked="" type="checkbox"/> Soiling	<input type="checkbox"/> Sunken			
<input type="checkbox"/> Tilt	<input type="checkbox"/> Corrosion					
<input checked="" type="checkbox"/> Other:	Inscription is illegible due to erosion/soiling.					
VI. TREATMENT RECOMMENDATIONS						
<input checked="" type="checkbox"/> Archaeology	<input type="checkbox"/> Excavate	<input type="checkbox"/> Reset on exist base	<input checked="" type="checkbox"/> Reset on salvaged base (if poss)

VII. ADDITIONAL INFORMATION						
Marker was face down; was turned over for identification during survey work.

<input checked="" type="checkbox"/> Clean/bio removal	<input type="checkbox"/> Consolidate	<input type="checkbox"/> Composite repair	<input type="checkbox"/> Pin/adhesive repair			
<input checked="" type="checkbox"/> Other:	Locate proper burial location. Identify appropriate base with flat surface (no cavity). Re-set base on pea gravel/mortar pad. Reinstall headstone with pins to attach headstone to base.					
VI. PHOTOGRAPHS						
Photo 1:			Photo 2:

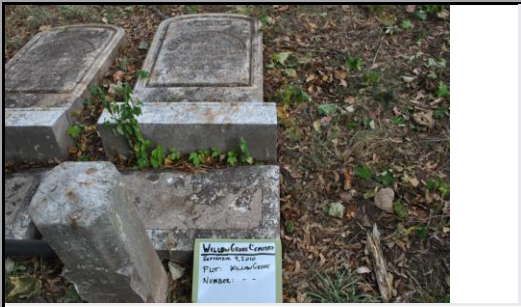
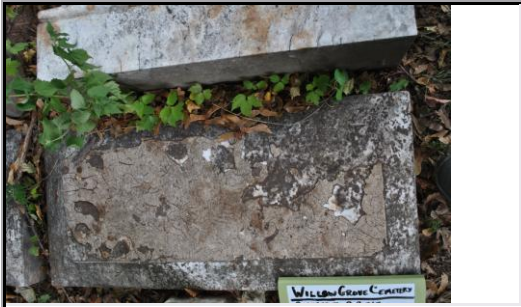
V. MATERIAL CONDITIONS						
<input checked="" type="checkbox"/> Biological - Algae	<input checked="" type="checkbox"/> Biological - Lichens	<input checked="" type="checkbox"/> Crack	<input type="checkbox"/> Delamination/Exfoliation			
<input checked="" type="checkbox"/> Disaggregation/Erosion	<input type="checkbox"/> Graffiti	<input type="checkbox"/> Off base (missing)	<input checked="" type="checkbox"/> Off base (adjacent)			
<input type="checkbox"/> Missing Fragment (s)	<input type="checkbox"/> Previous Repair	<input checked="" type="checkbox"/> Soiling	<input type="checkbox"/> Sunken			
<input type="checkbox"/> Tilt	<input type="checkbox"/> Corrosion					
<input type="checkbox"/> Other:	_____					
VI. TREATMENT RECOMMENDATIONS						
<input checked="" type="checkbox"/> Archaeology	<input type="checkbox"/> Excavate	<input checked="" type="checkbox"/> Reset on exist base	<input type="checkbox"/> Reset on salvaged base (if poss)

<input checked="" type="checkbox"/> Clean/bio removal	<input type="checkbox"/> Consolidate	<input type="checkbox"/> Composite repair	<input type="checkbox"/> Pin/adhesive repair			
<input checked="" type="checkbox"/> Other:	Level base as required, installing on pea gravel and mortar pad if required. Reinstall headstone with pins to attach headstone to base.					
VI. PHOTOGRAPHS						
Photo 1:			Photo 2:

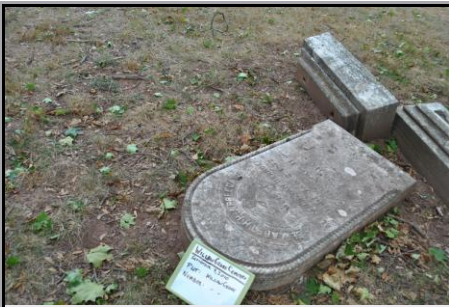
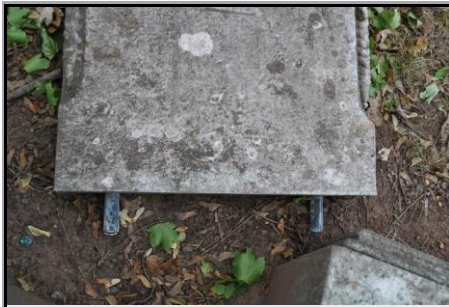
I. BURIAL INFORMATION					II. PRIORITIZATION	
First name	Last name	Birth	Death	Survey date	Condition	Prioritization
Elizabeth	Applegate (Van De	0	1872	9/9/2010	Fair	Moderate term

V. MATERIAL CONDITIONS			
<input checked="" type="checkbox"/> Biological - Algae	<input checked="" type="checkbox"/> Biological - Lichens	<input type="checkbox"/> Crack	<input type="checkbox"/> Delamination/Exfoliation
<input checked="" type="checkbox"/> Disaggregation/Erosion	<input type="checkbox"/> Graffiti	<input type="checkbox"/> Off base (missing)	<input checked="" type="checkbox"/> Off base (adjacent)
<input type="checkbox"/> Missing Fragment (s)	<input type="checkbox"/> Previous Repair	<input checked="" type="checkbox"/> Soiling	<input type="checkbox"/> Sunken
<input type="checkbox"/> Tilt	<input type="checkbox"/> Corrosion		
<input type="checkbox"/> Other:	_____

VI. TREATMENT RECOMMENDATIONS			
<input type="checkbox"/> Archaeology	<input type="checkbox"/> Excavate	<input checked="" type="checkbox"/> Reset on exist base	<input type="checkbox"/> Reset on salvaged base (if poss)
<input checked="" type="checkbox"/> Clean/bio removal	<input type="checkbox"/> Consolidate	<input type="checkbox"/> Composite repair	<input type="checkbox"/> Pin/adhesive repair
<input checked="" type="checkbox"/> Other:	Re-set existing base on pea gravel/mortar pad. Reinstall headstone with pins to attach headstone to base.

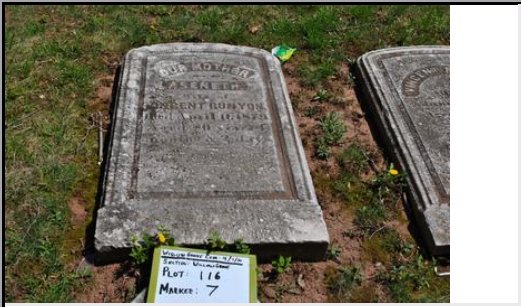
V. MATERIAL CONDITIONS						
<input checked="" type="checkbox"/> Biological - Algae	<input type="checkbox"/> Biological - Lichens	<input type="checkbox"/> Crack	<input type="checkbox"/> Delamination/Exfoliation			
<input checked="" type="checkbox"/> Disaggregation/Erosion	<input type="checkbox"/> Graffiti	<input type="checkbox"/> Off base (missing)	<input checked="" type="checkbox"/> Off base (adjacent)			
<input type="checkbox"/> Missing Fragment (s)	<input type="checkbox"/> Previous Repair	<input type="checkbox"/> Soiling	<input type="checkbox"/> Sunken			
<input type="checkbox"/> Tilt	<input type="checkbox"/> Corrosion					
<input checked="" type="checkbox"/> Other:	No tongue at base of headstone.					
VI. TREATMENT RECOMMENDATIONS						
<input type="checkbox"/> Archaeology	<input type="checkbox"/> Excavate	<input type="checkbox"/> Reset on exist base	<input checked="" type="checkbox"/> Reset on salvaged base (if poss)

<input checked="" type="checkbox"/> Clean/bio removal	<input type="checkbox"/> Consolidate	<input type="checkbox"/> Composite repair	<input type="checkbox"/> Pin/adhesive repair			
<input checked="" type="checkbox"/> Other:	Locate proper burial location. Identify appropriate base with flat surface (no cavity). Re-set base on pea gravel/mortar pad. Reinstall headstone with pins to attach headstone to base.					
VI. PHOTOGRAPHS						
Photo 1:			Photo 2:

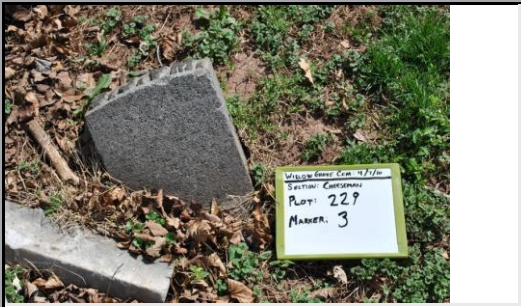
V. MATERIAL CONDITIONS						
<input type="checkbox"/> Biological - Algae	<input type="checkbox"/> Biological - Lichens	<input type="checkbox"/> Crack	<input type="checkbox"/> Delamination/Exfoliation			
<input type="checkbox"/> Disaggregation/Erosion	<input type="checkbox"/> Graffiti	<input type="checkbox"/> Off base (missing)	<input type="checkbox"/> Off base (adjacent)			
<input type="checkbox"/> Missing Fragment (s)	<input type="checkbox"/> Previous Repair	<input type="checkbox"/> Soiling	<input checked="" type="checkbox"/> Sunken			
<input checked="" type="checkbox"/> Tilt	<input type="checkbox"/> Corrosion					
<input type="checkbox"/> Other:	_____					
VI. TREATMENT RECOMMENDATIONS						
<input checked="" type="checkbox"/> Archaeology	<input checked="" type="checkbox"/> Excavate	<input type="checkbox"/> Reset on exist base	<input type="checkbox"/> Reset on salvaged base (if poss)			
<input type="checkbox"/> Clean/bio removal	<input type="checkbox"/> Consolidate	<input type="checkbox"/> Composite repair	<input type="checkbox"/> Pin/adhesive repair

<input checked="" type="checkbox"/> Other:	Re-set on new pea gravel base.					
VI. PHOTOGRAPHS						
Photo 1:			Photo 2:

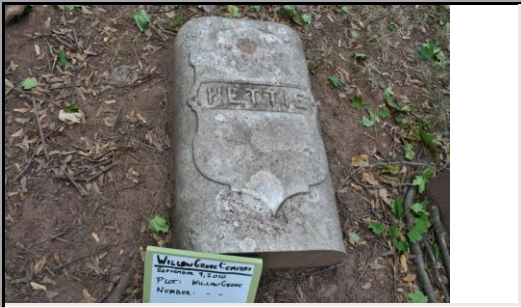
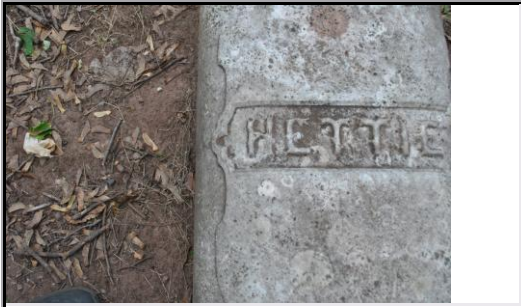
I. BURIAL INFORMATION					II. PRIORITIZATION	
First name	Last name	Birth	Death	Survey date	Condition	Prioritization
Hettie		0		9/9/2010	Fair	Moderate term
III. LOCATION						
Cemetery Section	Plot/Marker Number	Original Location	Original Marker/Feature			
Willow Grove	068.02	Yes	Yes			
IV. MARKER INFORMATION						
Marker Type						
Headstone w/ base		Height: 32	Width: 18	Depth: 10		
<input checked="" type="checkbox"/> Marble	<input type="checkbox"/> Granite	<input type="checkbox"/> Sandstone	<input type="checkbox"/> Slate			
<input type="checkbox"/> Brick	<input type="checkbox"/> Iron	<input type="checkbox"/> Other: _____

V. MATERIAL CONDITIONS						
<input checked="" type="checkbox"/> Biological - Algae	<input checked="" type="checkbox"/> Biological - Lichens	<input type="checkbox"/> Crack	<input type="checkbox"/> Delamination/Exfoliation			
<input checked="" type="checkbox"/> Disaggregation/Erosion	<input type="checkbox"/> Graffiti	<input checked="" type="checkbox"/> Off base (missing)	<input type="checkbox"/> Off base (adjacent)			
<input type="checkbox"/> Missing Fragment (s)	<input type="checkbox"/> Previous Repair	<input checked="" type="checkbox"/> Soiling	<input type="checkbox"/> Sunken			
<input type="checkbox"/> Tilt	<input type="checkbox"/> Corrosion					
<input type="checkbox"/> Other:	_____					
VI. TREATMENT RECOMMENDATIONS						
<input checked="" type="checkbox"/> Archaeology	<input type="checkbox"/> Excavate	<input type="checkbox"/> Reset on exist base	<input checked="" type="checkbox"/> Reset on salvaged base (if poss)

VII. ADDITIONAL INFORMATION						
Marker may have been set upon an oval base.

<input checked="" type="checkbox"/> Clean/bio removal	<input type="checkbox"/> Consolidate	<input type="checkbox"/> Composite repair	<input type="checkbox"/> Pin/adhesive repair			
<input checked="" type="checkbox"/> Other:	Locate proper burial location. Identify appropriate base with flat surface (no cavity). Re-set base on pea gravel/mortar pad. Reinstall headstone with pins to attach headstone to base.					
VI. PHOTOGRAPHS						
Photo 1:			Photo 2:

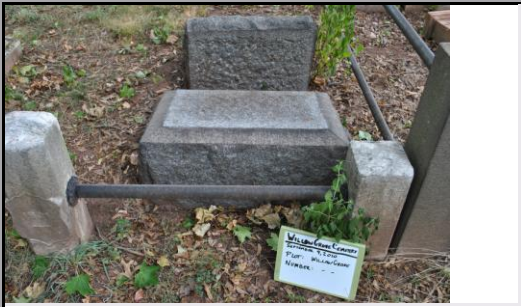
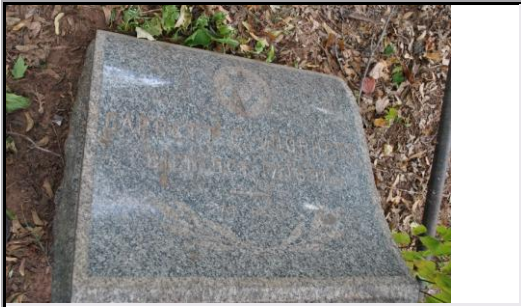
I. BURIAL INFORMATION					II. PRIORITIZATION	
First name	Last name	Birth	Death	Survey date	Condition	Prioritization
Garrett C.	Voorhees	0	1896	9/9/2010	Fair	Moderate term
III. LOCATION						
Cemetery Section	Plot/Marker Number	Original Location	Original Marker/Feature			
Willow Grove	065.01	Unknown	No			
IV. MARKER INFORMATION						
Marker Type						
Headstone w/ base		Height: 50	Width: 42	Depth: 22		
<input type="checkbox"/> Marble	<input checked="" type="checkbox"/> Granite	<input type="checkbox"/> Sandstone	<input type="checkbox"/> Slate			
<input type="checkbox"/> Brick	<input type="checkbox"/> Iron	<input type="checkbox"/> Other: _____

V. MATERIAL CONDITIONS						
<input checked="" type="checkbox"/> Biological - Algae	<input type="checkbox"/> Biological - Lichens	<input type="checkbox"/> Crack	<input type="checkbox"/> Delamination/Exfoliation			
<input type="checkbox"/> Disaggregation/Erosion	<input type="checkbox"/> Graffiti	<input type="checkbox"/> Off base (missing)	<input checked="" type="checkbox"/> Off base (adjacent)			
<input type="checkbox"/> Missing Fragment (s)	<input type="checkbox"/> Previous Repair	<input checked="" type="checkbox"/> Soiling	<input type="checkbox"/> Sunken			
<input type="checkbox"/> Tilt	<input type="checkbox"/> Corrosion					
<input type="checkbox"/> Other:	_____					
VI. TREATMENT RECOMMENDATIONS						
<input checked="" type="checkbox"/> Archaeology	<input type="checkbox"/> Excavate	<input checked="" type="checkbox"/> Reset on exist base	<input type="checkbox"/> Reset on salvaged base (if poss)

<input checked="" type="checkbox"/> Clean/bio removal	<input type="checkbox"/> Consolidate	<input type="checkbox"/> Composite repair	<input type="checkbox"/> Pin/adhesive repair			
<input checked="" type="checkbox"/> Other:	Locate proper burial location. Re-set existing base on pea gravel/mortar pad. Reinstall headstone on mortar bed between base and headstone.					
VI. PHOTOGRAPHS						
Photo 1:			Photo 2:

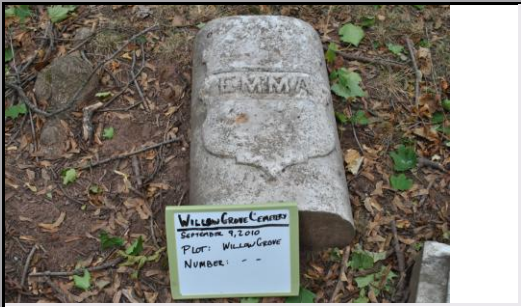
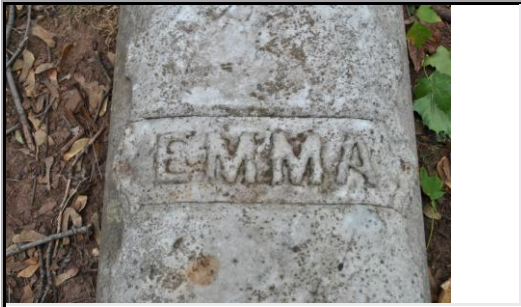
I. BURIAL INFORMATION					II. PRIORITIZATION	
First name	Last name	Birth	Death	Survey date	Condition	Prioritization
Emma		0		9/9/2010	Fair	Moderate term
III. LOCATION						
Cemetery Section	Plot/Marker Number	Original Location	Original Marker/Feature			
Willow Grove	068.03	Yes	Yes			
IV. MARKER INFORMATION						
Marker Type						
Headstone w/ base		Height: 26	Width: 15	Depth: 6		
<input checked="" type="checkbox"/> Marble	<input type="checkbox"/> Granite	<input type="checkbox"/> Sandstone	<input type="checkbox"/> Slate			
<input type="checkbox"/> Brick	<input type="checkbox"/> Iron	<input type="checkbox"/> Other: _____

V. MATERIAL CONDITIONS						
<input checked="" type="checkbox"/> Biological - Algae	<input checked="" type="checkbox"/> Biological - Lichens	<input type="checkbox"/> Crack	<input type="checkbox"/> Delamination/Exfoliation			
<input checked="" type="checkbox"/> Disaggregation/Erosion	<input type="checkbox"/> Graffiti	<input checked="" type="checkbox"/> Off base (missing)	<input type="checkbox"/> Off base (adjacent)			
<input type="checkbox"/> Missing Fragment (s)	<input type="checkbox"/> Previous Repair	<input checked="" type="checkbox"/> Soiling	<input type="checkbox"/> Sunken			
<input type="checkbox"/> Tilt	<input type="checkbox"/> Corrosion					
<input type="checkbox"/> Other:	_____					
VI. TREATMENT RECOMMENDATIONS						
<input checked="" type="checkbox"/> Archaeology	<input type="checkbox"/> Excavate	<input type="checkbox"/> Reset on exist base	<input checked="" type="checkbox"/> Reset on salvaged base (if poss)

VII. ADDITIONAL INFORMATION						
Marker may have been set upon an oval base.

<input checked="" type="checkbox"/> Clean/bio removal	<input type="checkbox"/> Consolidate	<input type="checkbox"/> Composite repair	<input type="checkbox"/> Pin/adhesive repair			
<input checked="" type="checkbox"/> Other:	Locate proper burial location. Identify appropriate base with flat surface (no cavity). Re-set base on pea gravel/mortar pad. Reinstall headstone with pins to attach headstone to base.					
VI. PHOTOGRAPHS						
Photo 1:			Photo 2:

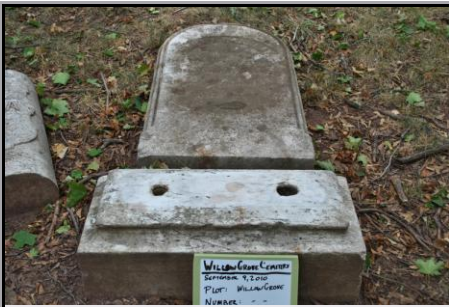
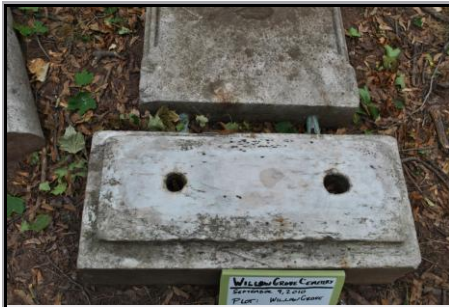
I. BURIAL INFORMATION					II. PRIORITIZATION	
First name	Last name	Birth	Death	Survey date	Condition	Prioritization
Sarah	Barclay	0	1867	9/9/2010	Fair	Moderate term

V. MATERIAL CONDITIONS			
<input checked="" type="checkbox"/> Biological - Algae	<input checked="" type="checkbox"/> Biological - Lichens	<input type="checkbox"/> Crack	<input type="checkbox"/> Delamination/Exfoliation
<input checked="" type="checkbox"/> Disaggregation/Erosion	<input type="checkbox"/> Graffiti	<input type="checkbox"/> Off base (missing)	<input checked="" type="checkbox"/> Off base (adjacent)
<input type="checkbox"/> Missing Fragment (s)	<input type="checkbox"/> Previous Repair	<input checked="" type="checkbox"/> Soiling	<input type="checkbox"/> Sunken
<input type="checkbox"/> Tilt	<input type="checkbox"/> Corrosion		
<input type="checkbox"/> Other:

VI. TREATMENT RECOMMENDATIONS			
<input type="checkbox"/> Archaeology	<input type="checkbox"/> Excavate	<input checked="" type="checkbox"/> Reset on exist base	<input type="checkbox"/> Reset on salvaged base (if poss)
<input checked="" type="checkbox"/> Clean/bio removal	<input type="checkbox"/> Consolidate	<input type="checkbox"/> Composite repair	<input type="checkbox"/> Pin/adhesive repair
<input checked="" type="checkbox"/> Other:	Re-set existing base on pea gravel/mortar pad if necessary. Reinstall headstone with pins to attach headstone to base.

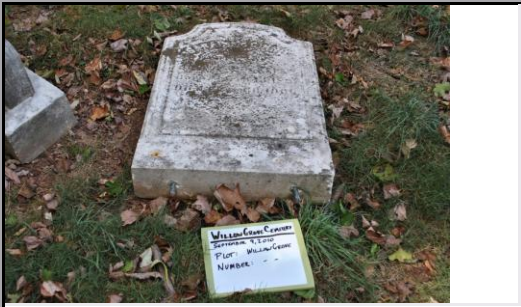
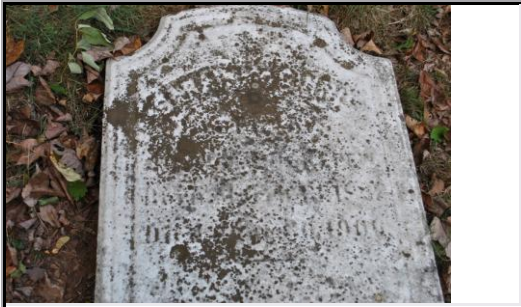
I. BURIAL INFORMATION					II. PRIORITIZATION	
First name	Last name	Birth	Death	Survey date	Condition	Prioritization
Sarah		18	1906?	9/9/2010	Fair	Moderate term
III. LOCATION						
Cemetery Section	Plot/Marker Number	Original Location	Original Marker/Feature			
Willow Grove	N/A	Unknown	Yes			
IV. MARKER INFORMATION						
Marker Type						
Headstone w/ base		Height: 36	Width: 23	Depth: 5		
<input checked="" type="checkbox"/> Marble	<input type="checkbox"/> Granite	<input type="checkbox"/> Sandstone	<input type="checkbox"/> Slate			
<input type="checkbox"/> Brick	<input type="checkbox"/> Iron	<input type="checkbox"/> Other: _____

V. MATERIAL CONDITIONS						
<input checked="" type="checkbox"/> Biological - Algae	<input checked="" type="checkbox"/> Biological - Lichens	<input type="checkbox"/> Crack	<input type="checkbox"/> Delamination/Exfoliation			
<input checked="" type="checkbox"/> Disaggregation/Erosion	<input type="checkbox"/> Graffiti	<input checked="" type="checkbox"/> Off base (missing)	<input type="checkbox"/> Off base (adjacent)			
<input type="checkbox"/> Missing Fragment (s)	<input type="checkbox"/> Previous Repair	<input checked="" type="checkbox"/> Soiling	<input type="checkbox"/> Sunken			
<input type="checkbox"/> Tilt	<input type="checkbox"/> Corrosion					
<input checked="" type="checkbox"/> Other:	Inscription is illegible due to erosion.					
VI. TREATMENT RECOMMENDATIONS						
<input type="checkbox"/> Archaeology	<input type="checkbox"/> Excavate	<input type="checkbox"/> Reset on exist base	<input checked="" type="checkbox"/> Reset on salvaged base (if poss)

VII. ADDITIONAL INFORMATION						
Located mid/E of SE quadrant of Willow Grove section.

<input checked="" type="checkbox"/> Clean/bio removal	<input type="checkbox"/> Consolidate	<input type="checkbox"/> Composite repair	<input type="checkbox"/> Pin/adhesive repair			
<input checked="" type="checkbox"/> Other:	Locate proper burial location. Identify appropriate base with flat surface (no cavity). Re-set base on pea gravel/mortar pad. Reinstall headstone with pins to attach headstone to base.					
VI. PHOTOGRAPHS						
Photo 1:			Photo 2:

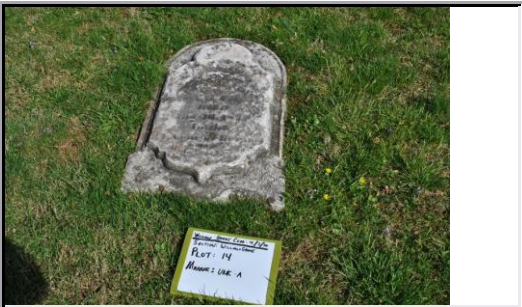
I. BURIAL INFORMATION					II. PRIORITIZATION	
First name	Last name	Birth	Death	Survey date	Condition	Prioritization
				4/7/2010	Fair	Moderate term
III. LOCATION						
Cemetery Section	Plot/Marker Number	Original Location	Original Marker/Feature			
Willow Grove	014.01	Unknown	Yes			
IV. MARKER INFORMATION						
Marker Type						
Headstone w/ base		Height: 34	Width: 22	Depth: 4		
<input checked="" type="checkbox"/> Marble	<input type="checkbox"/> Granite	<input type="checkbox"/> Sandstone	<input type="checkbox"/> Slate			
<input type="checkbox"/> Brick	<input type="checkbox"/> Iron	<input type="checkbox"/> Other: _____

V. MATERIAL CONDITIONS						
<input checked="" type="checkbox"/> Biological - Algae	<input checked="" type="checkbox"/> Biological - Lichens	<input type="checkbox"/> Crack	<input type="checkbox"/> Delamination/Exfoliation			
<input checked="" type="checkbox"/> Disaggregation/Erosion	<input type="checkbox"/> Graffiti	<input checked="" type="checkbox"/> Off base (missing)	<input type="checkbox"/> Off base (adjacent)			
<input type="checkbox"/> Missing Fragment (s)	<input type="checkbox"/> Previous Repair	<input checked="" type="checkbox"/> Soiling	<input type="checkbox"/> Sunken			
<input type="checkbox"/> Tilt	<input type="checkbox"/> Corrosion					
<input checked="" type="checkbox"/> Other:	Inscription is illegible due to erosion.					
VI. TREATMENT RECOMMENDATIONS						
<input checked="" type="checkbox"/> Archaeology	<input type="checkbox"/> Excavate	<input type="checkbox"/> Reset on exist base	<input checked="" type="checkbox"/> Reset on salvaged base (if poss)

<input checked="" type="checkbox"/> Clean/bio removal	<input type="checkbox"/> Consolidate	<input type="checkbox"/> Composite repair	<input type="checkbox"/> Pin/adhesive repair			
<input checked="" type="checkbox"/> Other:	Locate proper burial location. Identify appropriate base with tongue cavity. Re-set base on pea gravel/mortar pad. Reinstall headstone with tongue in mortared cavity.					
VI. PHOTOGRAPHS						
Photo 1:			Photo 2:

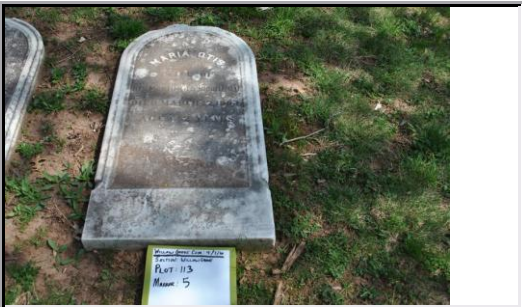
I. BURIAL INFORMATION					II. PRIORITIZATION	
First name	Last name	Birth	Death	Survey date	Condition	Prioritization
Maria Otis	Riddell		1904	4/7/2010	Fair	Moderate term
III. LOCATION						
Cemetery Section	Plot/Marker Number	Original Location	Original Marker/Feature			
Willow Grove	113.05	Yes	Yes			
IV. MARKER INFORMATION						
Marker Type						
Headstone w/ base		Height: 48	Width: 24	Depth: 4		
<input checked="" type="checkbox"/> Marble	<input type="checkbox"/> Granite	<input type="checkbox"/> Sandstone	<input type="checkbox"/> Slate			
<input type="checkbox"/> Brick	<input type="checkbox"/> Iron	<input type="checkbox"/> Other: _____

V. MATERIAL CONDITIONS						
<input checked="" type="checkbox"/> Biological - Algae	<input type="checkbox"/> Biological - Lichens	<input type="checkbox"/> Crack	<input type="checkbox"/> Delamination/Exfoliation			
<input checked="" type="checkbox"/> Disaggregation/Erosion	<input type="checkbox"/> Graffiti	<input checked="" type="checkbox"/> Off base (missing)	<input type="checkbox"/> Off base (adjacent)			
<input type="checkbox"/> Missing Fragment (s)	<input type="checkbox"/> Previous Repair	<input checked="" type="checkbox"/> Soiling	<input type="checkbox"/> Sunken			
<input type="checkbox"/> Tilt	<input type="checkbox"/> Corrosion					
<input checked="" type="checkbox"/> Other:	No tongue or anchors. Bottom of headstone may have been set into cavity at base.					
VI. TREATMENT RECOMMENDATIONS						
<input checked="" type="checkbox"/> Archaeology	<input type="checkbox"/> Excavate	<input type="checkbox"/> Reset on exist base	<input checked="" type="checkbox"/> Reset on salvaged base (if poss)

<input checked="" type="checkbox"/> Clean/bio removal	<input type="checkbox"/> Consolidate	<input type="checkbox"/> Composite repair	<input type="checkbox"/> Pin/adhesive repair			
<input checked="" type="checkbox"/> Other:	Locate proper burial location. Identify appropriate base with flat surface (no cavity). Re-set base on pea gravel/mortar pad. Reinstall headstone with pins to attach headstone to base.					
VI. PHOTOGRAPHS						
Photo 1:			Photo 2:

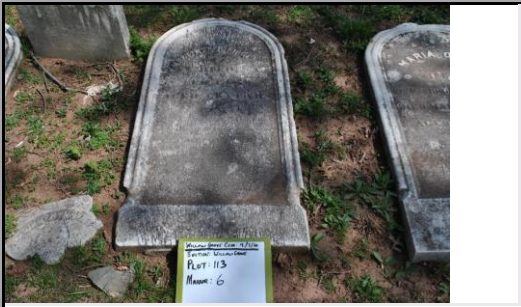
I. BURIAL INFORMATION					II. PRIORITIZATION	
First name	Last name	Birth	Death	Survey date	Condition	Prioritization
Rev. Matthew	Riddell		1870	4/7/2010	Fair	Moderate term
III. LOCATION						
Cemetery Section	Plot/Marker Number	Original Location	Original Marker/Feature			
Willow Grove	113.06	Yes	Yes			
IV. MARKER INFORMATION						
Marker Type	Height:	Width:	Depth:			
Headstone w/ base	48	24	4			
<input checked="" type="checkbox"/> Marble	<input type="checkbox"/> Granite	<input type="checkbox"/> Sandstone	<input type="checkbox"/> Slate			
<input type="checkbox"/> Brick	<input type="checkbox"/> Iron	<input type="checkbox"/> Other:

V. MATERIAL CONDITIONS						
<input checked="" type="checkbox"/> Biological - Algae	<input type="checkbox"/> Biological - Lichens	<input type="checkbox"/> Crack	<input type="checkbox"/> Delamination/Exfoliation			
<input checked="" type="checkbox"/> Disaggregation/Erosion	<input type="checkbox"/> Graffiti	<input checked="" type="checkbox"/> Off base (missing)	<input type="checkbox"/> Off base (adjacent)			
<input type="checkbox"/> Missing Fragment (s)	<input type="checkbox"/> Previous Repair	<input checked="" type="checkbox"/> Soiling	<input type="checkbox"/> Sunken			
<input type="checkbox"/> Tilt	<input type="checkbox"/> Corrosion					
<input checked="" type="checkbox"/> Other:	Tongue at base of marker - original attachment to base - has been broken off.					
VI. TREATMENT RECOMMENDATIONS						
<input checked="" type="checkbox"/> Archaeology	<input type="checkbox"/> Excavate	<input type="checkbox"/> Reset on exist base	<input checked="" type="checkbox"/> Reset on salvaged base (if poss)

<input checked="" type="checkbox"/> Clean/bio removal	<input type="checkbox"/> Consolidate	<input type="checkbox"/> Composite repair	<input type="checkbox"/> Pin/adhesive repair			
<input checked="" type="checkbox"/> Other:	Locate proper burial location. Identify appropriate base with flat surface (no cavity). Re-set base on pea gravel/mortar pad. Reinstall headstone with pins to attach headstone to base.					
VI. PHOTOGRAPHS						
Photo 1:			Photo 2:

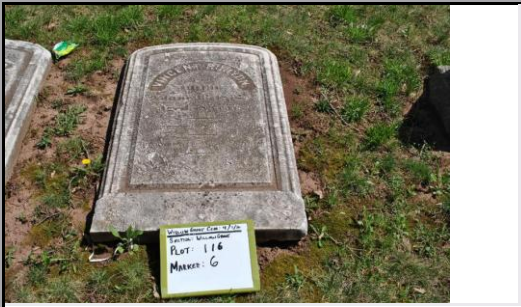
I. BURIAL INFORMATION					II. PRIORITIZATION	
First name	Last name	Birth	Death	Survey date	Condition	Prioritization
Vincent	Runyon		1892	4/7/2010	Fair	Moderate term
III. LOCATION						
Cemetery Section	Plot/Marker Number	Original Location	Original Marker/Feature			
Willow Grove	116.06	Yes	Yes			
IV. MARKER INFORMATION						
Marker Type						
Headstone w/ base		Height: 43	Width: 26	Depth: 5		
<input checked="" type="checkbox"/> Marble	<input type="checkbox"/> Granite	<input type="checkbox"/> Sandstone	<input type="checkbox"/> Slate			
<input type="checkbox"/> Brick	<input type="checkbox"/> Iron	<input type="checkbox"/> Other: _____

V. MATERIAL CONDITIONS						
<input checked="" type="checkbox"/> Biological - Algae	<input type="checkbox"/> Biological - Lichens	<input type="checkbox"/> Crack	<input type="checkbox"/> Delamination/Exfoliation			
<input checked="" type="checkbox"/> Disaggregation/Erosion	<input type="checkbox"/> Graffiti	<input checked="" type="checkbox"/> Off base (missing)	<input type="checkbox"/> Off base (adjacent)			
<input type="checkbox"/> Missing Fragment (s)	<input type="checkbox"/> Previous Repair	<input type="checkbox"/> Soiling	<input type="checkbox"/> Sunken			
<input type="checkbox"/> Tilt	<input type="checkbox"/> Corrosion					
<input checked="" type="checkbox"/> Other:	Pattern of biological growth suggests that water pools in recessed portions of the marker, forming a chronically wet condition. Anchor cavities at base of main headstone.					
VI. TREATMENT RECOMMENDATIONS						
<input checked="" type="checkbox"/> Archaeology	<input type="checkbox"/> Excavate	<input type="checkbox"/> Reset on exist base	<input checked="" type="checkbox"/> Reset on salvaged base (if poss)

<input checked="" type="checkbox"/> Clean/bio removal	<input type="checkbox"/> Consolidate	<input type="checkbox"/> Composite repair	<input type="checkbox"/> Pin/adhesive repair			
<input checked="" type="checkbox"/> Other:	Locate proper burial location. Identify appropriate base with flat surface (no cavity). Re-set base on pea gravel/mortar pad. Reinstall headstone with pins to attach headstone to base.					
VI. PHOTOGRAPHS						
Photo 1:			Photo 2:

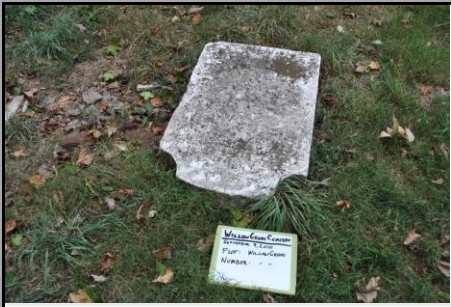
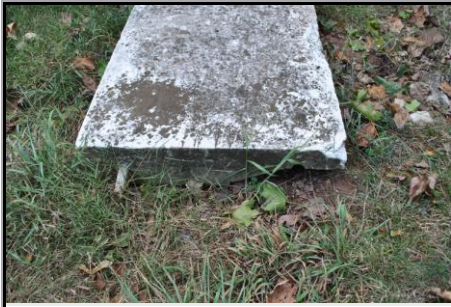
I. BURIAL INFORMATION					II. PRIORITIZATION	
First name	Last name	Birth	Death	Survey date	Condition	Prioritization
		0		9/9/2010	Fair	Moderate term
III. LOCATION						
Cemetery Section	Plot/Marker Number	Original Location	Original Marker/Feature			
Willow Grove	N/A	Unknown	Yes			
IV. MARKER INFORMATION						
Marker Type						
Headstone w/ base		Height: 36	Width: 23	Depth: 5		
<input checked="" type="checkbox"/> Marble	<input type="checkbox"/> Granite	<input type="checkbox"/> Sandstone	<input type="checkbox"/> Slate			
<input type="checkbox"/> Brick	<input type="checkbox"/> Iron	<input type="checkbox"/> Other: _____

V. MATERIAL CONDITIONS						
<input checked="" type="checkbox"/> Biological - Algae	<input checked="" type="checkbox"/> Biological - Lichens	<input type="checkbox"/> Crack	<input type="checkbox"/> Delamination/Exfoliation			
<input type="checkbox"/> Disaggregation/Erosion	<input type="checkbox"/> Graffiti	<input checked="" type="checkbox"/> Off base (missing)	<input type="checkbox"/> Off base (adjacent)			
<input checked="" type="checkbox"/> Missing Fragment (s)	<input type="checkbox"/> Previous Repair	<input checked="" type="checkbox"/> Soiling	<input type="checkbox"/> Sunken			
<input type="checkbox"/> Tilt	<input type="checkbox"/> Corrosion					
<input checked="" type="checkbox"/> Other:	_____					
VI. TREATMENT RECOMMENDATIONS						
<input checked="" type="checkbox"/> Archaeology	<input type="checkbox"/> Excavate	<input type="checkbox"/> Reset on exist base	<input checked="" type="checkbox"/> Reset on salvaged base (if poss)

VII. ADDITIONAL INFORMATION						
One pin missing. Located mid/E of SE quadrant of Willow Grove section.

<input checked="" type="checkbox"/> Clean/bio removal	<input type="checkbox"/> Consolidate	<input type="checkbox"/> Composite repair	<input type="checkbox"/> Pin/adhesive repair			
<input checked="" type="checkbox"/> Other:	Locate proper burial location. Identify appropriate base with flat surface (no cavity). Re-set base on pea gravel/mortar pad. Reinstall headstone with pins to attach headstone to base.					
VI. PHOTOGRAPHS						
Photo 1:			Photo 2:

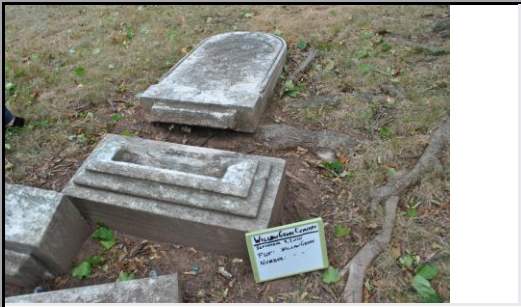
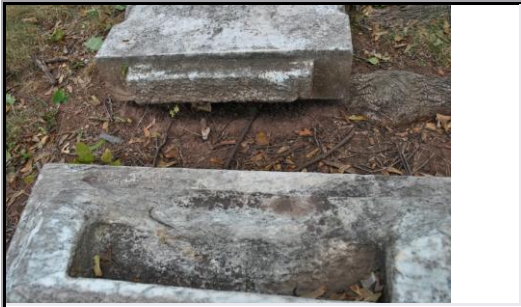
I. BURIAL INFORMATION					II. PRIORITIZATION	
First name	Last name	Birth	Death	Survey date	Condition	Prioritization
Alfred	Van Derhoef	0	1861	9/9/2010	Fair	Moderate term
III. LOCATION						
Cemetery Section	Plot/Marker Number	Original Location	Original Marker/Feature			
Willow Grove	068.09	Yes	Yes			
IV. MARKER INFORMATION						
Marker Type	Height:	Width:	Depth:			
Headstone w/ base	60	24	6			
<input checked="" type="checkbox"/> Marble	<input type="checkbox"/> Granite	<input type="checkbox"/> Sandstone	<input type="checkbox"/> Slate			
<input type="checkbox"/> Brick	<input type="checkbox"/> Iron	<input type="checkbox"/> Other:

V. MATERIAL CONDITIONS						
<input checked="" type="checkbox"/> Biological - Algae	<input checked="" type="checkbox"/> Biological - Lichens	<input type="checkbox"/> Crack	<input type="checkbox"/> Delamination/Exfoliation			
<input checked="" type="checkbox"/> Disaggregation/Erosion	<input type="checkbox"/> Graffiti	<input type="checkbox"/> Off base (missing)	<input checked="" type="checkbox"/> Off base (adjacent)			
<input checked="" type="checkbox"/> Missing Fragment (s)	<input type="checkbox"/> Previous Repair	<input checked="" type="checkbox"/> Soiling	<input type="checkbox"/> Sunken			
<input type="checkbox"/> Tilt	<input type="checkbox"/> Corrosion					
<input type="checkbox"/> Other:						
VI. TREATMENT RECOMMENDATIONS						
<input checked="" type="checkbox"/> Archaeology	<input type="checkbox"/> Excavate	<input checked="" type="checkbox"/> Reset on exist base	<input type="checkbox"/> Reset on salvaged base (if poss)

<input checked="" type="checkbox"/> Clean/bio removal	<input type="checkbox"/> Consolidate	<input type="checkbox"/> Composite repair	<input type="checkbox"/> Pin/adhesive repair			
<input checked="" type="checkbox"/> Other:	Locate proper burial location. Identify appropriate base with tongue cavity. Re-set base on pea gravel/mortar pad. Reinstall headstone with tongue in mortared cavity.					
VI. PHOTOGRAPHS						
Photo 1:			Photo 2:

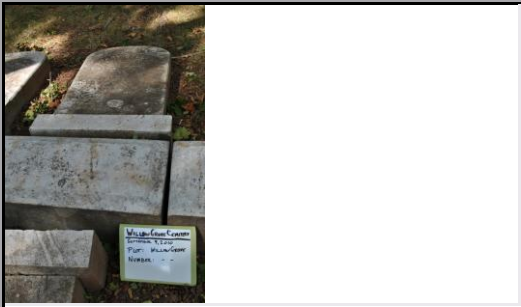
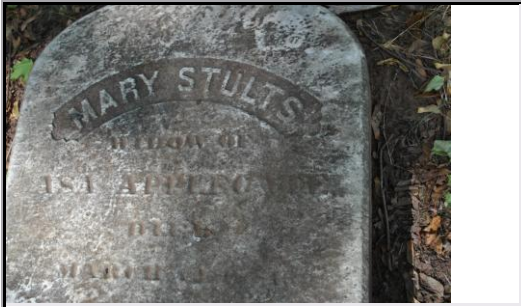
I. BURIAL INFORMATION					II. PRIORITIZATION	
First name	Last name	Birth	Death	Survey date	Condition	Prioritization
Mary	Stults (Applegate)	0	1881	9/9/2010	Fair	Moderate term
III. LOCATION						
Cemetery Section	Plot/Marker Number	Original Location	Original Marker/Feature			
Willow Grove	074.02	Yes	Yes			
IV. MARKER INFORMATION						
Marker Type						
Headstone w/ base		Height: 54	Width: 32	Depth: 17		
<input checked="" type="checkbox"/> Marble	<input type="checkbox"/> Granite	<input type="checkbox"/> Sandstone	<input type="checkbox"/> Slate			
<input type="checkbox"/> Brick	<input type="checkbox"/> Iron	<input type="checkbox"/> Other: _____

V. MATERIAL CONDITIONS						
<input checked="" type="checkbox"/> Biological - Algae	<input checked="" type="checkbox"/> Biological - Lichens	<input type="checkbox"/> Crack	<input type="checkbox"/> Delamination/Exfoliation			
<input checked="" type="checkbox"/> Disaggregation/Erosion	<input type="checkbox"/> Graffiti	<input type="checkbox"/> Off base (missing)	<input checked="" type="checkbox"/> Off base (adjacent)			
<input type="checkbox"/> Missing Fragment (s)	<input type="checkbox"/> Previous Repair	<input checked="" type="checkbox"/> Soiling	<input type="checkbox"/> Sunken			
<input type="checkbox"/> Tilt	<input type="checkbox"/> Corrosion					
<input type="checkbox"/> Other:	_____					
VI. TREATMENT RECOMMENDATIONS						
<input type="checkbox"/> Archaeology	<input type="checkbox"/> Excavate	<input checked="" type="checkbox"/> Reset on exist base	<input type="checkbox"/> Reset on salvaged base (if poss)

<input checked="" type="checkbox"/> Clean/bio removal	<input type="checkbox"/> Consolidate	<input type="checkbox"/> Composite repair	<input type="checkbox"/> Pin/adhesive repair			
<input checked="" type="checkbox"/> Other:	Re-set existing base on pea gravel/mortar pad if necessary. Reinstall headstone with pins to attach headstone to base.					
VI. PHOTOGRAPHS						
Photo 1:			Photo 2:

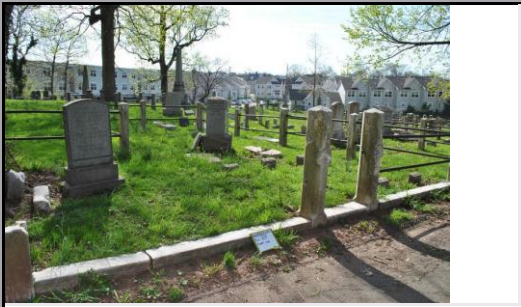
I. BURIAL INFORMATION					II. PRIORITIZATION	
First name	Last name	Birth	Death	Survey date	Condition	Prioritization
				4/7/2010	Fair	Moderate term
III. LOCATION						
Cemetery Section	Plot/Marker Number	Original Location	Original Marker/Feature			
Cheesman	237.00	Yes	Yes			
IV. MARKER INFORMATION						
Marker Type	Site Feature	Height:	Width:	Depth:		
<input checked="" type="checkbox"/> Marble	<input type="checkbox"/> Granite	<input type="checkbox"/> Sandstone	<input type="checkbox"/> Slate			
<input type="checkbox"/> Brick	<input checked="" type="checkbox"/> Iron	<input type="checkbox"/> Other: _____

V. MATERIAL CONDITIONS						
<input checked="" type="checkbox"/> Biological - Algae	<input type="checkbox"/> Biological - Lichens	<input type="checkbox"/> Crack	<input type="checkbox"/> Delamination/Exfoliation			
<input checked="" type="checkbox"/> Disaggregation/Erosion	<input type="checkbox"/> Graffiti	<input type="checkbox"/> Off base (missing)	<input type="checkbox"/> Off base (adjacent)			
<input type="checkbox"/> Missing Fragment (s)	<input type="checkbox"/> Previous Repair	<input checked="" type="checkbox"/> Soiling	<input type="checkbox"/> Sunken			
<input type="checkbox"/> Tilt	<input checked="" type="checkbox"/> Corrosion					
<input checked="" type="checkbox"/> Other:	Missing two posts, several rails and gate.					
VI. TREATMENT RECOMMENDATIONS						
<input type="checkbox"/> Archaeology	<input type="checkbox"/> Excavate	<input type="checkbox"/> Reset on exist base	<input type="checkbox"/> Reset on salvaged base (if poss)

<input checked="" type="checkbox"/> Clean/bio removal	<input type="checkbox"/> Consolidate	<input type="checkbox"/> Composite repair	<input type="checkbox"/> Pin/adhesive repair			
<input checked="" type="checkbox"/> Other:	Repair and repaint surviving rails. Replace missing posts, rails and gate.					
VI. PHOTOGRAPHS						
Photo 1:			Photo 2:

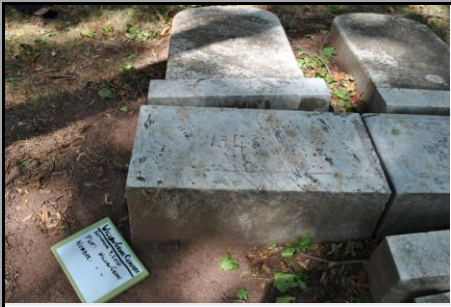
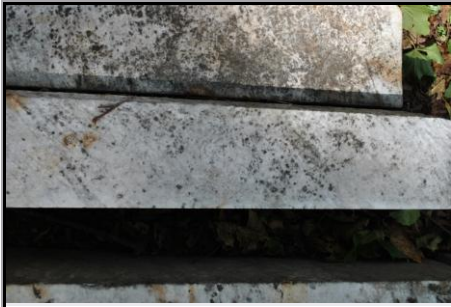
I. BURIAL INFORMATION					II. PRIORITIZATION	
First name	Last name	Birth	Death	Survey date	Condition	Prioritization
Asa	Applegate	0	1872	9/9/2010	Fair	Moderate term
III. LOCATION						
Cemetery Section	Plot/Marker Number	Original Location	Original Marker/Feature			
Willow Grove	074.01	Yes	Yes			
IV. MARKER INFORMATION						
Marker Type	Height:	Width:	Depth:			
Headstone w/ base	54	32	17			
<input checked="" type="checkbox"/> Marble	<input type="checkbox"/> Granite	<input type="checkbox"/> Sandstone	<input type="checkbox"/> Slate			
<input type="checkbox"/> Brick	<input type="checkbox"/> Iron	<input type="checkbox"/> Other:

V. MATERIAL CONDITIONS						
<input checked="" type="checkbox"/> Biological - Algae	<input checked="" type="checkbox"/> Biological - Lichens	<input type="checkbox"/> Crack	<input type="checkbox"/> Delamination/Exfoliation			
<input checked="" type="checkbox"/> Disaggregation/Erosion	<input type="checkbox"/> Graffiti	<input checked="" type="checkbox"/> Off base (missing)	<input checked="" type="checkbox"/> Off base (adjacent)			
<input type="checkbox"/> Missing Fragment (s)	<input type="checkbox"/> Previous Repair	<input checked="" type="checkbox"/> Soiling	<input type="checkbox"/> Sunken			
<input type="checkbox"/> Tilt	<input type="checkbox"/> Corrosion					
<input checked="" type="checkbox"/> Other:	Level existing base. Replace pins in headstone, re-set on base.					
VI. TREATMENT RECOMMENDATIONS						
<input type="checkbox"/> Archaeology	<input type="checkbox"/> Excavate	<input checked="" type="checkbox"/> Reset on exist base	<input type="checkbox"/> Reset on salvaged base (if poss)

<input checked="" type="checkbox"/> Clean/bio removal	<input type="checkbox"/> Consolidate	<input type="checkbox"/> Composite repair	<input type="checkbox"/> Pin/adhesive repair			
<input checked="" type="checkbox"/> Other:	Re-set existing base on pea gravel/mortar pad if necessary. Identify appropriate base piece with flat surface (no cavity). Reinstall headstone with pins to attach headstone to base.					
VI. PHOTOGRAPHS						
Photo 1:			Photo 2:

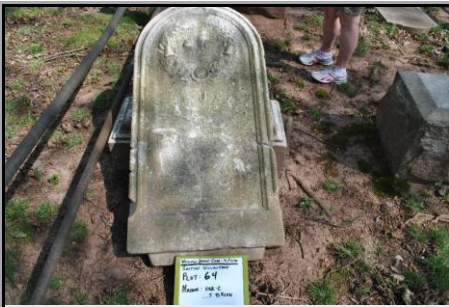
I. BURIAL INFORMATION					II. PRIORITIZATION	
First name	Last name	Birth	Death	Survey date	Condition	Prioritization
J.	Brian			4/7/2010	Fair	Moderate term
III. LOCATION						
Cemetery Section	Plot/Marker Number	Original Location	Original Marker/Feature			
Willow Grove	064.C	Unknown	Yes			
IV. MARKER INFORMATION						
Marker Type						
Headstone w/ base		Height: 48	Width: 24	Depth: 4		
<input checked="" type="checkbox"/> Marble	<input type="checkbox"/> Granite	<input type="checkbox"/> Sandstone	<input type="checkbox"/> Slate			
<input type="checkbox"/> Brick	<input type="checkbox"/> Iron	<input type="checkbox"/> Other: _____

V. MATERIAL CONDITIONS						
<input checked="" type="checkbox"/> Biological - Algae	<input type="checkbox"/> Biological - Lichens	<input type="checkbox"/> Crack	<input type="checkbox"/> Delamination/Exfoliation			
<input checked="" type="checkbox"/> Disaggregation/Erosion	<input type="checkbox"/> Graffiti	<input checked="" type="checkbox"/> Off base (missing)	<input type="checkbox"/> Off base (adjacent)			
<input type="checkbox"/> Missing Fragment (s)	<input type="checkbox"/> Previous Repair	<input checked="" type="checkbox"/> Soiling	<input type="checkbox"/> Sunken			
<input type="checkbox"/> Tilt	<input type="checkbox"/> Corrosion					
<input checked="" type="checkbox"/> Other:	Marker has been removed from base, and moved from original location.					
VI. TREATMENT RECOMMENDATIONS						
<input checked="" type="checkbox"/> Archaeology	<input type="checkbox"/> Excavate	<input type="checkbox"/> Reset on exist base	<input checked="" type="checkbox"/> Reset on salvaged base (if poss)

<input checked="" type="checkbox"/> Clean/bio removal	<input type="checkbox"/> Consolidate	<input type="checkbox"/> Composite repair	<input type="checkbox"/> Pin/adhesive repair			
<input checked="" type="checkbox"/> Other:	Locate proper burial location. Identify appropriate base with tongue cavity. Re-set base on pea gravel/mortar pad. Reinstall headstone with tongue in mortared cavity.					
VI. PHOTOGRAPHS						
Photo 1:			Photo 2:

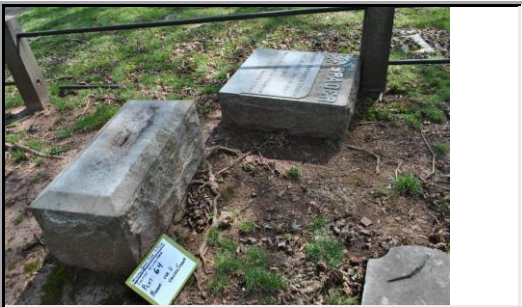
I. BURIAL INFORMATION					II. PRIORITIZATION	
First name	Last name	Birth	Death	Survey date	Condition	Prioritization
	Spader		1902	4/7/2010	Fair	Moderate term
III. LOCATION						
Cemetery Section	Plot/Marker Number	Original Location	Original Marker/Feature			
Willow Grove	064.D	Unknown	No			
IV. MARKER INFORMATION						
Marker Type						
Headstone w/ base		Height: 36	Width: 32	Depth: 12		
<input type="checkbox"/> Marble	<input checked="" type="checkbox"/> Granite	<input type="checkbox"/> Sandstone	<input type="checkbox"/> Slate			
<input type="checkbox"/> Brick	<input type="checkbox"/> Iron	<input type="checkbox"/> Other: _____

V. MATERIAL CONDITIONS						
<input checked="" type="checkbox"/> Biological - Algae	<input type="checkbox"/> Biological - Lichens	<input type="checkbox"/> Crack	<input type="checkbox"/> Delamination/Exfoliation			
<input type="checkbox"/> Disaggregation/Erosion	<input type="checkbox"/> Graffiti	<input type="checkbox"/> Off base (missing)	<input checked="" type="checkbox"/> Off base (adjacent)			
<input type="checkbox"/> Missing Fragment (s)	<input type="checkbox"/> Previous Repair	<input type="checkbox"/> Soiling	<input type="checkbox"/> Sunken			
<input type="checkbox"/> Tilt	<input type="checkbox"/> Corrosion					
<input type="checkbox"/> Other:	_____					
VI. TREATMENT RECOMMENDATIONS						
<input type="checkbox"/> Archaeology	<input type="checkbox"/> Excavate	<input checked="" type="checkbox"/> Reset on exist base	<input type="checkbox"/> Reset on salvaged base (if poss)			
<input checked="" type="checkbox"/> Clean/bio removal	<input type="checkbox"/> Consolidate	<input type="checkbox"/> Composite repair	<input type="checkbox"/> Pin/adhesive repair

<input checked="" type="checkbox"/> Other:	Center marker on base. Point as required.					
VI. PHOTOGRAPHS						
Photo 1:			Photo 2:
