HISTORIC PRESERVATION PLAN

WILLOW GROVE CEMETERY

New Brunswick, Middlesex County, New Jersey

DATE: 4 October 2010

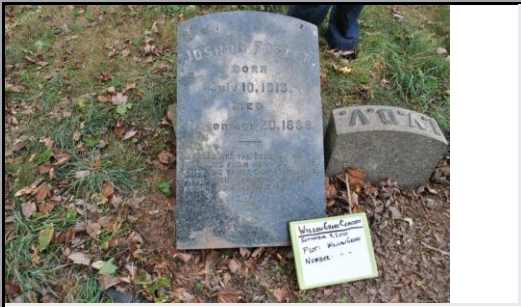
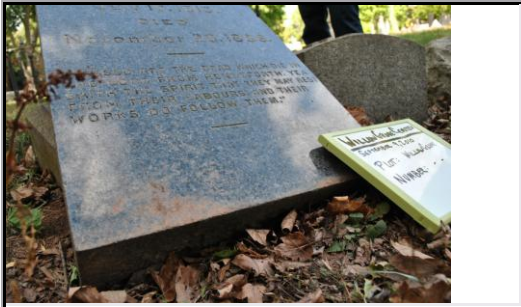
I. BURIAL INFORMATION					II. PRIORITIZATION	
First name	Last name	Birth	Death	Survey date	Condition	Prioritization
Joshua	Foster	1813	1888	9/9/2010	Fair	Moderate term
III. LOCATION						
Cemetery Section	Plot/Marker Number	Original Location	Original Marker/Feature			
Willow Grove	133.07	Unknown	No			
IV. MARKER INFORMATION						
Marker Type						
Headstone w/ base		Height: 38	Width: 20	Depth: 7		
<input type="checkbox"/> Marble	<input checked="" type="checkbox"/> Granite	<input type="checkbox"/> Sandstone	<input type="checkbox"/> Slate			
<input type="checkbox"/> Brick	<input type="checkbox"/> Iron	<input type="checkbox"/> Other: _____

V. MATERIAL CONDITIONS						
<input checked="" type="checkbox"/> Biological - Algae	<input type="checkbox"/> Biological - Lichens	<input type="checkbox"/> Crack	<input type="checkbox"/> Delamination/Exfoliation			
<input type="checkbox"/> Disaggregation/Erosion	<input type="checkbox"/> Graffiti	<input type="checkbox"/> Off base (missing)	<input checked="" type="checkbox"/> Off base (adjacent)			
<input type="checkbox"/> Missing Fragment (s)	<input type="checkbox"/> Previous Repair	<input checked="" type="checkbox"/> Soiling	<input type="checkbox"/> Sunken			
<input checked="" type="checkbox"/> Tilt	<input type="checkbox"/> Corrosion					
<input type="checkbox"/> Other:	_____					
VI. TREATMENT RECOMMENDATIONS						
<input type="checkbox"/> Archaeology	<input checked="" type="checkbox"/> Excavate	<input checked="" type="checkbox"/> Reset on exist base	<input type="checkbox"/> Reset on salvaged base (if poss)

<input checked="" type="checkbox"/> Clean/bio removal	<input type="checkbox"/> Consolidate	<input type="checkbox"/> Composite repair	<input type="checkbox"/> Pin/adhesive repair			
<input checked="" type="checkbox"/> Other:	Locate proper burial location. Re-set existing base on pea gravel/mortar pad. Reinstall headstone on mortar bed between base and headstone.					
VI. PHOTOGRAPHS						
Photo 1:			Photo 2:

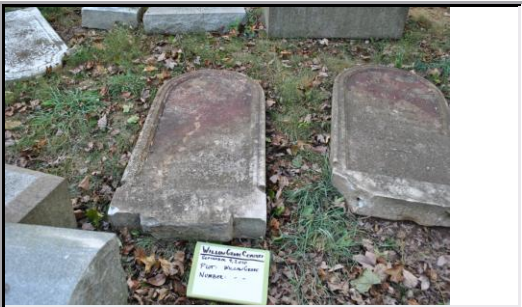
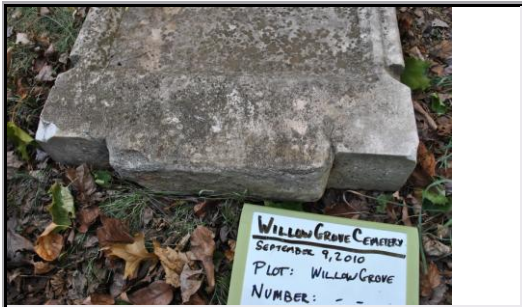
I. BURIAL INFORMATION					II. PRIORITIZATION	
First name	Last name	Birth	Death	Survey date	Condition	Prioritization
John	Foster	0		9/9/2010	Fair	Moderate term
III. LOCATION						
Cemetery Section	Plot/Marker Number	Original Location	Original Marker/Feature			
Willow Grove	133.14	Yes	Yes			
IV. MARKER INFORMATION						
Marker Type						
Headstone w/ base		Height: 48	Width: 24	Depth: 5		
<input checked="" type="checkbox"/> Marble	<input type="checkbox"/> Granite	<input type="checkbox"/> Sandstone	<input type="checkbox"/> Slate			
<input type="checkbox"/> Brick	<input type="checkbox"/> Iron	<input type="checkbox"/> Other: _____

V. MATERIAL CONDITIONS						
<input checked="" type="checkbox"/> Biological - Algae	<input checked="" type="checkbox"/> Biological - Lichens	<input type="checkbox"/> Crack	<input type="checkbox"/> Delamination/Exfoliation			
<input checked="" type="checkbox"/> Disaggregation/Erosion	<input type="checkbox"/> Graffiti	<input checked="" type="checkbox"/> Off base (missing)	<input type="checkbox"/> Off base (adjacent)			
<input checked="" type="checkbox"/> Missing Fragment (s)	<input type="checkbox"/> Previous Repair	<input checked="" type="checkbox"/> Soiling	<input type="checkbox"/> Sunken			
<input type="checkbox"/> Tilt	<input type="checkbox"/> Corrosion					
<input type="checkbox"/> Other:	_____					
VI. TREATMENT RECOMMENDATIONS						
<input checked="" type="checkbox"/> Archaeology	<input type="checkbox"/> Excavate	<input type="checkbox"/> Reset on exist base	<input checked="" type="checkbox"/> Reset on salvaged base (if poss)

<input checked="" type="checkbox"/> Clean/bio removal	<input type="checkbox"/> Consolidate	<input checked="" type="checkbox"/> Composite repair	<input type="checkbox"/> Pin/adhesive repair			
<input checked="" type="checkbox"/> Other:	Locate proper burial location. Identify appropriate base with tongue cavity. Re-set base on pea gravel/mortar pad. Reinstall headstone with tongue in mortared cavity. .					
VI. PHOTOGRAPHS						
Photo 1:			Photo 2:

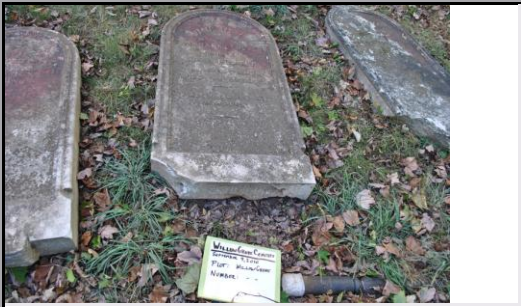
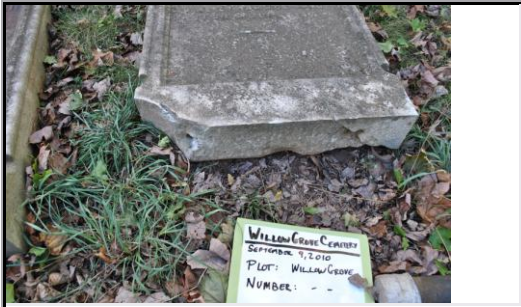
I. BURIAL INFORMATION					II. PRIORITIZATION	
First name	Last name	Birth	Death	Survey date	Condition	Prioritization
Margaret	Foster	1805	1871	9/9/2010	Fair	Moderate term
III. LOCATION						
Cemetery Section	Plot/Marker Number	Original Location	Original Marker/Feature			
Willow Grove	133.13	Yes	Yes			
IV. MARKER INFORMATION						
Marker Type						
Headstone w/ base		Height: 48	Width: 24	Depth: 5		
<input checked="" type="checkbox"/> Marble	<input type="checkbox"/> Granite	<input type="checkbox"/> Sandstone	<input type="checkbox"/> Slate			
<input type="checkbox"/> Brick	<input type="checkbox"/> Iron	<input type="checkbox"/> Other: _____

V. MATERIAL CONDITIONS						
<input checked="" type="checkbox"/> Biological - Algae	<input checked="" type="checkbox"/> Biological - Lichens	<input type="checkbox"/> Crack	<input type="checkbox"/> Delamination/Exfoliation			
<input checked="" type="checkbox"/> Disaggregation/Erosion	<input type="checkbox"/> Graffiti	<input checked="" type="checkbox"/> Off base (missing)	<input type="checkbox"/> Off base (adjacent)			
<input checked="" type="checkbox"/> Missing Fragment (s)	<input type="checkbox"/> Previous Repair	<input checked="" type="checkbox"/> Soiling	<input type="checkbox"/> Sunken			
<input type="checkbox"/> Tilt	<input type="checkbox"/> Corrosion					
<input type="checkbox"/> Other:	_____					
VI. TREATMENT RECOMMENDATIONS						
<input checked="" type="checkbox"/> Archaeology	<input type="checkbox"/> Excavate	<input type="checkbox"/> Reset on exist base	<input checked="" type="checkbox"/> Reset on salvaged base (if poss)

VII. ADDITIONAL INFORMATION						
Pin cavities

<input checked="" type="checkbox"/> Clean/bio removal	<input type="checkbox"/> Consolidate	<input checked="" type="checkbox"/> Composite repair	<input type="checkbox"/> Pin/adhesive repair			
<input checked="" type="checkbox"/> Other:	Locate proper burial location. Identify appropriate base with flat surface (no cavity). Re-set base on pea gravel/mortar pad. Reinstall headstone with pins to attach headstone to base.					
VI. PHOTOGRAPHS						
Photo 1:			Photo 2:

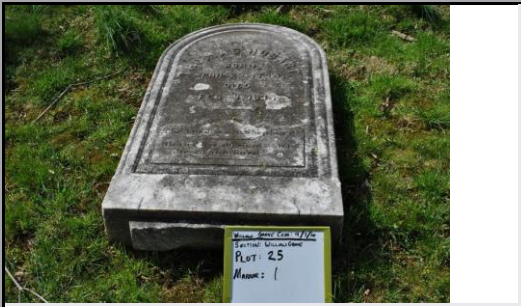
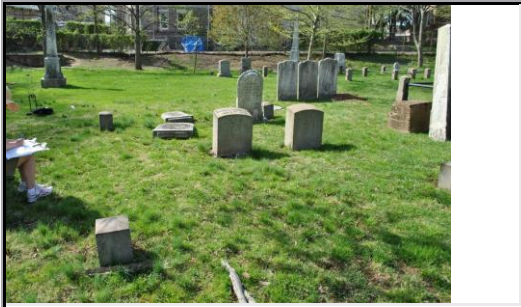
I. BURIAL INFORMATION					II. PRIORITIZATION	
First name	Last name	Birth	Death	Survey date	Condition	Prioritization
Thomas	Hobart	1794	1874	4/7/2010	Fair	Moderate term
III. LOCATION						
Cemetery Section	Plot/Marker Number	Original Location	Original Marker/Feature			
Willow Grove	025.01	Yes	Yes			
IV. MARKER INFORMATION						
Marker Type						
Headstone w/ base		Height: 48	Width: 26	Depth: 5		
<input checked="" type="checkbox"/> Marble	<input type="checkbox"/> Granite	<input type="checkbox"/> Sandstone	<input type="checkbox"/> Slate			
<input type="checkbox"/> Brick	<input type="checkbox"/> Iron	<input type="checkbox"/> Other: _____

V. MATERIAL CONDITIONS						
<input checked="" type="checkbox"/> Biological - Algae	<input checked="" type="checkbox"/> Biological - Lichens	<input type="checkbox"/> Crack	<input type="checkbox"/> Delamination/Exfoliation			
<input type="checkbox"/> Disaggregation/Erosion	<input type="checkbox"/> Graffiti	<input checked="" type="checkbox"/> Off base (missing)	<input type="checkbox"/> Off base (adjacent)			
<input checked="" type="checkbox"/> Missing Fragment (s)	<input type="checkbox"/> Previous Repair	<input checked="" type="checkbox"/> Soiling	<input type="checkbox"/> Sunken			
<input type="checkbox"/> Tilt	<input type="checkbox"/> Corrosion					
<input checked="" type="checkbox"/> Other:	Tongue at base of marker - original attachment to base - may have been broken or insufficient.					
VI. TREATMENT RECOMMENDATIONS						
<input checked="" type="checkbox"/> Archaeology	<input type="checkbox"/> Excavate	<input type="checkbox"/> Reset on exist base	<input checked="" type="checkbox"/> Reset on salvaged base (if poss)

<input checked="" type="checkbox"/> Clean/bio removal	<input type="checkbox"/> Consolidate	<input type="checkbox"/> Composite repair	<input type="checkbox"/> Pin/adhesive repair			
<input checked="" type="checkbox"/> Other:	Locate proper burial location. Identify appropriate base with tongue cavity. Re-set base on pea gravel/mortar pad. Reinstall headstone with tongue in mortared cavity.					
VI. PHOTOGRAPHS						
Photo 1:			Photo 2:

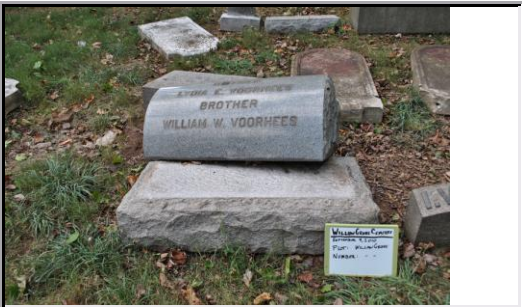
I. BURIAL INFORMATION					II. PRIORITIZATION	
First name	Last name	Birth	Death	Survey date	Condition	Prioritization
William W.	Voorhees	0		9/9/2010	Fair	Moderate term
III. LOCATION						
Cemetery Section	Plot/Marker Number	Original Location	Original Marker/Feature			
Willow Grove	132.02	Unknown	No			
IV. MARKER INFORMATION						
Marker Type						
Headstone w/ base		Height: 24	Width: 44	Depth: 20		
<input type="checkbox"/> Marble	<input checked="" type="checkbox"/> Granite	<input type="checkbox"/> Sandstone	<input type="checkbox"/> Slate			
<input type="checkbox"/> Brick	<input type="checkbox"/> Iron	<input type="checkbox"/> Other: _____

V. MATERIAL CONDITIONS						
<input checked="" type="checkbox"/> Biological - Algae	<input type="checkbox"/> Biological - Lichens	<input type="checkbox"/> Crack	<input type="checkbox"/> Delamination/Exfoliation			
<input type="checkbox"/> Disaggregation/Erosion	<input type="checkbox"/> Graffiti	<input type="checkbox"/> Off base (missing)	<input checked="" type="checkbox"/> Off base (adjacent)			
<input type="checkbox"/> Missing Fragment (s)	<input type="checkbox"/> Previous Repair	<input checked="" type="checkbox"/> Soiling	<input type="checkbox"/> Sunken			
<input checked="" type="checkbox"/> Tilt	<input type="checkbox"/> Corrosion					
<input type="checkbox"/> Other:	_____					
VI. TREATMENT RECOMMENDATIONS						
<input type="checkbox"/> Archaeology	<input checked="" type="checkbox"/> Excavate	<input checked="" type="checkbox"/> Reset on exist base	<input type="checkbox"/> Reset on salvaged base (if poss)

<input checked="" type="checkbox"/> Clean/bio removal	<input type="checkbox"/> Consolidate	<input type="checkbox"/> Composite repair	<input type="checkbox"/> Pin/adhesive repair			
<input checked="" type="checkbox"/> Other:	Needs new foundation. Install new mortar pad and set base. Set new anchors into headstone and base. Point as required.					
VI. PHOTOGRAPHS						
Photo 1:			Photo 2:

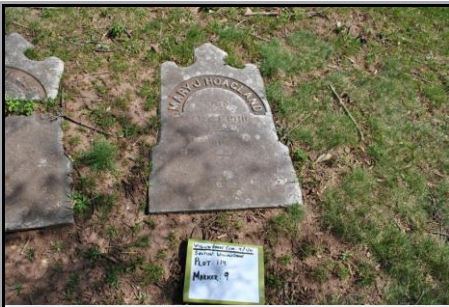
VI. PHOTOGRAPHS	
Photo 1:

I. BURIAL INFORMATION					II. PRIORITIZATION	
First name	Last name	Birth	Death	Survey date	Condition	Prioritization
Mary Jane	Hoagland	1836	1910	4/7/2010	Fair	Moderate term

V. MATERIAL CONDITIONS			
<input checked="" type="checkbox"/> Biological - Algae	<input type="checkbox"/> Biological - Lichens	<input type="checkbox"/> Crack	<input type="checkbox"/> Delamination/Exfoliation
<input checked="" type="checkbox"/> Disaggregation/Erosion	<input type="checkbox"/> Graffiti	<input checked="" type="checkbox"/> Off base (missing)	<input type="checkbox"/> Off base (adjacent)
<input type="checkbox"/> Missing Fragment (s)	<input type="checkbox"/> Previous Repair	<input checked="" type="checkbox"/> Soiling	<input type="checkbox"/> Sunken
<input type="checkbox"/> Tilt	<input type="checkbox"/> Corrosion		
<input checked="" type="checkbox"/> Other:	No tongue or anchors. Bottom of headstone may have been set into cavity at base.

VI. TREATMENT RECOMMENDATIONS			
<input checked="" type="checkbox"/> Archaeology	<input type="checkbox"/> Excavate	<input type="checkbox"/> Reset on exist base	<input checked="" type="checkbox"/> Reset on salvaged base (if poss)
<input checked="" type="checkbox"/> Clean/bio removal	<input type="checkbox"/> Consolidate	<input type="checkbox"/> Composite repair	<input type="checkbox"/> Pin/adhesive repair
<input checked="" type="checkbox"/> Other:	Locate proper burial location. Identify appropriate base with flat surface (no cavity). Re-set base on pea gravel/mortar pad. Reinstall headstone with pins to attach headstone to base.

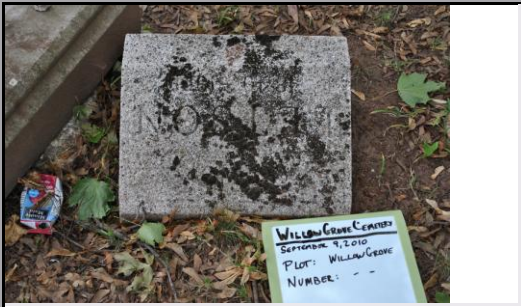
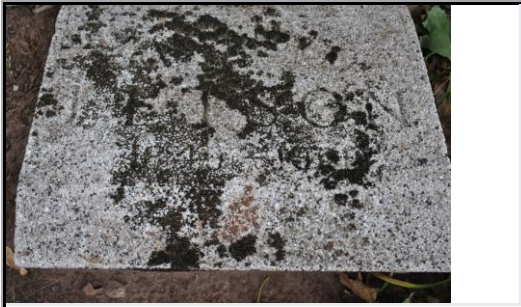
I. BURIAL INFORMATION					II. PRIORITIZATION	
First name	Last name	Birth	Death	Survey date	Condition	Prioritization
	Letson			9/9/2010	Fair	Moderate term
III. LOCATION						
Cemetery Section	Plot/Marker Number	Original Location	Original Marker/Feature			
Willow Grove	067.08	Unknown	No			
IV. MARKER INFORMATION						
Marker Type						
Headstone	Height: 14	Width: 18	Depth: 8			
<input type="checkbox"/> Marble	<input type="checkbox"/> Granite	<input type="checkbox"/> Sandstone	<input type="checkbox"/> Slate			
<input type="checkbox"/> Brick	<input type="checkbox"/> Iron	<input checked="" type="checkbox"/> Other: Cast stone

V. MATERIAL CONDITIONS						
<input checked="" type="checkbox"/> Biological - Algae	<input checked="" type="checkbox"/> Biological - Lichens	<input type="checkbox"/> Crack	<input type="checkbox"/> Delamination/Exfoliation			
<input type="checkbox"/> Disaggregation/Erosion	<input type="checkbox"/> Graffiti	<input type="checkbox"/> Off base (missing)	<input type="checkbox"/> Off base (adjacent)			
<input type="checkbox"/> Missing Fragment (s)	<input type="checkbox"/> Previous Repair	<input checked="" type="checkbox"/> Soiling	<input type="checkbox"/> Sunken			
<input type="checkbox"/> Tilt	<input type="checkbox"/> Corrosion					
<input type="checkbox"/> Other:						
VI. TREATMENT RECOMMENDATIONS						
<input checked="" type="checkbox"/> Archaeology	<input type="checkbox"/> Excavate	<input type="checkbox"/> Reset on exist base	<input type="checkbox"/> Reset on salvaged base (if poss)			
<input checked="" type="checkbox"/> Clean/bio removal	<input type="checkbox"/> Consolidate	<input type="checkbox"/> Composite repair	<input type="checkbox"/> Pin/adhesive repair

<input checked="" type="checkbox"/> Other:	Locate proper burial location. Identify appropriate base and re-set on pea gravel/mortar pad. Reinstall headstone on mortar bed between base and headstone.					
VI. PHOTOGRAPHS						
Photo 1:			Photo 2:

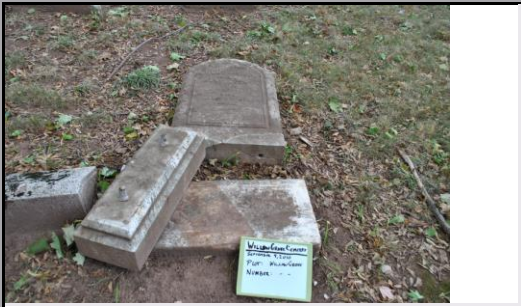
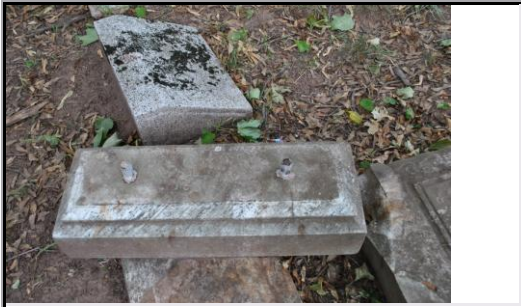
I. BURIAL INFORMATION					II. PRIORITIZATION	
First name	Last name	Birth	Death	Survey date	Condition	Prioritization
Phebe A.	Quick (Moore)	1817	1869	9/9/2010	Fair	Moderate term
III. LOCATION						
Cemetery Section	Plot/Marker Number	Original Location	Original Marker/Feature			
Willow Grove	066.01	Yes	Yes			
IV. MARKER INFORMATION						
Marker Type						
Headstone w/ base		Height: 48	Width: 32	Depth: 14		
<input checked="" type="checkbox"/> Marble	<input type="checkbox"/> Granite	<input type="checkbox"/> Sandstone	<input type="checkbox"/> Slate			
<input type="checkbox"/> Brick	<input type="checkbox"/> Iron	<input type="checkbox"/> Other: _____

V. MATERIAL CONDITIONS						
<input checked="" type="checkbox"/> Biological - Algae	<input checked="" type="checkbox"/> Biological - Lichens	<input checked="" type="checkbox"/> Crack	<input type="checkbox"/> Delamination/Exfoliation			
<input checked="" type="checkbox"/> Disaggregation/Erosion	<input type="checkbox"/> Graffiti	<input type="checkbox"/> Off base (missing)	<input checked="" type="checkbox"/> Off base (adjacent)			
<input checked="" type="checkbox"/> Missing Fragment (s)	<input checked="" type="checkbox"/> Previous Repair	<input checked="" type="checkbox"/> Soiling	<input type="checkbox"/> Sunken			
<input type="checkbox"/> Tilt	<input type="checkbox"/> Corrosion					
<input type="checkbox"/> Other:	_____					
VI. TREATMENT RECOMMENDATIONS						
<input checked="" type="checkbox"/> Archaeology	<input checked="" type="checkbox"/> Excavate	<input checked="" type="checkbox"/> Reset on exist base	<input type="checkbox"/> Reset on salvaged base (if poss)

<input checked="" type="checkbox"/> Clean/bio removal	<input type="checkbox"/> Consolidate	<input checked="" type="checkbox"/> Composite repair	<input type="checkbox"/> Pin/adhesive repair			
<input checked="" type="checkbox"/> Other:	Level base as required, installing on pea gravel and mortar pad if required. Reinstall headstone with pins to attach headstone to base.					
VI. PHOTOGRAPHS						
Photo 1:			Photo 2:

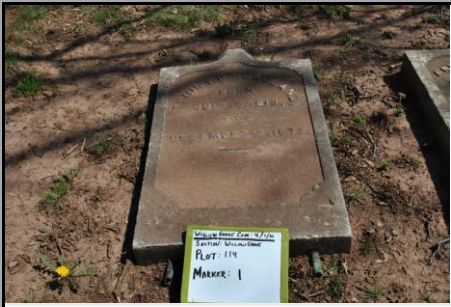
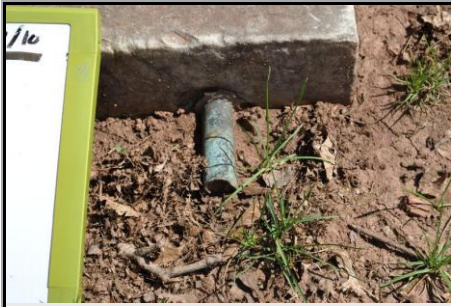
VI. PHOTOGRAPHS	
Photo 1:	Photo 2:

I. BURIAL INFORMATION					II. PRIORITIZATION	
First name	Last name	Birth	Death	Survey date	Condition	Prioritization
Tunis	Hoagland	1813	1872	4/7/2010	Fair	Moderate term

V. MATERIAL CONDITIONS			
<input checked="" type="checkbox"/> Biological - Algae	<input type="checkbox"/> Biological - Lichens	<input type="checkbox"/> Crack	<input type="checkbox"/> Delamination/Exfoliation
<input type="checkbox"/> Disaggregation/Erosion	<input type="checkbox"/> Graffiti	<input checked="" type="checkbox"/> Off base (missing)	<input type="checkbox"/> Off base (adjacent)
<input type="checkbox"/> Missing Fragment (s)	<input type="checkbox"/> Previous Repair	<input checked="" type="checkbox"/> Soiling	<input type="checkbox"/> Sunken
<input type="checkbox"/> Tilt	<input type="checkbox"/> Corrosion		
<input checked="" type="checkbox"/> Other:	Anchors remain embedded at bottom of main headstone.

VI. TREATMENT RECOMMENDATIONS			
<input type="checkbox"/> Archaeology	<input type="checkbox"/> Excavate	<input type="checkbox"/> Reset on exist base	<input checked="" type="checkbox"/> Reset on salvaged base (if poss)
<input checked="" type="checkbox"/> Clean/bio removal	<input type="checkbox"/> Consolidate	<input type="checkbox"/> Composite repair	<input type="checkbox"/> Pin/adhesive repair
<input checked="" type="checkbox"/> Other:	Locate proper burial location. Identify appropriate base with flat surface (no cavity). Re-set base on pea gravel/mortar pad. Reinstall headstone with pins to attach headstone to base.

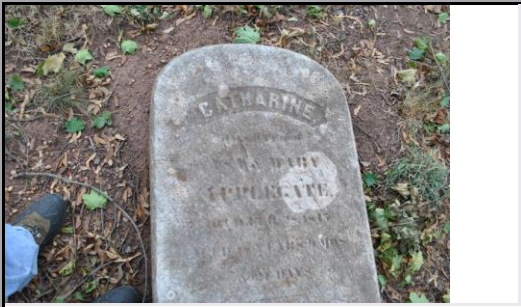
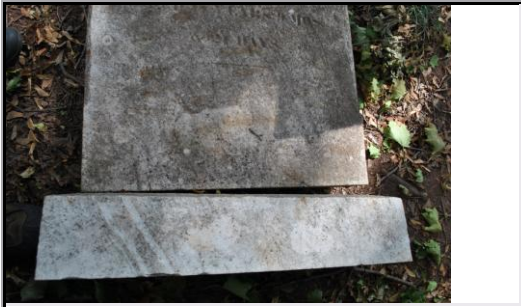
I. BURIAL INFORMATION					II. PRIORITIZATION	
First name	Last name	Birth	Death	Survey date	Condition	Prioritization
Catharine	Applegate	0	1845	9/9/2010	Fair	Moderate term
III. LOCATION						
Cemetery Section	Plot/Marker Number	Original Location	Original Marker/Feature			
Willow Grove	074.03	Yes	Yes			
IV. MARKER INFORMATION						
Marker Type						
Headstone w/ base		Height: 54	Width: 32	Depth: 17		
<input checked="" type="checkbox"/> Marble	<input type="checkbox"/> Granite	<input type="checkbox"/> Sandstone	<input type="checkbox"/> Slate			
<input type="checkbox"/> Brick	<input type="checkbox"/> Iron	<input type="checkbox"/> Other: _____

V. MATERIAL CONDITIONS						
<input checked="" type="checkbox"/> Biological - Algae	<input checked="" type="checkbox"/> Biological - Lichens	<input type="checkbox"/> Crack	<input type="checkbox"/> Delamination/Exfoliation			
<input checked="" type="checkbox"/> Disaggregation/Erosion	<input type="checkbox"/> Graffiti	<input type="checkbox"/> Off base (missing)	<input checked="" type="checkbox"/> Off base (adjacent)			
<input type="checkbox"/> Missing Fragment (s)	<input type="checkbox"/> Previous Repair	<input checked="" type="checkbox"/> Soiling	<input type="checkbox"/> Sunken			
<input type="checkbox"/> Tilt	<input type="checkbox"/> Corrosion					
<input type="checkbox"/> Other:	_____					
VI. TREATMENT RECOMMENDATIONS						
<input type="checkbox"/> Archaeology	<input type="checkbox"/> Excavate	<input checked="" type="checkbox"/> Reset on exist base	<input type="checkbox"/> Reset on salvaged base (if poss)

<input checked="" type="checkbox"/> Clean/bio removal	<input type="checkbox"/> Consolidate	<input type="checkbox"/> Composite repair	<input type="checkbox"/> Pin/adhesive repair			
<input checked="" type="checkbox"/> Other:	Locate proper burial location. Re-set existing base on pea gravel/mortar pad if necessary. Reinstall headstone with pins to attach headstone to base.					
VI. PHOTOGRAPHS						
Photo 1:			Photo 2:

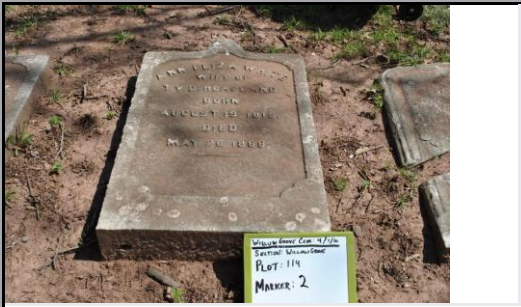
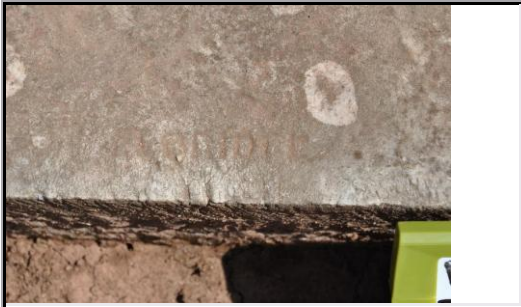
I. BURIAL INFORMATION					II. PRIORITIZATION	
First name	Last name	Birth	Death	Survey date	Condition	Prioritization
Ann Eliza	Hoagland	1815	1868	4/7/2010	Fair	Moderate term

V. MATERIAL CONDITIONS			
<input checked="" type="checkbox"/> Biological - Algae	<input type="checkbox"/> Biological - Lichens	<input type="checkbox"/> Crack	<input type="checkbox"/> Delamination/Exfoliation
<input type="checkbox"/> Disaggregation/Erosion	<input type="checkbox"/> Graffiti	<input checked="" type="checkbox"/> Off base (missing)	<input type="checkbox"/> Off base (adjacent)
<input type="checkbox"/> Missing Fragment (s)	<input type="checkbox"/> Previous Repair	<input checked="" type="checkbox"/> Soiling	<input type="checkbox"/> Sunken
<input type="checkbox"/> Tilt	<input type="checkbox"/> Corrosion		
<input checked="" type="checkbox"/> Other:	Unclear whether anchors were ever present. Possible that headstone was set into cavity without.

VII. ADDITIONAL INFORMATION
Original carver's mark at base of headstone.

VI. TREATMENT RECOMMENDATIONS			
<input type="checkbox"/> Archaeology	<input type="checkbox"/> Excavate	<input type="checkbox"/> Reset on exist base	<input checked="" type="checkbox"/> Reset on salvaged base (if poss)
<input checked="" type="checkbox"/> Clean/bio removal	<input type="checkbox"/> Consolidate	<input type="checkbox"/> Composite repair	<input type="checkbox"/> Pin/adhesive repair
<input checked="" type="checkbox"/> Other:	Locate proper burial location. Identify appropriate base with flat surface (no cavity). Re-set base on pea gravel/mortar pad. Reinstall headstone with pins to attach headstone to base.

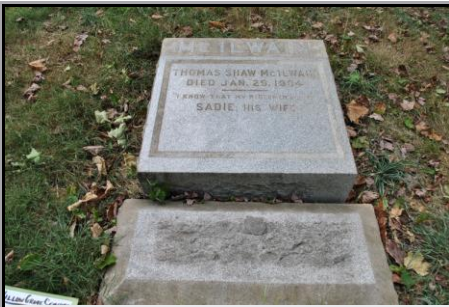
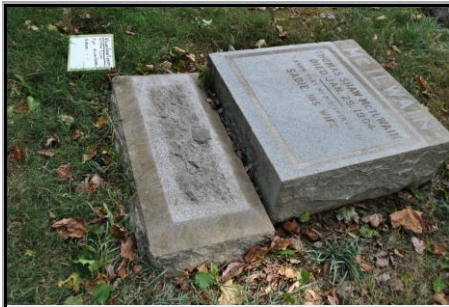
I. BURIAL INFORMATION					II. PRIORITIZATION	
First name	Last name	Birth	Death	Survey date	Condition	Prioritization
Thomas Shaw	McIlwain	0	1904	9/9/2010	Fair	Moderate term
III. LOCATION						
Cemetery Section	Plot/Marker Number	Original Location	Original Marker/Feature			
Willow Grove	132.00	Unknown	No			
IV. MARKER INFORMATION						
Marker Type						
Headstone w/ base		Height: 38	Width: 30	Depth: 12		
<input type="checkbox"/> Marble	<input checked="" type="checkbox"/> Granite	<input type="checkbox"/> Sandstone	<input type="checkbox"/> Slate			
<input type="checkbox"/> Brick	<input type="checkbox"/> Iron	<input type="checkbox"/> Other: _____

V. MATERIAL CONDITIONS						
<input checked="" type="checkbox"/> Biological - Algae	<input type="checkbox"/> Biological - Lichens	<input type="checkbox"/> Crack	<input type="checkbox"/> Delamination/Exfoliation			
<input type="checkbox"/> Disaggregation/Erosion	<input type="checkbox"/> Graffiti	<input type="checkbox"/> Off base (missing)	<input checked="" type="checkbox"/> Off base (adjacent)			
<input type="checkbox"/> Missing Fragment (s)	<input type="checkbox"/> Previous Repair	<input checked="" type="checkbox"/> Soiling	<input type="checkbox"/> Sunken			
<input type="checkbox"/> Tilt	<input type="checkbox"/> Corrosion					
<input type="checkbox"/> Other:	_____					
VI. TREATMENT RECOMMENDATIONS						
<input type="checkbox"/> Archaeology	<input type="checkbox"/> Excavate	<input checked="" type="checkbox"/> Reset on exist base	<input type="checkbox"/> Reset on salvaged base (if poss)			
<input checked="" type="checkbox"/> Clean/bio removal	<input type="checkbox"/> Consolidate	<input type="checkbox"/> Composite repair	<input type="checkbox"/> Pin/adhesive repair

<input checked="" type="checkbox"/> Other:	Install new mortar pad and set base. Point as required.					
VI. PHOTOGRAPHS						
Photo 1:			Photo 2:

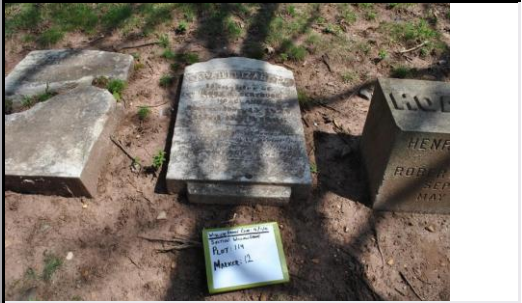
VI. PHOTOGRAPHS	
Photo 1:

I. BURIAL INFORMATION					II. PRIORITIZATION	
First name	Last name	Birth	Death	Survey date	Condition	Prioritization
Sarah Elizabeth	Hoagland	1828	1866	4/7/2010	Fair	Moderate term

V. MATERIAL CONDITIONS			
<input checked="" type="checkbox"/> Biological - Algae	<input type="checkbox"/> Biological - Lichens	<input type="checkbox"/> Crack	<input type="checkbox"/> Delamination/Exfoliation
<input checked="" type="checkbox"/> Disaggregation/Erosion	<input type="checkbox"/> Graffiti	<input checked="" type="checkbox"/> Off base (missing)	<input type="checkbox"/> Off base (adjacent)
<input type="checkbox"/> Missing Fragment (s)	<input type="checkbox"/> Previous Repair	<input checked="" type="checkbox"/> Soiling	<input type="checkbox"/> Sunken
<input type="checkbox"/> Tilt	<input type="checkbox"/> Corrosion		
<input checked="" type="checkbox"/> Other:	Tongue at base of marker - original attachment to base.

VI. TREATMENT RECOMMENDATIONS			
<input checked="" type="checkbox"/> Archaeology	<input type="checkbox"/> Excavate	<input type="checkbox"/> Reset on exist base	<input checked="" type="checkbox"/> Reset on salvaged base (if poss)
<input checked="" type="checkbox"/> Clean/bio removal	<input type="checkbox"/> Consolidate	<input type="checkbox"/> Composite repair	<input type="checkbox"/> Pin/adhesive repair
<input checked="" type="checkbox"/> Other:	Locate proper burial location. Identify appropriate base with tongue cavity. Re-set base on pea gravel/mortar pad. Reinstall headstone with tongue in mortared cavity.

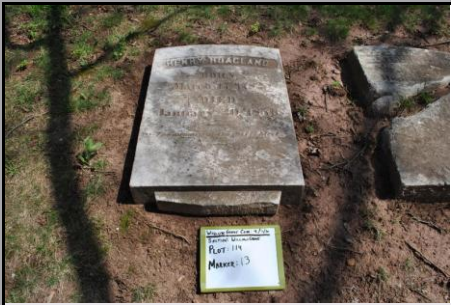
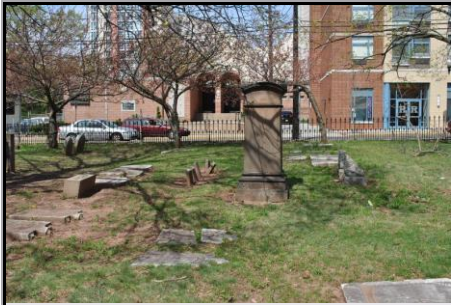
I. BURIAL INFORMATION					II. PRIORITIZATION	
First name	Last name	Birth	Death	Survey date	Condition	Prioritization
Henry	Hoagland	1782	1858	4/7/2010	Fair	Moderate term
III. LOCATION						
Cemetery Section	Plot/Marker Number	Original Location	Original Marker/Feature			
Willow Grove	114.13	Yes	Yes			
IV. MARKER INFORMATION						
Marker Type						
Headstone w/ base		Height: 34	Width: 22	Depth: 4		
<input checked="" type="checkbox"/> Marble	<input type="checkbox"/> Granite	<input type="checkbox"/> Sandstone	<input type="checkbox"/> Slate			
<input type="checkbox"/> Brick	<input type="checkbox"/> Iron	<input type="checkbox"/> Other: _____

V. MATERIAL CONDITIONS						
<input checked="" type="checkbox"/> Biological - Algae	<input type="checkbox"/> Biological - Lichens	<input type="checkbox"/> Crack	<input type="checkbox"/> Delamination/Exfoliation			
<input checked="" type="checkbox"/> Disaggregation/Erosion	<input type="checkbox"/> Graffiti	<input checked="" type="checkbox"/> Off base (missing)	<input type="checkbox"/> Off base (adjacent)			
<input type="checkbox"/> Missing Fragment (s)	<input type="checkbox"/> Previous Repair	<input checked="" type="checkbox"/> Soiling	<input type="checkbox"/> Sunken			
<input type="checkbox"/> Tilt	<input type="checkbox"/> Corrosion					
<input checked="" type="checkbox"/> Other:	Tongue at base of marker - original attachment to base.					
VI. TREATMENT RECOMMENDATIONS						
<input checked="" type="checkbox"/> Archaeology	<input type="checkbox"/> Excavate	<input type="checkbox"/> Reset on exist base	<input type="checkbox"/> Reset on salvaged base (if poss)

<input checked="" type="checkbox"/> Clean/bio removal	<input type="checkbox"/> Consolidate	<input type="checkbox"/> Composite repair	<input type="checkbox"/> Pin/adhesive repair			
<input checked="" type="checkbox"/> Other:	Locate proper burial location. Identify appropriate base with tongue cavity. Re-set base on pea gravel/mortar pad. Reinstall headstone with tongue in mortared cavity.					
VII. PHOTOGRAPHS						
Photo 1:			Photo 2:

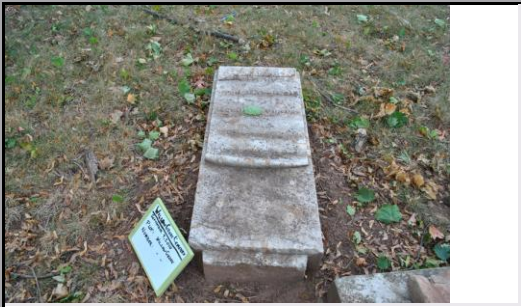
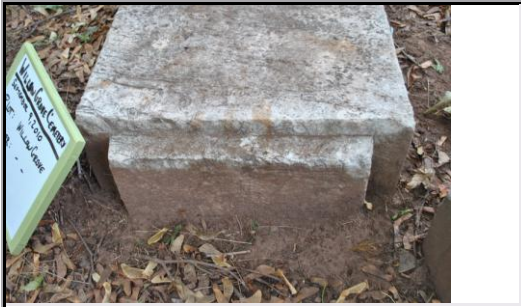
I. BURIAL INFORMATION					II. PRIORITIZATION	
First name	Last name	Birth	Death	Survey date	Condition	Prioritization
Sarah		0		9/9/2010	Fair	Moderate term
III. LOCATION						
Cemetery Section	Plot/Marker Number	Original Location	Original Marker/Feature			
Willow Grove	067.06	Yes	Yes			
IV. MARKER INFORMATION						
Marker Type						
Headstone w/ base		Height: 50	Width: 26	Depth: 16		
<input checked="" type="checkbox"/> Marble	<input type="checkbox"/> Granite	<input type="checkbox"/> Sandstone	<input type="checkbox"/> Slate			
<input type="checkbox"/> Brick	<input type="checkbox"/> Iron	<input type="checkbox"/> Other: _____

V. MATERIAL CONDITIONS						
<input checked="" type="checkbox"/> Biological - Algae	<input checked="" type="checkbox"/> Biological - Lichens	<input type="checkbox"/> Crack	<input type="checkbox"/> Delamination/Exfoliation			
<input checked="" type="checkbox"/> Disaggregation/Erosion	<input type="checkbox"/> Graffiti	<input type="checkbox"/> Off base (missing)	<input checked="" type="checkbox"/> Off base (adjacent)			
<input type="checkbox"/> Missing Fragment (s)	<input type="checkbox"/> Previous Repair	<input type="checkbox"/> Soiling	<input type="checkbox"/> Sunken			
<input type="checkbox"/> Tilt	<input type="checkbox"/> Corrosion					
<input checked="" type="checkbox"/> Other:	Inscription is illegible due to erosion.					
VI. TREATMENT RECOMMENDATIONS						
<input checked="" type="checkbox"/> Archaeology	<input type="checkbox"/> Excavate	<input checked="" type="checkbox"/> Reset on exist base	<input type="checkbox"/> Reset on salvaged base (if poss)

<input checked="" type="checkbox"/> Clean/bio removal	<input type="checkbox"/> Consolidate	<input type="checkbox"/> Composite repair	<input type="checkbox"/> Pin/adhesive repair			
<input checked="" type="checkbox"/> Other:	Locate proper burial location. Identify appropriate base with tongue cavity. Re-set base on pea gravel/mortar pad. Reinstall headstone with tongue in mortared cavity.					
VI. PHOTOGRAPHS						
Photo 1:			Photo 2:

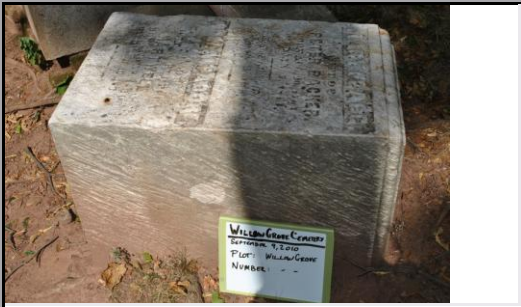
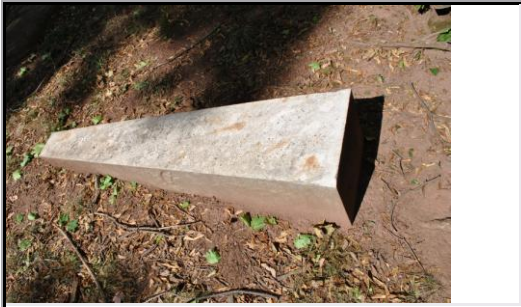
I. BURIAL INFORMATION					II. PRIORITIZATION	
First name	Last name	Birth	Death	Survey date	Condition	Prioritization
Mary	Flagg (Packer)	1761	1843	9/9/2010	Fair	Moderate term
III. LOCATION						
Cemetery Section	Plot/Marker Number	Original Location	Original Marker/Feature			
Willow Grove	067.01	Yes	Yes			
IV. MARKER INFORMATION						
Marker Type						
Obelisk		Height: 120	Width: 32	Depth: 32		
<input checked="" type="checkbox"/> Marble	<input checked="" type="checkbox"/> Granite	<input type="checkbox"/> Sandstone	<input type="checkbox"/> Slate			
<input checked="" type="checkbox"/> Brick	<input type="checkbox"/> Iron	<input type="checkbox"/> Other: _____

V. MATERIAL CONDITIONS						
<input checked="" type="checkbox"/> Biological - Algae	<input checked="" type="checkbox"/> Biological - Lichens	<input type="checkbox"/> Crack	<input type="checkbox"/> Delamination/Exfoliation			
<input checked="" type="checkbox"/> Disaggregation/Erosion	<input type="checkbox"/> Graffiti	<input type="checkbox"/> Off base (missing)	<input checked="" type="checkbox"/> Off base (adjacent)			
<input type="checkbox"/> Missing Fragment (s)	<input type="checkbox"/> Previous Repair	<input checked="" type="checkbox"/> Soiling	<input type="checkbox"/> Sunken			
<input type="checkbox"/> Tilt	<input type="checkbox"/> Corrosion					
<input checked="" type="checkbox"/> Other:	Open brick base.					
VI. TREATMENT RECOMMENDATIONS						
<input checked="" type="checkbox"/> Archaeology	<input checked="" type="checkbox"/> Excavate	<input checked="" type="checkbox"/> Reset on exist base	<input type="checkbox"/> Reset on salvaged base (if poss)

<input checked="" type="checkbox"/> Clean/bio removal	<input type="checkbox"/> Consolidate	<input type="checkbox"/> Composite repair	<input type="checkbox"/> Pin/adhesive repair			
<input checked="" type="checkbox"/> Other:	Rebuild brick foundation, reinstall base and obelisk. Install new pins to anchor obelisk to base.					
VI. PHOTOGRAPHS						
Photo 1:			Photo 2:

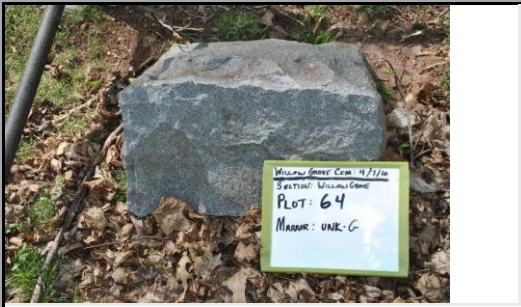
I. BURIAL INFORMATION					II. PRIORITIZATION	
First name	Last name	Birth	Death	Survey date	Condition	Prioritization
				4/7/2010	Fair	Moderate term
III. LOCATION						
Cemetery Section	Plot/Marker Number	Original Location	Original Marker/Feature			
Willow Grove	064.G	Unknown	No			
IV. MARKER INFORMATION						
Marker Type						
Headstone w/ base		Height: 19	Width: 19	Depth: 10		
<input type="checkbox"/> Marble	<input checked="" type="checkbox"/> Granite	<input type="checkbox"/> Sandstone	<input type="checkbox"/> Slate			
<input type="checkbox"/> Brick	<input type="checkbox"/> Iron	<input type="checkbox"/> Other: _____

V. MATERIAL CONDITIONS						
<input type="checkbox"/> Biological - Algae	<input type="checkbox"/> Biological - Lichens	<input type="checkbox"/> Crack	<input type="checkbox"/> Delamination/Exfoliation			
<input type="checkbox"/> Disaggregation/Erosion	<input type="checkbox"/> Graffiti	<input checked="" type="checkbox"/> Off base (missing)	<input type="checkbox"/> Off base (adjacent)			
<input type="checkbox"/> Missing Fragment (s)	<input type="checkbox"/> Previous Repair	<input type="checkbox"/> Soiling	<input type="checkbox"/> Sunken			
<input type="checkbox"/> Tilt	<input type="checkbox"/> Corrosion					
<input checked="" type="checkbox"/> Other:	Marker has been removed from base, and moved from original location.					
VI. TREATMENT RECOMMENDATIONS						
<input checked="" type="checkbox"/> Archaeology	<input type="checkbox"/> Excavate	<input type="checkbox"/> Reset on exist base	<input checked="" type="checkbox"/> Reset on salvaged base (if poss)

<input type="checkbox"/> Clean/bio removal	<input type="checkbox"/> Consolidate	<input type="checkbox"/> Composite repair	<input type="checkbox"/> Pin/adhesive repair			
<input checked="" type="checkbox"/> Other:	Locate and set upon existing base if possible. Archaeology may be necessary to determine original location.					
VI. PHOTOGRAPHS						
Photo 1:			Photo 2:

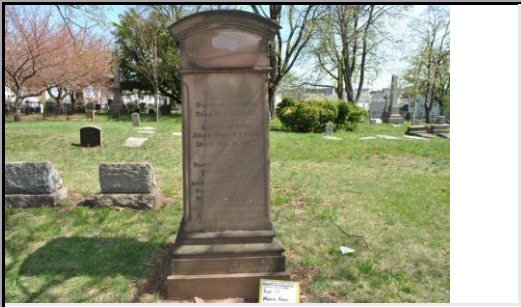
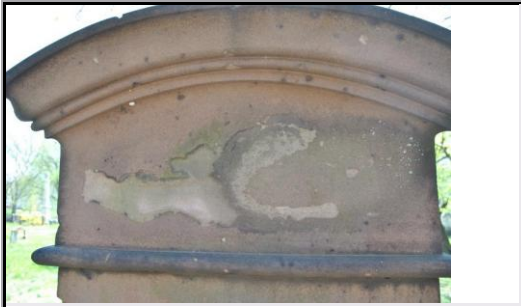
I. BURIAL INFORMATION					II. PRIORITIZATION	
First name	Last name	Birth	Death	Survey date	Condition	Prioritization
	Hoagland			4/7/2010	Fair	Moderate term
III. LOCATION						
Cemetery Section	Plot/Marker Number	Original Location	Original Marker/Feature			
Willow Grove	114.0.F	Yes	Yes			
IV. MARKER INFORMATION						
Marker Type						
Monument	Height: 72	Width: 30	Depth: 30			
<input type="checkbox"/> Marble	<input type="checkbox"/> Granite	<input checked="" type="checkbox"/> Sandstone	<input type="checkbox"/> Slate			
<input type="checkbox"/> Brick	<input type="checkbox"/> Iron	<input checked="" type="checkbox"/> Other: Concrete base

V. MATERIAL CONDITIONS						
<input checked="" type="checkbox"/> Biological - Algae	<input type="checkbox"/> Biological - Lichens	<input type="checkbox"/> Crack	<input checked="" type="checkbox"/> Delamination/Exfoliation			
<input type="checkbox"/> Disaggregation/Erosion	<input type="checkbox"/> Graffiti	<input type="checkbox"/> Off base (missing)	<input type="checkbox"/> Off base (adjacent)			
<input checked="" type="checkbox"/> Missing Fragment (s)	<input type="checkbox"/> Previous Repair	<input checked="" type="checkbox"/> Soiling	<input type="checkbox"/> Sunken			
<input type="checkbox"/> Tilt	<input type="checkbox"/> Corrosion					
<input checked="" type="checkbox"/> Other:	Marker may have been re-set on or encased in concrete base. Cracking of base.					
VI. TREATMENT RECOMMENDATIONS						
<input type="checkbox"/> Archaeology	<input type="checkbox"/> Excavate	<input type="checkbox"/> Reset on exist base	<input type="checkbox"/> Reset on salvaged base (if poss)

<input checked="" type="checkbox"/> Clean/bio removal	<input type="checkbox"/> Consolidate	<input checked="" type="checkbox"/> Composite repair	<input type="checkbox"/> Pin/adhesive repair			
<input checked="" type="checkbox"/> Other:	Stabilize at base or install new concrete base on level, stable surface and pad.					
VI. PHOTOGRAPHS						
Photo 1:			Photo 2:

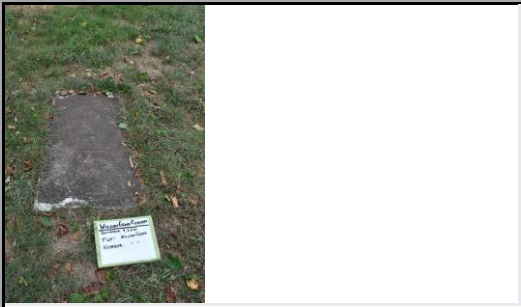
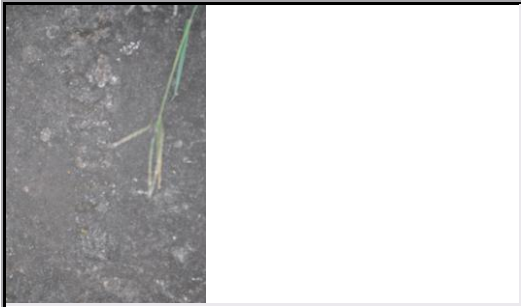
I. BURIAL INFORMATION					II. PRIORITIZATION	
First name	Last name	Birth	Death	Survey date	Condition	Prioritization
		0		9/9/2010	Fair	Moderate term
III. LOCATION						
Cemetery Section	Plot/Marker Number	Original Location	Original Marker/Feature			
Willow Grove	N/A	Unknown	Yes			
IV. MARKER INFORMATION						
Marker Type						
Headstone w/ base		Height: 44	Width: 22	Depth: 4		
<input checked="" type="checkbox"/> Marble	<input type="checkbox"/> Granite	<input type="checkbox"/> Sandstone	<input type="checkbox"/> Slate			
<input type="checkbox"/> Brick	<input type="checkbox"/> Iron	<input type="checkbox"/> Other: _____

V. MATERIAL CONDITIONS						
<input checked="" type="checkbox"/> Biological - Algae	<input checked="" type="checkbox"/> Biological - Lichens	<input type="checkbox"/> Crack	<input type="checkbox"/> Delamination/Exfoliation			
<input type="checkbox"/> Disaggregation/Erosion	<input type="checkbox"/> Graffiti	<input checked="" type="checkbox"/> Off base (missing)	<input type="checkbox"/> Off base (adjacent)			
<input checked="" type="checkbox"/> Missing Fragment (s)	<input type="checkbox"/> Previous Repair	<input checked="" type="checkbox"/> Soiling	<input type="checkbox"/> Sunken			
<input type="checkbox"/> Tilt	<input type="checkbox"/> Corrosion					
<input type="checkbox"/> Other:	_____					
VI. TREATMENT RECOMMENDATIONS						
<input type="checkbox"/> Archaeology	<input type="checkbox"/> Excavate	<input type="checkbox"/> Reset on exist base	<input checked="" type="checkbox"/> Reset on salvaged base (if poss)

VII. ADDITIONAL INFORMATION						
May be legible once clean. Located mid/E of SE quadrant of Willow Grove section.

<input checked="" type="checkbox"/> Clean/bio removal	<input type="checkbox"/> Consolidate	<input type="checkbox"/> Composite repair	<input type="checkbox"/> Pin/adhesive repair			
<input checked="" type="checkbox"/> Other:	Locate proper burial location. Identify appropriate base with flat surface (no cavity). Re-set base on pea gravel/mortar pad. Reinstall headstone with pins to attach headstone to base.					
VI. PHOTOGRAPHS						
Photo 1:			Photo 2:

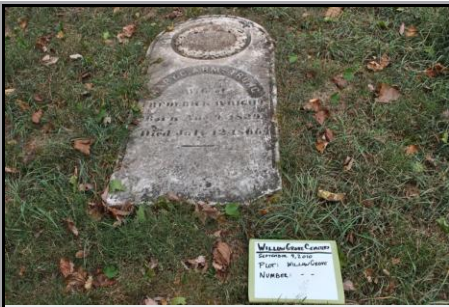
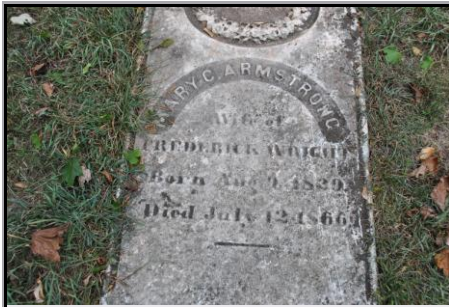
VI. PHOTOGRAPHS	
Photo 1:	Photo 2:

I. BURIAL INFORMATION					II. PRIORITIZATION	
First name	Last name	Birth	Death	Survey date	Condition	Prioritization
Mary C.	Armstrong	1839	1866	9/9/2010	Fair	Moderate term

V. MATERIAL CONDITIONS			
<input checked="" type="checkbox"/> Biological - Algae	<input checked="" type="checkbox"/> Biological - Lichens	<input type="checkbox"/> Crack	<input type="checkbox"/> Delamination/Exfoliation
<input checked="" type="checkbox"/> Disaggregation/Erosion	<input type="checkbox"/> Graffiti	<input checked="" type="checkbox"/> Off base (missing)	<input type="checkbox"/> Off base (adjacent)
<input checked="" type="checkbox"/> Missing Fragment (s)	<input type="checkbox"/> Previous Repair	<input type="checkbox"/> Soiling	<input type="checkbox"/> Sunken
<input type="checkbox"/> Tilt	<input type="checkbox"/> Corrosion		
<input type="checkbox"/> Other:	_____

VII. ADDITIONAL INFORMATION
Has no pins or tongue. Located mid/E of SE quadrant of Willow Grove section.

VI. TREATMENT RECOMMENDATIONS			
<input type="checkbox"/> Archaeology	<input type="checkbox"/> Excavate	<input type="checkbox"/> Reset on exist base	<input checked="" type="checkbox"/> Reset on salvaged base (if poss)
<input checked="" type="checkbox"/> Clean/bio removal	<input type="checkbox"/> Consolidate	<input type="checkbox"/> Composite repair	<input type="checkbox"/> Pin/adhesive repair
<input checked="" type="checkbox"/> Other:	Locate proper burial location. Identify appropriate base with flat surface (no cavity). Re-set base on pea gravel/mortar pad. Reinstall headstone with pins to attach headstone to base.

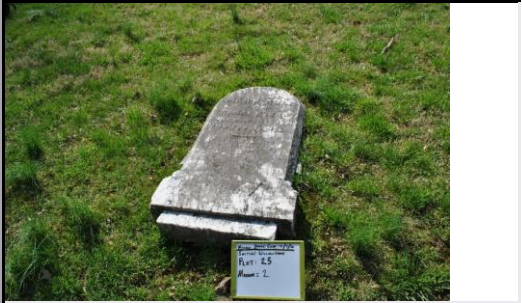
VI. PHOTOGRAPHS	
Photo 1:	Photo 2:

I. BURIAL INFORMATION					II. PRIORITIZATION	
First name	Last name	Birth	Death	Survey date	Condition	Prioritization
Mary R.	Hobart	1801	1861	4/7/2010	Good	Moderate term

V. MATERIAL CONDITIONS			
<input checked="" type="checkbox"/> Biological - Algae	<input checked="" type="checkbox"/> Biological - Lichens	<input type="checkbox"/> Crack	<input type="checkbox"/> Delamination/Exfoliation
<input type="checkbox"/> Disaggregation/Erosion	<input type="checkbox"/> Graffiti	<input checked="" type="checkbox"/> Off base (missing)	<input type="checkbox"/> Off base (adjacent)
<input type="checkbox"/> Missing Fragment (s)	<input type="checkbox"/> Previous Repair	<input type="checkbox"/> Soiling	<input type="checkbox"/> Sunken
<input type="checkbox"/> Tilt	<input type="checkbox"/> Corrosion		
<input checked="" type="checkbox"/> Other:	Tongue at base of marker - original attachment to base.

VI. TREATMENT RECOMMENDATIONS			
<input checked="" type="checkbox"/> Archaeology	<input type="checkbox"/> Excavate	<input type="checkbox"/> Reset on exist base	<input type="checkbox"/> Reset on salvaged base (if poss)
<input checked="" type="checkbox"/> Clean/bio removal	<input type="checkbox"/> Consolidate	<input type="checkbox"/> Composite repair	<input type="checkbox"/> Pin/adhesive repair
<input checked="" type="checkbox"/> Other:	Locate proper burial location. Identify appropriate base with tongue cavity. Re-set base on pea gravel/mortar pad. Reinstall headstone with tongue in mortared cavity.

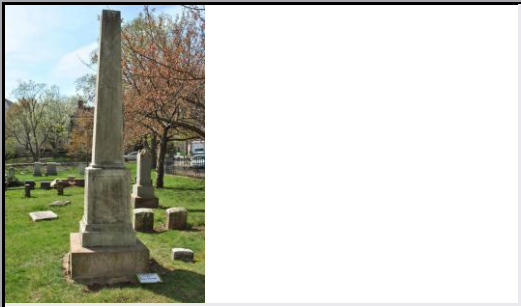
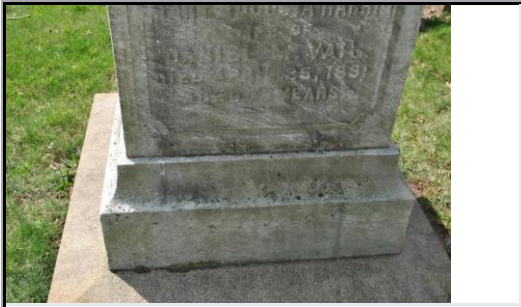
I. BURIAL INFORMATION					II. PRIORITIZATION	
First name	Last name	Birth	Death	Survey date	Condition	Prioritization
	Munroe			4/7/2010	Good	Moderate term
III. LOCATION						
Cemetery Section	Plot/Marker Number	Original Location	Original Marker/Feature			
Willow Grove	080.00.F	Yes	Yes			
IV. MARKER INFORMATION						
Marker Type	Height:	Width:	Depth:			
Obelisk	120	36	36			
<input checked="" type="checkbox"/> Marble	<input checked="" type="checkbox"/> Granite	<input type="checkbox"/> Sandstone	<input type="checkbox"/> Slate			
<input type="checkbox"/> Brick	<input type="checkbox"/> Iron	<input checked="" type="checkbox"/> Other: Concrete base.

V. MATERIAL CONDITIONS						
<input checked="" type="checkbox"/> Biological - Algae	<input checked="" type="checkbox"/> Biological - Lichens	<input type="checkbox"/> Crack	<input type="checkbox"/> Delamination/Exfoliation			
<input checked="" type="checkbox"/> Disaggregation/Erosion	<input type="checkbox"/> Graffiti	<input type="checkbox"/> Off base (missing)	<input type="checkbox"/> Off base (adjacent)			
<input type="checkbox"/> Missing Fragment (s)	<input type="checkbox"/> Previous Repair	<input checked="" type="checkbox"/> Soiling	<input type="checkbox"/> Sunken			
<input checked="" type="checkbox"/> Tilt	<input type="checkbox"/> Corrosion					
<input checked="" type="checkbox"/> Other:	Loss of mortar at junction of marble and granite, as well as base and obelisk.					
VI. TREATMENT RECOMMENDATIONS						
<input type="checkbox"/> Archaeology	<input type="checkbox"/> Excavate	<input type="checkbox"/> Reset on exist base	<input type="checkbox"/> Reset on salvaged base (if poss)

<input checked="" type="checkbox"/> Clean/bio removal	<input type="checkbox"/> Consolidate	<input type="checkbox"/> Composite repair	<input type="checkbox"/> Pin/adhesive repair			
<input checked="" type="checkbox"/> Other:	Monitor for tilt. Stabilize as required. Repoint when necessary					
VI. PHOTOGRAPHS						
Photo 1:			Photo 2:

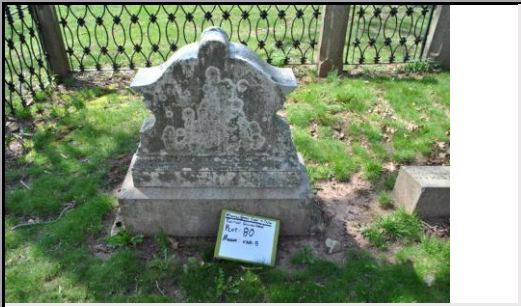
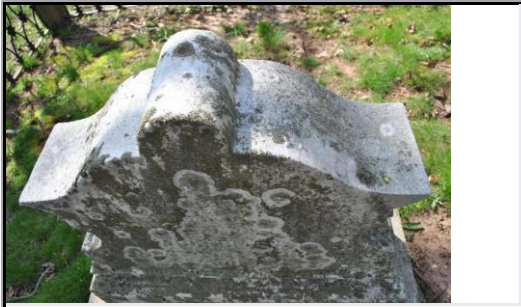
<input type="checkbox"/> Other:	_____					
VI. PHOTOGRAPHS						
Photo 1:			Photo 2:

I. BURIAL INFORMATION					II. PRIORITIZATION	
First name	Last name	Birth	Death	Survey date	Condition	Prioritization
I.	Ackerman			4/7/2010	Good	Moderate term
III. LOCATION						
Cemetery Section	Plot/Marker Number	Original Location	Original Marker/Feature			
Willow Grove	080.B	Yes	Yes			
IV. MARKER INFORMATION						
Marker Type						
Headstone w/ base		Height: 37	Width: 34	Depth: 14		
<input checked="" type="checkbox"/> Marble	<input checked="" type="checkbox"/> Granite	<input type="checkbox"/> Sandstone	<input type="checkbox"/> Slate			
<input type="checkbox"/> Brick	<input type="checkbox"/> Iron	<input type="checkbox"/> Other: _____

V. MATERIAL CONDITIONS						
<input checked="" type="checkbox"/> Biological - Algae	<input checked="" type="checkbox"/> Biological - Lichens	<input type="checkbox"/> Crack	<input type="checkbox"/> Delamination/Exfoliation			
<input checked="" type="checkbox"/> Disaggregation/Erosion	<input type="checkbox"/> Graffiti	<input type="checkbox"/> Off base (missing)	<input type="checkbox"/> Off base (adjacent)			
<input type="checkbox"/> Missing Fragment (s)	<input type="checkbox"/> Previous Repair	<input type="checkbox"/> Soiling	<input type="checkbox"/> Sunken			
<input type="checkbox"/> Tilt	<input type="checkbox"/> Corrosion					
<input type="checkbox"/> Other:	_____					
VI. TREATMENT RECOMMENDATIONS						
<input type="checkbox"/> Archaeology	<input type="checkbox"/> Excavate	<input type="checkbox"/> Reset on exist base	<input type="checkbox"/> Reset on salvaged base (if poss)			
<input checked="" type="checkbox"/> Clean/bio removal	<input type="checkbox"/> Consolidate	<input type="checkbox"/> Composite repair	<input type="checkbox"/> Pin/adhesive repair

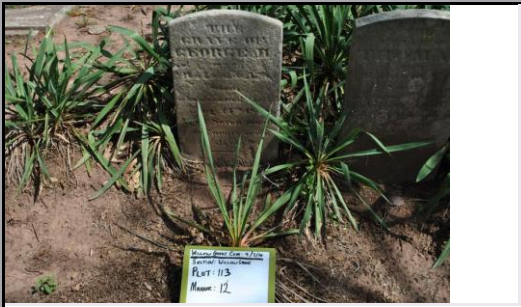
I. BURIAL INFORMATION					II. PRIORITIZATION	
First name	Last name	Birth	Death	Survey date	Condition	Prioritization
George	Stout			4/7/2010	Good	Moderate term
III. LOCATION						
Cemetery Section	Plot/Marker Number	Original Location	Original Marker/Feature			
Willow Grove	113.12	Yes	Yes			
IV. MARKER INFORMATION						
Marker Type						
Headstone		Height: 28	Width: 15	Depth: 2		
<input checked="" type="checkbox"/> Marble	<input type="checkbox"/> Granite	<input type="checkbox"/> Sandstone	<input type="checkbox"/> Slate			
<input type="checkbox"/> Brick	<input type="checkbox"/> Iron	<input type="checkbox"/> Other: _____

V. MATERIAL CONDITIONS						
<input checked="" type="checkbox"/> Biological - Algae	<input type="checkbox"/> Biological - Lichens	<input type="checkbox"/> Crack	<input type="checkbox"/> Delamination/Exfoliation			
<input checked="" type="checkbox"/> Disaggregation/Erosion	<input type="checkbox"/> Graffiti	<input type="checkbox"/> Off base (missing)	<input type="checkbox"/> Off base (adjacent)			
<input type="checkbox"/> Missing Fragment (s)	<input type="checkbox"/> Previous Repair	<input type="checkbox"/> Soiling	<input type="checkbox"/> Sunken			
<input type="checkbox"/> Tilt	<input type="checkbox"/> Corrosion					
<input checked="" type="checkbox"/> Other:	Surrounded by vegetation.					
VI. TREATMENT RECOMMENDATIONS						
<input type="checkbox"/> Archaeology	<input type="checkbox"/> Excavate	<input type="checkbox"/> Reset on exist base	<input type="checkbox"/> Reset on salvaged base (if poss)

<input checked="" type="checkbox"/> Clean/bio removal	<input type="checkbox"/> Consolidate	<input type="checkbox"/> Composite repair	<input type="checkbox"/> Pin/adhesive repair			
<input checked="" type="checkbox"/> Other:	Possible candidate for consolidation. Remove or trim vegetation.					
VI. PHOTOGRAPHS						
Photo 1:			Photo 2:

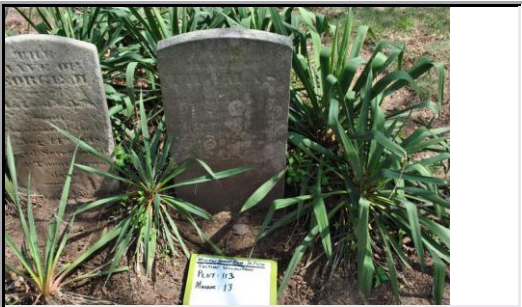
I. BURIAL INFORMATION					II. PRIORITIZATION	
First name	Last name	Birth	Death	Survey date	Condition	Prioritization
Stout	Thomas			4/7/2010	Good	Moderate term
III. LOCATION						
Cemetery Section	Plot/Marker Number	Original Location	Original Marker/Feature			
Willow Grove	113.13	Yes	Yes			
IV. MARKER INFORMATION						
Marker Type						
Headstone		Height: 28	Width: 15	Depth: 2		
<input checked="" type="checkbox"/> Marble	<input type="checkbox"/> Granite	<input type="checkbox"/> Sandstone	<input type="checkbox"/> Slate			
<input type="checkbox"/> Brick	<input type="checkbox"/> Iron	<input type="checkbox"/> Other: _____

V. MATERIAL CONDITIONS						
<input checked="" type="checkbox"/> Biological - Algae	<input checked="" type="checkbox"/> Biological - Lichens	<input type="checkbox"/> Crack	<input type="checkbox"/> Delamination/Exfoliation			
<input checked="" type="checkbox"/> Disaggregation/Erosion	<input type="checkbox"/> Graffiti	<input type="checkbox"/> Off base (missing)	<input type="checkbox"/> Off base (adjacent)			
<input type="checkbox"/> Missing Fragment (s)	<input type="checkbox"/> Previous Repair	<input checked="" type="checkbox"/> Soiling	<input type="checkbox"/> Sunken			
<input type="checkbox"/> Tilt	<input type="checkbox"/> Corrosion					
<input checked="" type="checkbox"/> Other:	Surrounded by vegetation					
VI. TREATMENT RECOMMENDATIONS						
<input type="checkbox"/> Archaeology	<input type="checkbox"/> Excavate	<input type="checkbox"/> Reset on exist base	<input type="checkbox"/> Reset on salvaged base (if poss)

<input checked="" type="checkbox"/> Clean/bio removal	<input type="checkbox"/> Consolidate	<input type="checkbox"/> Composite repair	<input type="checkbox"/> Pin/adhesive repair			
<input checked="" type="checkbox"/> Other:	Possible candidate for consolidation. Remove or trim vegetation.					
VI. PHOTOGRAPHS						
Photo 1:			Photo 2:

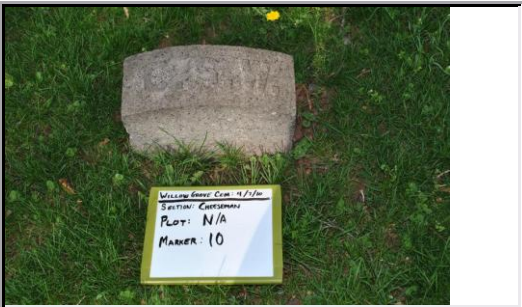
I. BURIAL INFORMATION					II. PRIORITIZATION	
First name	Last name	Birth	Death	Survey date	Condition	Prioritization
Francis C.	Manley	1807	1870	4/7/2010	Poor	Moderate term
III. LOCATION						
Cemetery Section	Plot/Marker Number	Original Location	Original Marker/Feature			
Cheesman	244.01	Yes	Yes			
IV. MARKER INFORMATION						
Marker Type						
Headstone w/ base		Height: 48	Width: 22	Depth: 3		
<input checked="" type="checkbox"/> Marble	<input type="checkbox"/> Granite	<input type="checkbox"/> Sandstone	<input type="checkbox"/> Slate			
<input type="checkbox"/> Brick	<input type="checkbox"/> Iron	<input type="checkbox"/> Other: _____

V. MATERIAL CONDITIONS						
<input checked="" type="checkbox"/> Biological - Algae	<input type="checkbox"/> Biological - Lichens	<input type="checkbox"/> Crack	<input type="checkbox"/> Delamination/Exfoliation			
<input checked="" type="checkbox"/> Disaggregation/Erosion	<input type="checkbox"/> Graffiti	<input checked="" type="checkbox"/> Off base (missing)	<input type="checkbox"/> Off base (adjacent)			
<input type="checkbox"/> Missing Fragment (s)	<input type="checkbox"/> Previous Repair	<input type="checkbox"/> Soiling	<input type="checkbox"/> Sunken			
<input type="checkbox"/> Tilt	<input type="checkbox"/> Corrosion					
<input checked="" type="checkbox"/> Other:	Marker may have collapsed in part due to presence of tree roots.					
VI. TREATMENT RECOMMENDATIONS						
<input checked="" type="checkbox"/> Archaeology	<input checked="" type="checkbox"/> Excavate	<input type="checkbox"/> Reset on exist base	<input checked="" type="checkbox"/> Reset on salvaged base (if poss)

<input checked="" type="checkbox"/> Clean/bio removal	<input type="checkbox"/> Consolidate	<input type="checkbox"/> Composite repair	<input type="checkbox"/> Pin/adhesive repair			
<input checked="" type="checkbox"/> Other:	Remedial work on tree roots.					
VI. PHOTOGRAPHS						
Photo 1:			Photo 2:

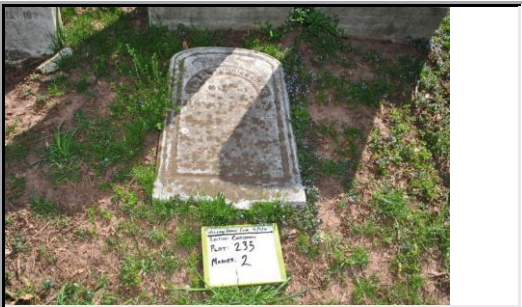
I. BURIAL INFORMATION					II. PRIORITIZATION	
First name	Last name	Birth	Death	Survey date	Condition	Prioritization
Elizabeth	Sillcocks	1815	1880	4/7/2010	Poor	Moderate term
III. LOCATION						
Cemetery Section	Plot/Marker Number	Original Location	Original Marker/Feature			
Cheesman	235.02	Yes	Yes			
IV. MARKER INFORMATION						
Marker Type						
Headstone w/ base		Height: 36	Width: 24	Depth: 5		
<input checked="" type="checkbox"/> Marble	<input type="checkbox"/> Granite	<input type="checkbox"/> Sandstone	<input type="checkbox"/> Slate			
<input type="checkbox"/> Brick	<input type="checkbox"/> Iron	<input type="checkbox"/> Other: _____

V. MATERIAL CONDITIONS						
<input checked="" type="checkbox"/> Biological - Algae	<input type="checkbox"/> Biological - Lichens	<input type="checkbox"/> Crack	<input type="checkbox"/> Delamination/Exfoliation			
<input checked="" type="checkbox"/> Disaggregation/Erosion	<input type="checkbox"/> Graffiti	<input checked="" type="checkbox"/> Off base (missing)	<input type="checkbox"/> Off base (adjacent)			
<input type="checkbox"/> Missing Fragment (s)	<input type="checkbox"/> Previous Repair	<input type="checkbox"/> Soiling	<input type="checkbox"/> Sunken			
<input type="checkbox"/> Tilt	<input type="checkbox"/> Corrosion					
<input type="checkbox"/> Other:	_____					
VI. TREATMENT RECOMMENDATIONS						
<input checked="" type="checkbox"/> Archaeology	<input checked="" type="checkbox"/> Excavate	<input type="checkbox"/> Reset on exist base	<input checked="" type="checkbox"/> Reset on salvaged base (if poss)

VII. ADDITIONAL INFORMATION						
Adjacent stone for Isaac Howell (235.3) is a headstone on two-part base. This marker may also have had a dual rather than single base.

<input checked="" type="checkbox"/> Clean/bio removal	<input type="checkbox"/> Consolidate	<input type="checkbox"/> Composite repair	<input type="checkbox"/> Pin/adhesive repair			
<input checked="" type="checkbox"/> Other:	Locate proper burial location. Identify appropriate base with tongue cavity. Re-set base on pea gravel/mortar pad. Reinstall headstone with tongue in mortared cavity.					
VI. PHOTOGRAPHS						
Photo 1:			Photo 2:
