HISTORIC PRESERVATION PLAN

WILLOW GROVE CEMETERY

New Brunswick, Middlesex County, New Jersey

DATE: 4 October 2010

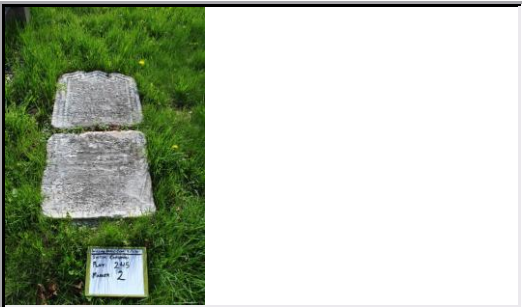
I. BURIAL INFORMATION					II. PRIORITIZATION	
First name	Last name	Birth	Death	Survey date	Condition	Prioritization
Joseph	Dixon			4/7/2010	Poor	Moderate term
III. LOCATION						
Cemetery Section	Plot/Marker Number	Original Location	Original Marker/Feature			
Cheesman	245.01	Yes	Yes			
IV. MARKER INFORMATION						
Marker Type						
Headstone w/ base		Height: 48	Width: 24	Depth: 3		
<input checked="" type="checkbox"/> Marble	<input type="checkbox"/> Granite	<input type="checkbox"/> Sandstone	<input type="checkbox"/> Slate			
<input type="checkbox"/> Brick	<input type="checkbox"/> Iron	<input type="checkbox"/> Other: _____

V. MATERIAL CONDITIONS						
<input checked="" type="checkbox"/> Biological - Algae	<input type="checkbox"/> Biological - Lichens	<input checked="" type="checkbox"/> Crack	<input type="checkbox"/> Delamination/Exfoliation			
<input checked="" type="checkbox"/> Disaggregation/Erosion	<input type="checkbox"/> Graffiti	<input checked="" type="checkbox"/> Off base (missing)	<input type="checkbox"/> Off base (adjacent)			
<input type="checkbox"/> Missing Fragment (s)	<input type="checkbox"/> Previous Repair	<input type="checkbox"/> Soiling	<input type="checkbox"/> Sunken			
<input type="checkbox"/> Tilt	<input type="checkbox"/> Corrosion					
<input type="checkbox"/> Other:	_____					
VI. TREATMENT RECOMMENDATIONS						
<input checked="" type="checkbox"/> Archaeology	<input checked="" type="checkbox"/> Excavate	<input type="checkbox"/> Reset on exist base	<input checked="" type="checkbox"/> Reset on salvaged base (if poss)

<input checked="" type="checkbox"/> Clean/bio removal	<input type="checkbox"/> Consolidate	<input type="checkbox"/> Composite repair	<input checked="" type="checkbox"/> Pin/adhesive repair			
<input checked="" type="checkbox"/> Other:	Locate proper burial location. Identify appropriate base with flat surface (no cavity). Re-set base on pea gravel/mortar pad. Reinstall headstone with pins to attach headstone to base.					
VI. PHOTOGRAPHS						
Photo 1:			Photo 2:

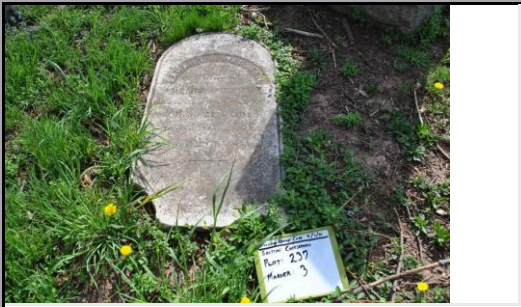
I. BURIAL INFORMATION					II. PRIORITIZATION	
First name	Last name	Birth	Death	Survey date	Condition	Prioritization
Sarah T.B.	Webster	1791	1877	4/7/2010	Poor	Moderate term
III. LOCATION						
Cemetery Section	Plot/Marker Number	Original Location	Original Marker/Feature			
Cheesman	237.03	Yes	Yes			
IV. MARKER INFORMATION						
Marker Type						
Headstone w/ base		Height: 48	Width: 24	Depth: 4		
<input checked="" type="checkbox"/> Marble	<input type="checkbox"/> Granite	<input type="checkbox"/> Sandstone	<input type="checkbox"/> Slate			
<input type="checkbox"/> Brick	<input type="checkbox"/> Iron	<input type="checkbox"/> Other: _____

V. MATERIAL CONDITIONS						
<input checked="" type="checkbox"/> Biological - Algae	<input type="checkbox"/> Biological - Lichens	<input type="checkbox"/> Crack	<input type="checkbox"/> Delamination/Exfoliation			
<input checked="" type="checkbox"/> Disaggregation/Erosion	<input type="checkbox"/> Graffiti	<input checked="" type="checkbox"/> Off base (missing)	<input type="checkbox"/> Off base (adjacent)			
<input checked="" type="checkbox"/> Missing Fragment (s)	<input type="checkbox"/> Previous Repair	<input checked="" type="checkbox"/> Soiling	<input type="checkbox"/> Sunken			
<input type="checkbox"/> Tilt	<input type="checkbox"/> Corrosion					
<input type="checkbox"/> Other:	_____					
VI. TREATMENT RECOMMENDATIONS						
<input checked="" type="checkbox"/> Archaeology	<input checked="" type="checkbox"/> Excavate	<input type="checkbox"/> Reset on exist base	<input checked="" type="checkbox"/> Reset on salvaged base (if poss)

<input checked="" type="checkbox"/> Clean/bio removal	<input type="checkbox"/> Consolidate	<input type="checkbox"/> Composite repair	<input type="checkbox"/> Pin/adhesive repair			
<input checked="" type="checkbox"/> Other:	Locate proper burial location. Identify appropriate base with flat surface (no cavity). Re-set base on pea gravel/mortar pad. Reinstall headstone with pins to attach headstone to base.					
VI. PHOTOGRAPHS						
Photo 1:			Photo 2:

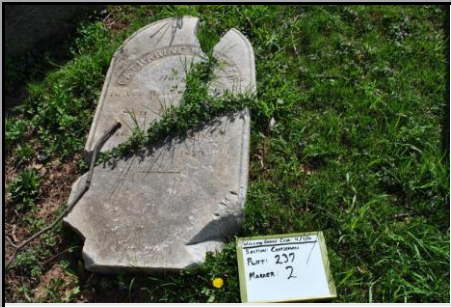
VI. PHOTOGRAPHS	
Photo 1:	Photo 2:

I. BURIAL INFORMATION					II. PRIORITIZATION	
First name	Last name	Birth	Death	Survey date	Condition	Prioritization
Catharine	Webster	1792	1879	4/7/2010	Poor	Moderate term

V. MATERIAL CONDITIONS			
<input checked="" type="checkbox"/> Biological - Algae	<input type="checkbox"/> Biological - Lichens	<input checked="" type="checkbox"/> Crack	<input type="checkbox"/> Delamination/Exfoliation
<input checked="" type="checkbox"/> Disaggregation/Erosion	<input type="checkbox"/> Graffiti	<input checked="" type="checkbox"/> Off base (missing)	<input type="checkbox"/> Off base (adjacent)
<input checked="" type="checkbox"/> Missing Fragment (s)	<input type="checkbox"/> Previous Repair	<input checked="" type="checkbox"/> Soiling	<input type="checkbox"/> Sunken
<input type="checkbox"/> Tilt	<input type="checkbox"/> Corrosion		
<input type="checkbox"/> Other:	_____

VI. TREATMENT RECOMMENDATIONS			
<input checked="" type="checkbox"/> Archaeology	<input checked="" type="checkbox"/> Excavate	<input type="checkbox"/> Reset on exist base	<input checked="" type="checkbox"/> Reset on salvaged base (if poss)
<input checked="" type="checkbox"/> Clean/bio removal	<input type="checkbox"/> Consolidate	<input checked="" type="checkbox"/> Composite repair	<input checked="" type="checkbox"/> Pin/adhesive repair
<input checked="" type="checkbox"/> Other:	Locate proper burial location. Identify appropriate base with tongue cavity. Re-set base on pea gravel/mortar pad. Reinstall headstone with tongue in mortared cavity.

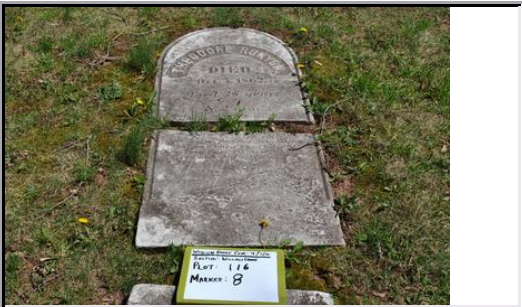
I. BURIAL INFORMATION					II. PRIORITIZATION	
First name	Last name	Birth	Death	Survey date	Condition	Prioritization
Theodore	Runyon		1862	4/7/2010	Poor	Moderate term
III. LOCATION						
Cemetery Section	Plot/Marker Number	Original Location	Original Marker/Feature			
Willow Grove	116.08	Yes	Yes			
IV. MARKER INFORMATION						
Marker Type						
Headstone w/ base		Height: 48	Width: 24	Depth: 4		
<input checked="" type="checkbox"/> Marble	<input type="checkbox"/> Granite	<input type="checkbox"/> Sandstone	<input type="checkbox"/> Slate			
<input type="checkbox"/> Brick	<input type="checkbox"/> Iron	<input type="checkbox"/> Other: _____

V. MATERIAL CONDITIONS						
<input checked="" type="checkbox"/> Biological - Algae	<input type="checkbox"/> Biological - Lichens	<input checked="" type="checkbox"/> Crack	<input type="checkbox"/> Delamination/Exfoliation			
<input checked="" type="checkbox"/> Disaggregation/Erosion	<input type="checkbox"/> Graffiti	<input type="checkbox"/> Off base (missing)	<input checked="" type="checkbox"/> Off base (adjacent)			
<input type="checkbox"/> Missing Fragment (s)	<input type="checkbox"/> Previous Repair	<input type="checkbox"/> Soiling	<input type="checkbox"/> Sunken			
<input type="checkbox"/> Tilt	<input type="checkbox"/> Corrosion					
<input checked="" type="checkbox"/> Other:	No tongue at base of headstone.					
VI. TREATMENT RECOMMENDATIONS						
<input checked="" type="checkbox"/> Archaeology	<input type="checkbox"/> Excavate	<input type="checkbox"/> Reset on exist base	<input checked="" type="checkbox"/> Reset on salvaged base (if poss)

<input checked="" type="checkbox"/> Clean/bio removal	<input type="checkbox"/> Consolidate	<input checked="" type="checkbox"/> Composite repair	<input checked="" type="checkbox"/> Pin/adhesive repair			
<input checked="" type="checkbox"/> Other:	Locate proper burial location. Identify appropriate base with flat surface (no cavity). Re-set base on pea gravel/mortar pad. Reinstall headstone with pins to attach headstone to base.					
VI. PHOTOGRAPHS						
Photo 1:			Photo 2:

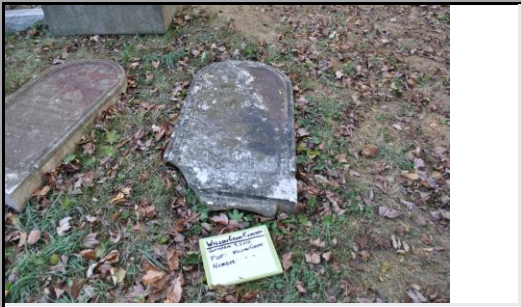
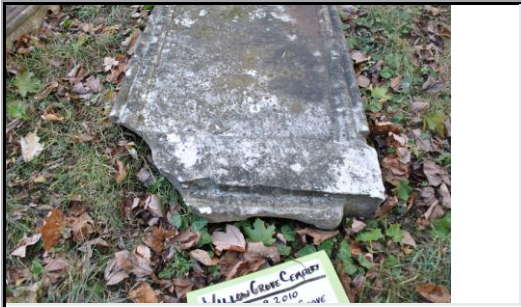
I. BURIAL INFORMATION					II. PRIORITIZATION	
First name	Last name	Birth	Death	Survey date	Condition	Prioritization
Hattie		0		9/9/2010	Poor	Moderate term
III. LOCATION						
Cemetery Section	Plot/Marker Number	Original Location	Original Marker/Feature			
Willow Grove	133.11	Yes	Yes			
IV. MARKER INFORMATION						
Marker Type						
Headstone w/ base		Height: 48	Width: 24	Depth: 5		
<input checked="" type="checkbox"/> Marble	<input type="checkbox"/> Granite	<input type="checkbox"/> Sandstone	<input type="checkbox"/> Slate			
<input type="checkbox"/> Brick	<input type="checkbox"/> Iron	<input type="checkbox"/> Other: _____

V. MATERIAL CONDITIONS						
<input checked="" type="checkbox"/> Biological - Algae	<input checked="" type="checkbox"/> Biological - Lichens	<input type="checkbox"/> Crack	<input type="checkbox"/> Delamination/Exfoliation			
<input checked="" type="checkbox"/> Disaggregation/Erosion	<input type="checkbox"/> Graffiti	<input checked="" type="checkbox"/> Off base (missing)	<input type="checkbox"/> Off base (adjacent)			
<input checked="" type="checkbox"/> Missing Fragment (s)	<input type="checkbox"/> Previous Repair	<input checked="" type="checkbox"/> Soiling	<input type="checkbox"/> Sunken			
<input type="checkbox"/> Tilt	<input type="checkbox"/> Corrosion					
<input checked="" type="checkbox"/> Other:	Inscription is illegible due to erosion/soiling.					
VI. TREATMENT RECOMMENDATIONS						
<input checked="" type="checkbox"/> Archaeology	<input type="checkbox"/> Excavate	<input type="checkbox"/> Reset on exist base	<input checked="" type="checkbox"/> Reset on salvaged base (if poss)

VII. ADDITIONAL INFORMATION						
Partial tongue

<input checked="" type="checkbox"/> Clean/bio removal	<input type="checkbox"/> Consolidate	<input checked="" type="checkbox"/> Composite repair	<input type="checkbox"/> Pin/adhesive repair			
<input checked="" type="checkbox"/> Other:	Locate proper burial location. Identify appropriate base with tongue cavity. Re-set base on pea gravel/mortar pad. Reinstall headstone with tongue in mortared cavity.					
VI. PHOTOGRAPHS						
Photo 1:			Photo 2:

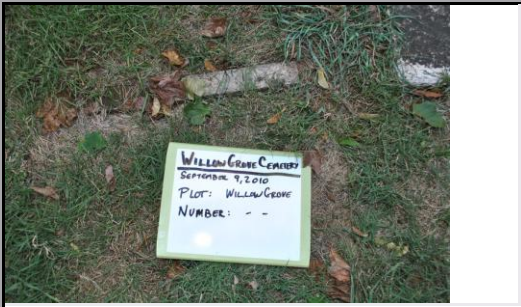
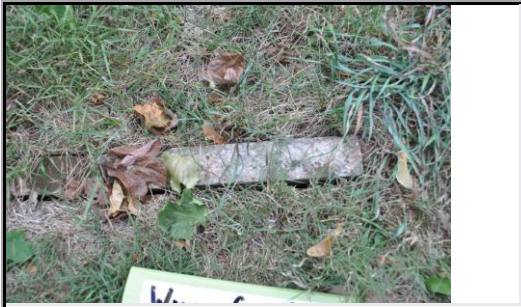
I. BURIAL INFORMATION					II. PRIORITIZATION	
First name	Last name	Birth	Death	Survey date	Condition	Prioritization
		0		9/9/2010	Poor	Moderate term
III. LOCATION						
Cemetery Section	Plot/Marker Number	Original Location	Original Marker/Feature			
Willow Grove	N/A	Unknown	Yes			
IV. MARKER INFORMATION						
Marker Type						
Headstone	Height:	Width: 17	Depth: 2			
<input checked="" type="checkbox"/> Marble	<input type="checkbox"/> Granite	<input type="checkbox"/> Sandstone	<input type="checkbox"/> Slate			
<input type="checkbox"/> Brick	<input type="checkbox"/> Iron	<input type="checkbox"/> Other: _____

V. MATERIAL CONDITIONS						
<input checked="" type="checkbox"/> Biological - Algae	<input checked="" type="checkbox"/> Biological - Lichens	<input type="checkbox"/> Crack	<input type="checkbox"/> Delamination/Exfoliation			
<input type="checkbox"/> Disaggregation/Erosion	<input type="checkbox"/> Graffiti	<input type="checkbox"/> Off base (missing)	<input type="checkbox"/> Off base (adjacent)			
<input checked="" type="checkbox"/> Missing Fragment (s)	<input type="checkbox"/> Previous Repair	<input checked="" type="checkbox"/> Soiling	<input type="checkbox"/> Sunken			
<input type="checkbox"/> Tilt	<input type="checkbox"/> Corrosion					
<input type="checkbox"/> Other:	_____					
VI. TREATMENT RECOMMENDATIONS						
<input type="checkbox"/> Archaeology	<input checked="" type="checkbox"/> Excavate	<input type="checkbox"/> Reset on exist base	<input type="checkbox"/> Reset on salvaged base (if poss)

VII. ADDITIONAL INFORMATION						
Fragment of headstone, main piece missing. Located mid/E of SE quadrant of Willow Grove section.

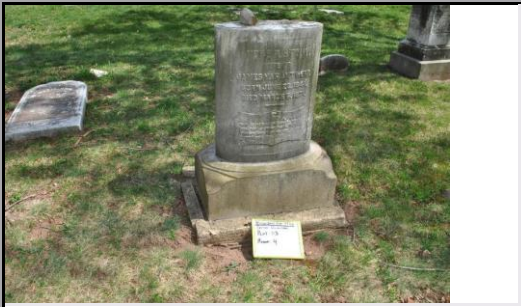
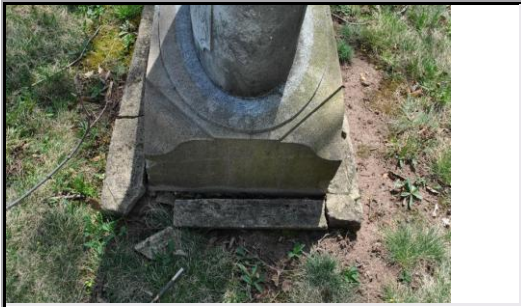
I. BURIAL INFORMATION					II. PRIORITIZATION	
First name	Last name	Birth	Death	Survey date	Condition	Prioritization
Phebe	Van Antwerp	1841	1871	4/7/2010	Poor	Moderate term
III. LOCATION						
Cemetery Section	Plot/Marker Number	Original Location	Original Marker/Feature			
Willow Grove	113.04	Yes	Yes			
IV. MARKER INFORMATION						
Marker Type						
Headstone w/ base		Height: 40	Width: 30	Depth: 18		
<input checked="" type="checkbox"/> Marble	<input checked="" type="checkbox"/> Granite	<input type="checkbox"/> Sandstone	<input type="checkbox"/> Slate			
<input type="checkbox"/> Brick	<input type="checkbox"/> Iron	<input checked="" type="checkbox"/> Other: Concrete base.

V. MATERIAL CONDITIONS						
<input checked="" type="checkbox"/> Biological - Algae	<input type="checkbox"/> Biological - Lichens	<input type="checkbox"/> Crack	<input type="checkbox"/> Delamination/Exfoliation			
<input type="checkbox"/> Disaggregation/Erosion	<input type="checkbox"/> Graffiti	<input type="checkbox"/> Off base (missing)	<input type="checkbox"/> Off base (adjacent)			
<input checked="" type="checkbox"/> Missing Fragment (s)	<input type="checkbox"/> Previous Repair	<input checked="" type="checkbox"/> Soiling	<input type="checkbox"/> Sunken			
<input type="checkbox"/> Tilt	<input type="checkbox"/> Corrosion					
<input checked="" type="checkbox"/> Other:	Inspect for stability. Broken concrete base.					
VI. TREATMENT RECOMMENDATIONS						
<input type="checkbox"/> Archaeology	<input type="checkbox"/> Excavate	<input type="checkbox"/> Reset on exist base	<input checked="" type="checkbox"/> Reset on salvaged base (if poss)

<input checked="" type="checkbox"/> Clean/bio removal	<input type="checkbox"/> Consolidate	<input type="checkbox"/> Composite repair	<input type="checkbox"/> Pin/adhesive repair			
<input checked="" type="checkbox"/> Other:	Repoint or anchor as required. Re-parge base.					
VI. PHOTOGRAPHS						
Photo 1:			Photo 2:

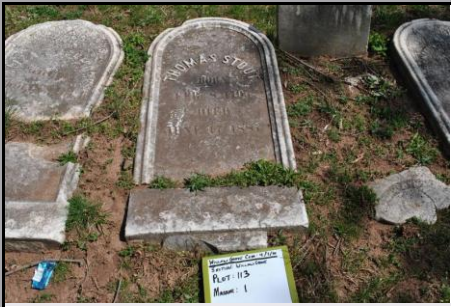
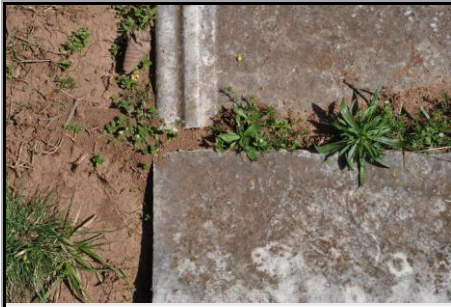
I. BURIAL INFORMATION					II. PRIORITIZATION	
First name	Last name	Birth	Death	Survey date	Condition	Prioritization
Thomas	Stout	1795	1881	4/7/2010	Poor	Moderate term

V. MATERIAL CONDITIONS			
<input checked="" type="checkbox"/> Biological - Algae	<input type="checkbox"/> Biological - Lichens	<input checked="" type="checkbox"/> Crack	<input type="checkbox"/> Delamination/Exfoliation
<input checked="" type="checkbox"/> Disaggregation/Erosion	<input type="checkbox"/> Graffiti	<input checked="" type="checkbox"/> Off base (missing)	<input type="checkbox"/> Off base (adjacent)
<input checked="" type="checkbox"/> Missing Fragment (s)	<input type="checkbox"/> Previous Repair	<input checked="" type="checkbox"/> Soiling	<input type="checkbox"/> Sunken
<input type="checkbox"/> Tilt	<input type="checkbox"/> Corrosion		
<input checked="" type="checkbox"/> Other:	Tongue at base of marker - original attachment to base.

VI. TREATMENT RECOMMENDATIONS			
<input checked="" type="checkbox"/> Archaeology	<input type="checkbox"/> Excavate	<input type="checkbox"/> Reset on exist base	<input checked="" type="checkbox"/> Reset on salvaged base (if poss)
<input checked="" type="checkbox"/> Clean/bio removal	<input type="checkbox"/> Consolidate	<input checked="" type="checkbox"/> Composite repair	<input checked="" type="checkbox"/> Pin/adhesive repair
<input checked="" type="checkbox"/> Other:	Locate proper burial location. Identify appropriate base with tongue cavity. Re-set base on pea gravel/mortar pad. Reinstall headstone with tongue in mortared cavity.

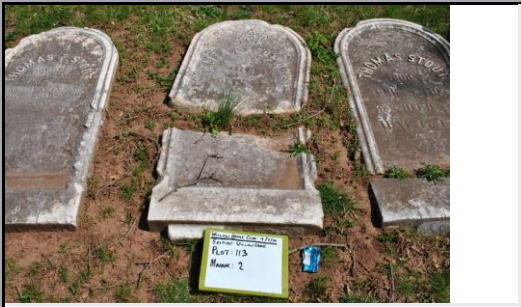
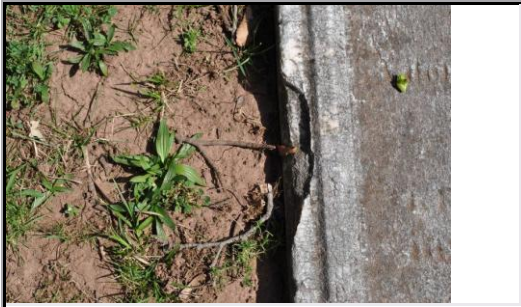
I. BURIAL INFORMATION					II. PRIORITIZATION	
First name	Last name	Birth	Death	Survey date	Condition	Prioritization
Eliza	Stout	1804	1858	4/7/2010	Poor	Moderate term
III. LOCATION						
Cemetery Section	Plot/Marker Number	Original Location	Original Marker/Feature			
Willow Grove	113.02	Yes	Yes			
IV. MARKER INFORMATION						
Marker Type						
Headstone w/ base		Height: 48	Width: 24	Depth: 4		
<input checked="" type="checkbox"/> Marble	<input type="checkbox"/> Granite	<input type="checkbox"/> Sandstone	<input type="checkbox"/> Slate			
<input type="checkbox"/> Brick	<input type="checkbox"/> Iron	<input type="checkbox"/> Other: _____

V. MATERIAL CONDITIONS						
<input checked="" type="checkbox"/> Biological - Algae	<input type="checkbox"/> Biological - Lichens	<input checked="" type="checkbox"/> Crack	<input type="checkbox"/> Delamination/Exfoliation			
<input checked="" type="checkbox"/> Disaggregation/Erosion	<input type="checkbox"/> Graffiti	<input checked="" type="checkbox"/> Off base (missing)	<input type="checkbox"/> Off base (adjacent)			
<input checked="" type="checkbox"/> Missing Fragment (s)	<input type="checkbox"/> Previous Repair	<input checked="" type="checkbox"/> Soiling	<input type="checkbox"/> Sunken			
<input type="checkbox"/> Tilt	<input type="checkbox"/> Corrosion					
<input checked="" type="checkbox"/> Other:	Tongue at base of marker - original attachment to base.					
VI. TREATMENT RECOMMENDATIONS						
<input checked="" type="checkbox"/> Archaeology	<input type="checkbox"/> Excavate	<input type="checkbox"/> Reset on exist base	<input checked="" type="checkbox"/> Reset on salvaged base (if poss)

<input checked="" type="checkbox"/> Clean/bio removal	<input type="checkbox"/> Consolidate	<input type="checkbox"/> Composite repair	<input checked="" type="checkbox"/> Pin/adhesive repair			
<input checked="" type="checkbox"/> Other:	Locate proper burial location. Identify appropriate base with tongue cavity. Re-set base on pea gravel/mortar pad. Reinstall headstone with tongue in mortared cavity.					
VI. PHOTOGRAPHS						
Photo 1:			Photo 2:

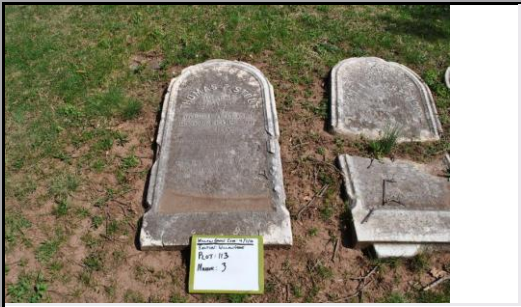
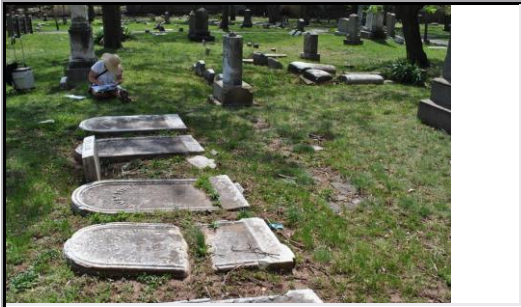
I. BURIAL INFORMATION					II. PRIORITIZATION	
First name	Last name	Birth	Death	Survey date	Condition	Prioritization
Thomas P.	Stout		1861	4/7/2010	Poor	Moderate term
III. LOCATION						
Cemetery Section	Plot/Marker Number	Original Location	Original Marker/Feature			
Willow Grove	113.03	Yes	Yes			
IV. MARKER INFORMATION						
Marker Type						
Headstone w/ base						
Height: 48	Width: 24	Depth: 4				
<input checked="" type="checkbox"/> Marble	<input type="checkbox"/> Granite	<input type="checkbox"/> Sandstone	<input type="checkbox"/> Slate			
<input type="checkbox"/> Brick	<input type="checkbox"/> Iron	<input type="checkbox"/> Other: _____

V. MATERIAL CONDITIONS						
<input checked="" type="checkbox"/> Biological - Algae	<input type="checkbox"/> Biological - Lichens	<input type="checkbox"/> Crack	<input type="checkbox"/> Delamination/Exfoliation			
<input checked="" type="checkbox"/> Disaggregation/Erosion	<input type="checkbox"/> Graffiti	<input checked="" type="checkbox"/> Off base (missing)	<input type="checkbox"/> Off base (adjacent)			
<input checked="" type="checkbox"/> Missing Fragment (s)	<input type="checkbox"/> Previous Repair	<input checked="" type="checkbox"/> Soiling	<input type="checkbox"/> Sunken			
<input type="checkbox"/> Tilt	<input type="checkbox"/> Corrosion					
<input checked="" type="checkbox"/> Other:	No tongue or anchors. Bottom of headstone may have been set into cavity at base.					
VI. TREATMENT RECOMMENDATIONS						
<input checked="" type="checkbox"/> Archaeology	<input type="checkbox"/> Excavate	<input type="checkbox"/> Reset on exist base	<input checked="" type="checkbox"/> Reset on salvaged base (if poss)

<input checked="" type="checkbox"/> Clean/bio removal	<input type="checkbox"/> Consolidate	<input type="checkbox"/> Composite repair	<input type="checkbox"/> Pin/adhesive repair			
<input checked="" type="checkbox"/> Other:	Locate proper burial location. Identify appropriate base with flat surface (no cavity). Re-set base on pea gravel/mortar pad. Reinstall headstone with pins to attach headstone to base.					
VI. PHOTOGRAPHS						
Photo 1:			Photo 2:

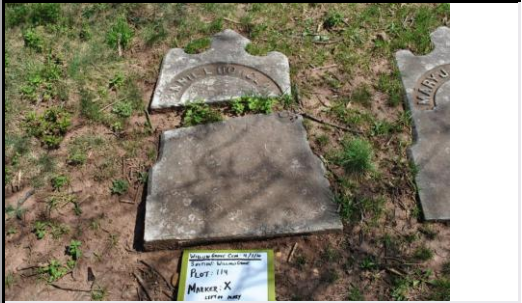
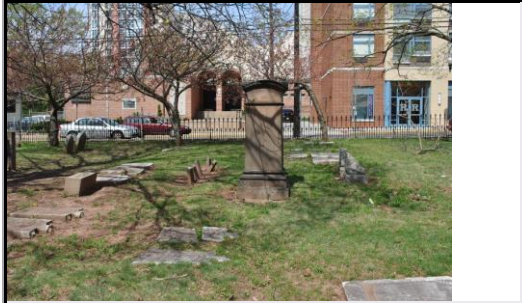
I. BURIAL INFORMATION					II. PRIORITIZATION	
First name	Last name	Birth	Death	Survey date	Condition	Prioritization
Anhill	Hoagland			4/7/2010	Poor	Moderate term
III. LOCATION						
Cemetery Section	Plot/Marker Number	Original Location	Original Marker/Feature			
Willow Grove	114.18	Yes	Yes			
IV. MARKER INFORMATION						
Marker Type						
Headstone w/ base		Height: 38	Width: 24	Depth: 4		
<input checked="" type="checkbox"/> Marble	<input type="checkbox"/> Granite	<input type="checkbox"/> Sandstone	<input type="checkbox"/> Slate			
<input type="checkbox"/> Brick	<input type="checkbox"/> Iron	<input type="checkbox"/> Other: _____

V. MATERIAL CONDITIONS						
<input checked="" type="checkbox"/> Biological - Algae	<input type="checkbox"/> Biological - Lichens	<input checked="" type="checkbox"/> Crack	<input type="checkbox"/> Delamination/Exfoliation			
<input checked="" type="checkbox"/> Disaggregation/Erosion	<input type="checkbox"/> Graffiti	<input checked="" type="checkbox"/> Off base (missing)	<input type="checkbox"/> Off base (adjacent)			
<input type="checkbox"/> Missing Fragment (s)	<input type="checkbox"/> Previous Repair	<input checked="" type="checkbox"/> Soiling	<input type="checkbox"/> Sunken			
<input type="checkbox"/> Tilt	<input type="checkbox"/> Corrosion					
<input checked="" type="checkbox"/> Other:	No tongue or anchors. Bottom of headstone may have been set into cavity at base.					
VI. TREATMENT RECOMMENDATIONS						
<input checked="" type="checkbox"/> Archaeology	<input type="checkbox"/> Excavate	<input type="checkbox"/> Reset on exist base	<input checked="" type="checkbox"/> Reset on salvaged base (if poss)

<input checked="" type="checkbox"/> Clean/bio removal	<input type="checkbox"/> Consolidate	<input checked="" type="checkbox"/> Composite repair	<input checked="" type="checkbox"/> Pin/adhesive repair			
<input checked="" type="checkbox"/> Other:	Locate proper burial location. Identify appropriate base with flat surface (no cavity). Re-set base on pea gravel/mortar pad. Reinstall headstone with pins to attach headstone to base.					
VI. PHOTOGRAPHS						
Photo 1:			Photo 2:

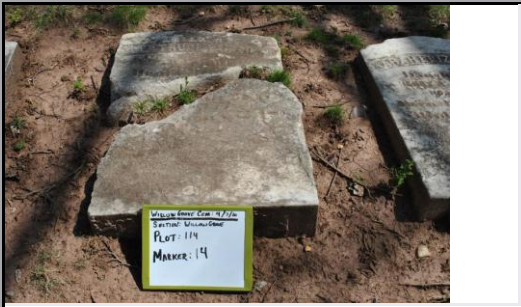
I. BURIAL INFORMATION					II. PRIORITIZATION	
First name	Last name	Birth	Death	Survey date	Condition	Prioritization
Gertrude	Hoagland	1840	1896	4/7/2010	Poor	Moderate term
III. LOCATION						
Cemetery Section	Plot/Marker Number	Original Location	Original Marker/Feature			
Willow Grove	114.14	Yes	Yes			
IV. MARKER INFORMATION						
Marker Type						
Headstone w/ base		Height: 34	Width: 22	Depth: 4		
<input checked="" type="checkbox"/> Marble	<input type="checkbox"/> Granite	<input type="checkbox"/> Sandstone	<input type="checkbox"/> Slate			
<input type="checkbox"/> Brick	<input type="checkbox"/> Iron	<input type="checkbox"/> Other: _____

V. MATERIAL CONDITIONS						
<input checked="" type="checkbox"/> Biological - Algae	<input type="checkbox"/> Biological - Lichens	<input checked="" type="checkbox"/> Crack	<input type="checkbox"/> Delamination/Exfoliation			
<input checked="" type="checkbox"/> Disaggregation/Erosion	<input type="checkbox"/> Graffiti	<input checked="" type="checkbox"/> Off base (missing)	<input type="checkbox"/> Off base (adjacent)			
<input type="checkbox"/> Missing Fragment (s)	<input type="checkbox"/> Previous Repair	<input type="checkbox"/> Soiling	<input type="checkbox"/> Sunken			
<input type="checkbox"/> Tilt	<input type="checkbox"/> Corrosion					
<input checked="" type="checkbox"/> Other:	No tongue or anchors. Bottom of headstone may have been set into cavity at base.					
VI. TREATMENT RECOMMENDATIONS						
<input checked="" type="checkbox"/> Archaeology	<input type="checkbox"/> Excavate	<input checked="" type="checkbox"/> Reset on exist base	<input type="checkbox"/> Reset on salvaged base (if poss)

<input checked="" type="checkbox"/> Clean/bio removal	<input type="checkbox"/> Consolidate	<input checked="" type="checkbox"/> Composite repair	<input checked="" type="checkbox"/> Pin/adhesive repair			
<input checked="" type="checkbox"/> Other:	Locate proper burial location. Identify appropriate base with flat surface (no cavity). Re-set base on pea gravel/mortar pad. Reinstall headstone with pins to attach headstone to base.					
VI. PHOTOGRAPHS						
Photo 1:			Photo 2:

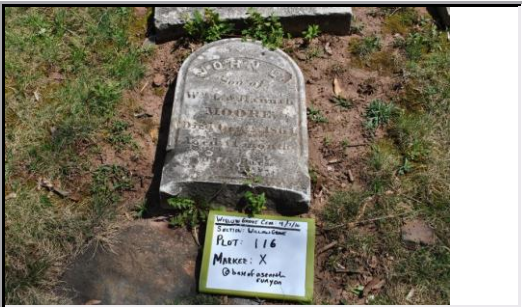
I. BURIAL INFORMATION					II. PRIORITIZATION	
First name	Last name	Birth	Death	Survey date	Condition	Prioritization
John	Moore		1861	4/7/2010	Poor	Moderate term
III. LOCATION						
Cemetery Section	Plot/Marker Number	Original Location	Original Marker/Feature			
Willow Grove	116.99	No	Yes			
IV. MARKER INFORMATION						
Marker Type						
Headstone w/ base		Height: 24	Width: 15	Depth: 4		
<input checked="" type="checkbox"/> Marble	<input type="checkbox"/> Granite	<input type="checkbox"/> Sandstone	<input type="checkbox"/> Slate			
<input type="checkbox"/> Brick	<input type="checkbox"/> Iron	<input type="checkbox"/> Other: _____

V. MATERIAL CONDITIONS						
<input checked="" type="checkbox"/> Biological - Algae	<input type="checkbox"/> Biological - Lichens	<input type="checkbox"/> Crack	<input type="checkbox"/> Delamination/Exfoliation			
<input checked="" type="checkbox"/> Disaggregation/Erosion	<input type="checkbox"/> Graffiti	<input checked="" type="checkbox"/> Off base (missing)	<input type="checkbox"/> Off base (adjacent)			
<input type="checkbox"/> Missing Fragment (s)	<input type="checkbox"/> Previous Repair	<input type="checkbox"/> Soiling	<input type="checkbox"/> Sunken			
<input type="checkbox"/> Tilt	<input type="checkbox"/> Corrosion					
<input checked="" type="checkbox"/> Other:	Patterns of biological growth indicate chronic moisture within recessed/carved elements on headstone.					
VI. TREATMENT RECOMMENDATIONS						
<input type="checkbox"/> Archaeology	<input type="checkbox"/> Excavate	<input type="checkbox"/> Reset on exist base	<input checked="" type="checkbox"/> Reset on salvaged base (if poss)

<input checked="" type="checkbox"/> Clean/bio removal	<input type="checkbox"/> Consolidate	<input checked="" type="checkbox"/> Composite repair	<input type="checkbox"/> Pin/adhesive repair			
<input checked="" type="checkbox"/> Other:	Locate proper burial location. Identify appropriate base with flat surface (no cavity). Re-set base on pea gravel/mortar pad. Reinstall headstone with pins to attach headstone to base.					
VI. PHOTOGRAPHS						
Photo 1:			Photo 2:

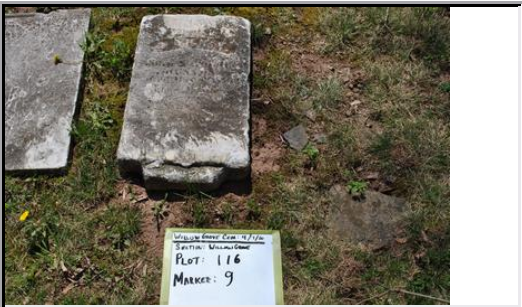
I. BURIAL INFORMATION					II. PRIORITIZATION	
First name	Last name	Birth	Death	Survey date	Condition	Prioritization
John	Runyon			4/7/2010	Poor	Moderate term
III. LOCATION						
Cemetery Section	Plot/Marker Number	Original Location	Original Marker/Feature			
Willow Grove	116.09	Yes	Yes			
IV. MARKER INFORMATION						
Marker Type						
Headstone w/ base		Height: 22	Width: 13	Depth: 4		
<input checked="" type="checkbox"/> Marble	<input type="checkbox"/> Granite	<input type="checkbox"/> Sandstone	<input type="checkbox"/> Slate			
<input type="checkbox"/> Brick	<input type="checkbox"/> Iron	<input type="checkbox"/> Other: _____

V. MATERIAL CONDITIONS						
<input checked="" type="checkbox"/> Biological - Algae	<input type="checkbox"/> Biological - Lichens	<input type="checkbox"/> Crack	<input type="checkbox"/> Delamination/Exfoliation			
<input checked="" type="checkbox"/> Disaggregation/Erosion	<input type="checkbox"/> Graffiti	<input checked="" type="checkbox"/> Off base (missing)	<input type="checkbox"/> Off base (adjacent)			
<input type="checkbox"/> Missing Fragment (s)	<input type="checkbox"/> Previous Repair	<input checked="" type="checkbox"/> Soiling	<input type="checkbox"/> Sunken			
<input type="checkbox"/> Tilt	<input type="checkbox"/> Corrosion					
<input checked="" type="checkbox"/> Other:	Tongue at base of marker - original attachment to base.					
VI. TREATMENT RECOMMENDATIONS						
<input type="checkbox"/> Archaeology	<input type="checkbox"/> Excavate	<input type="checkbox"/> Reset on exist base	<input checked="" type="checkbox"/> Reset on salvaged base (if poss)

<input checked="" type="checkbox"/> Clean/bio removal	<input type="checkbox"/> Consolidate	<input type="checkbox"/> Composite repair	<input type="checkbox"/> Pin/adhesive repair			
<input checked="" type="checkbox"/> Other:	Locate proper burial location. Identify appropriate base with tongue cavity. Re-set base on pea gravel/mortar pad. Reinstall headstone with tongue in mortared cavity.					
VI. PHOTOGRAPHS						
Photo 1:			Photo 2:

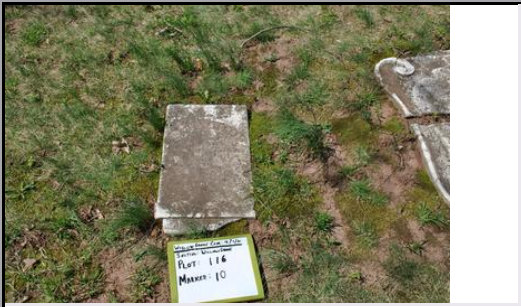
I. BURIAL INFORMATION					II. PRIORITIZATION	
First name	Last name	Birth	Death	Survey date	Condition	Prioritization
Cornelia	Runyon			4/7/2010	Poor	Moderate term
III. LOCATION						
Cemetery Section	Plot/Marker Number	Original Location	Original Marker/Feature			
Willow Grove	116.10	Yes	Yes			
IV. MARKER INFORMATION						
Marker Type						
Headstone w/ base		Height: 24	Width: 14	Depth: 3		
<input checked="" type="checkbox"/> Marble	<input type="checkbox"/> Granite	<input type="checkbox"/> Sandstone	<input type="checkbox"/> Slate			
<input type="checkbox"/> Brick	<input type="checkbox"/> Iron	<input type="checkbox"/> Other: _____

V. MATERIAL CONDITIONS						
<input checked="" type="checkbox"/> Biological - Algae	<input type="checkbox"/> Biological - Lichens	<input type="checkbox"/> Crack	<input type="checkbox"/> Delamination/Exfoliation			
<input checked="" type="checkbox"/> Disaggregation/Erosion	<input type="checkbox"/> Graffiti	<input checked="" type="checkbox"/> Off base (missing)	<input type="checkbox"/> Off base (adjacent)			
<input type="checkbox"/> Missing Fragment (s)	<input type="checkbox"/> Previous Repair	<input type="checkbox"/> Soiling	<input type="checkbox"/> Sunken			
<input type="checkbox"/> Tilt	<input type="checkbox"/> Corrosion					
<input checked="" type="checkbox"/> Other:	Tongue at base of marker - original attachment to base.					
VI. TREATMENT RECOMMENDATIONS						
<input type="checkbox"/> Archaeology	<input type="checkbox"/> Excavate	<input type="checkbox"/> Reset on exist base	<input checked="" type="checkbox"/> Reset on salvaged base (if poss)

<input checked="" type="checkbox"/> Clean/bio removal	<input type="checkbox"/> Consolidate	<input type="checkbox"/> Composite repair	<input type="checkbox"/> Pin/adhesive repair			
<input checked="" type="checkbox"/> Other:	Locate proper burial location. Identify appropriate base with tongue cavity. Re-set base on pea gravel/mortar pad. Reinstall headstone with tongue in mortared cavity.					
VI. PHOTOGRAPHS						
Photo 1:			Photo 2:

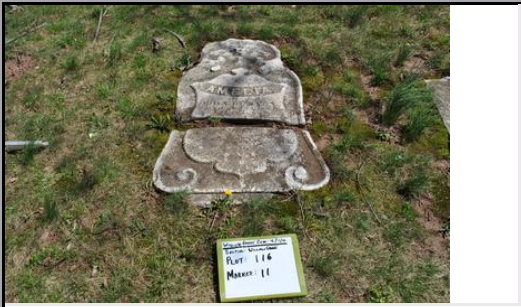
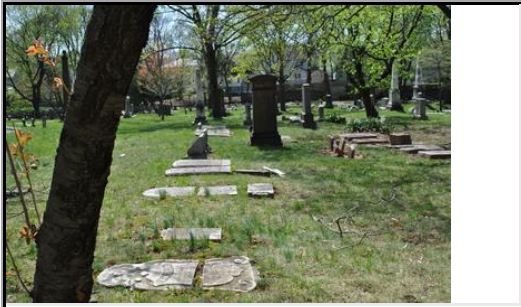
I. BURIAL INFORMATION					II. PRIORITIZATION	
First name	Last name	Birth	Death	Survey date	Condition	Prioritization
Runyon	Amelia			4/7/2010	Poor	Moderate term
III. LOCATION						
Cemetery Section	Plot/Marker Number	Original Location	Original Marker/Feature			
Willow Grove	116.11	Yes	Yes			
IV. MARKER INFORMATION						
Marker Type						
Headstone w/ base		Height: 48	Width: 28	Depth: 4		
<input checked="" type="checkbox"/> Marble	<input type="checkbox"/> Granite	<input type="checkbox"/> Sandstone	<input type="checkbox"/> Slate			
<input type="checkbox"/> Brick	<input type="checkbox"/> Iron	<input type="checkbox"/> Other: _____

V. MATERIAL CONDITIONS						
<input checked="" type="checkbox"/> Biological - Algae	<input type="checkbox"/> Biological - Lichens	<input checked="" type="checkbox"/> Crack	<input type="checkbox"/> Delamination/Exfoliation			
<input checked="" type="checkbox"/> Disaggregation/Erosion	<input type="checkbox"/> Graffiti	<input checked="" type="checkbox"/> Off base (missing)	<input type="checkbox"/> Off base (adjacent)			
<input type="checkbox"/> Missing Fragment (s)	<input type="checkbox"/> Previous Repair	<input type="checkbox"/> Soiling	<input type="checkbox"/> Sunken			
<input type="checkbox"/> Tilt	<input type="checkbox"/> Corrosion					
<input checked="" type="checkbox"/> Other:	Tongue at base of marker - original attachment to base.					
VI. TREATMENT RECOMMENDATIONS						
<input type="checkbox"/> Archaeology	<input type="checkbox"/> Excavate	<input type="checkbox"/> Reset on exist base	<input checked="" type="checkbox"/> Reset on salvaged base (if poss)

<input checked="" type="checkbox"/> Clean/bio removal	<input type="checkbox"/> Consolidate	<input type="checkbox"/> Composite repair	<input type="checkbox"/> Pin/adhesive repair			
<input checked="" type="checkbox"/> Other:	Locate proper burial location. Identify appropriate base with tongue cavity. Re-set base on pea gravel/mortar pad. Reinstall headstone with tongue in mortared cavity.					
VI. PHOTOGRAPHS						
Photo 1:			Photo 2:

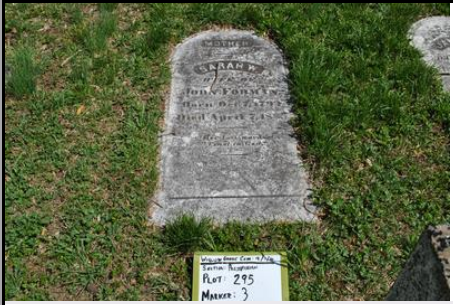
I. BURIAL INFORMATION					II. PRIORITIZATION	
First name	Last name	Birth	Death	Survey date	Condition	Prioritization
Sarah	Forman	1793	1885	4/7/2010	Poor	Moderate term
III. LOCATION						
Cemetery Section	Plot/Marker Number	Original Location	Original Marker/Feature			
Presbyterian	295.03	Yes	Yes			
IV. MARKER INFORMATION						
Marker Type						
Headstone w/ base		Height: 48	Width: 22	Depth: 4		
<input checked="" type="checkbox"/> Marble	<input type="checkbox"/> Granite	<input type="checkbox"/> Sandstone	<input type="checkbox"/> Slate			
<input type="checkbox"/> Brick	<input type="checkbox"/> Iron	<input type="checkbox"/> Other: _____

V. MATERIAL CONDITIONS						
<input checked="" type="checkbox"/> Biological - Algae	<input type="checkbox"/> Biological - Lichens	<input type="checkbox"/> Crack	<input type="checkbox"/> Delamination/Exfoliation			
<input checked="" type="checkbox"/> Disaggregation/Erosion	<input type="checkbox"/> Graffiti	<input type="checkbox"/> Off base (missing)	<input type="checkbox"/> Off base (adjacent)			
<input type="checkbox"/> Missing Fragment (s)	<input type="checkbox"/> Previous Repair	<input checked="" type="checkbox"/> Soiling	<input type="checkbox"/> Sunken			
<input type="checkbox"/> Tilt	<input type="checkbox"/> Corrosion					
<input type="checkbox"/> Other:	_____					
VI. TREATMENT RECOMMENDATIONS						
<input checked="" type="checkbox"/> Archaeology	<input type="checkbox"/> Excavate	<input type="checkbox"/> Reset on exist base	<input checked="" type="checkbox"/> Reset on salvaged base (if poss)

<input checked="" type="checkbox"/> Clean/bio removal	<input type="checkbox"/> Consolidate	<input type="checkbox"/> Composite repair	<input type="checkbox"/> Pin/adhesive repair			
<input checked="" type="checkbox"/> Other:	Locate proper burial location. Identify appropriate base with flat surface (no cavity). Re-set base on pea gravel/mortar pad. Reinstall headstone with pins to attach headstone to base.					
VI. PHOTOGRAPHS						
Photo 1:			Photo 2:

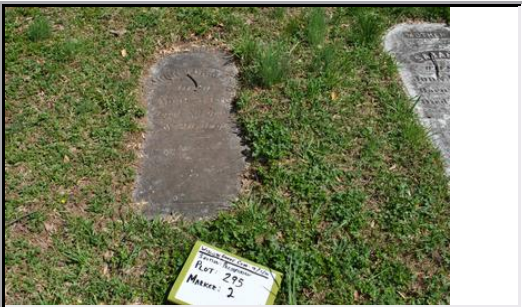
I. BURIAL INFORMATION					II. PRIORITIZATION	
First name	Last name	Birth	Death	Survey date	Condition	Prioritization
John	Forman		1875	4/7/2010	Poor	Moderate term
III. LOCATION						
Cemetery Section	Plot/Marker Number	Original Location	Original Marker/Feature			
Presbyterian	295.02	Yes	Yes			
IV. MARKER INFORMATION						
Marker Type						
Headstone w/ base		Height: 48	Width: 22	Depth: 4		
<input type="checkbox"/> Marble	<input type="checkbox"/> Granite	<input checked="" type="checkbox"/> Sandstone	<input type="checkbox"/> Slate			
<input type="checkbox"/> Brick	<input type="checkbox"/> Iron	<input type="checkbox"/> Other: _____

V. MATERIAL CONDITIONS						
<input checked="" type="checkbox"/> Biological - Algae	<input type="checkbox"/> Biological - Lichens	<input type="checkbox"/> Crack	<input type="checkbox"/> Delamination/Exfoliation			
<input checked="" type="checkbox"/> Disaggregation/Erosion	<input type="checkbox"/> Graffiti	<input checked="" type="checkbox"/> Off base (missing)	<input type="checkbox"/> Off base (adjacent)			
<input type="checkbox"/> Missing Fragment (s)	<input type="checkbox"/> Previous Repair	<input type="checkbox"/> Soiling	<input checked="" type="checkbox"/> Sunken			
<input type="checkbox"/> Tilt	<input type="checkbox"/> Corrosion					
<input type="checkbox"/> Other:	_____					
VI. TREATMENT RECOMMENDATIONS						
<input checked="" type="checkbox"/> Archaeology	<input checked="" type="checkbox"/> Excavate	<input type="checkbox"/> Reset on exist base	<input checked="" type="checkbox"/> Reset on salvaged base (if poss)

<input checked="" type="checkbox"/> Clean/bio removal	<input type="checkbox"/> Consolidate	<input type="checkbox"/> Composite repair	<input type="checkbox"/> Pin/adhesive repair			
<input checked="" type="checkbox"/> Other:	Locate proper burial location. Identify appropriate base with tongue cavity. Re-set base on pea gravel/mortar pad. Reinstall headstone with tongue in mortared cavity.					
VI. PHOTOGRAPHS						
Photo 1:			Photo 2:

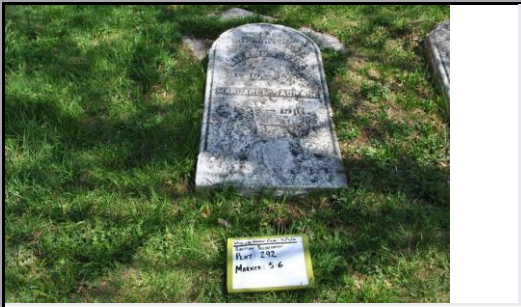
I. BURIAL INFORMATION					II. PRIORITIZATION	
First name	Last name	Birth	Death	Survey date	Condition	Prioritization
Sarah	Adrain		1915	4/7/2010	Poor	Moderate term
III. LOCATION						
Cemetery Section	Plot/Marker Number	Original Location	Original Marker/Feature			
Presbyterian	292.05	Yes	Yes			
IV. MARKER INFORMATION						
Marker Type						
Headstone w/ base		Height: 48	Width: 24	Depth: 4		
<input checked="" type="checkbox"/> Marble	<input type="checkbox"/> Granite	<input type="checkbox"/> Sandstone	<input type="checkbox"/> Slate			
<input type="checkbox"/> Brick	<input type="checkbox"/> Iron	<input type="checkbox"/> Other: _____

V. MATERIAL CONDITIONS						
<input checked="" type="checkbox"/> Biological - Algae	<input type="checkbox"/> Biological - Lichens	<input type="checkbox"/> Crack	<input type="checkbox"/> Delamination/Exfoliation			
<input type="checkbox"/> Disaggregation/Erosion	<input type="checkbox"/> Graffiti	<input checked="" type="checkbox"/> Off base (missing)	<input type="checkbox"/> Off base (adjacent)			
<input type="checkbox"/> Missing Fragment (s)	<input type="checkbox"/> Previous Repair	<input checked="" type="checkbox"/> Soiling	<input type="checkbox"/> Sunken			
<input type="checkbox"/> Tilt	<input type="checkbox"/> Corrosion					
<input type="checkbox"/> Other:	_____					
VI. TREATMENT RECOMMENDATIONS						
<input checked="" type="checkbox"/> Archaeology	<input type="checkbox"/> Excavate	<input type="checkbox"/> Reset on exist base	<input checked="" type="checkbox"/> Reset on salvaged base (if poss)

<input checked="" type="checkbox"/> Clean/bio removal	<input type="checkbox"/> Consolidate	<input type="checkbox"/> Composite repair	<input type="checkbox"/> Pin/adhesive repair			
<input checked="" type="checkbox"/> Other:	Locate proper burial location. Identify appropriate base with tongue cavity. Re-set base on pea gravel/mortar pad. Reinstall headstone with tongue in mortared cavity.					
VI. PHOTOGRAPHS						
Photo 1:			Photo 2:

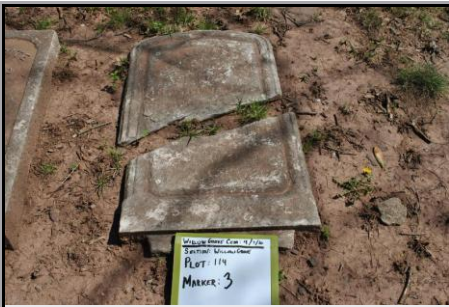
I. BURIAL INFORMATION					II. PRIORITIZATION	
First name	Last name	Birth	Death	Survey date	Condition	Prioritization
Arietta	Hoagland			4/7/2010	Poor	Moderate term
III. LOCATION						
Cemetery Section	Plot/Marker Number	Original Location	Original Marker/Feature			
Willow Grove	114.03	Yes	Yes			
IV. MARKER INFORMATION						
Marker Type						
Headstone w/ base		Height: 38	Width: 22	Depth: 4		
<input checked="" type="checkbox"/> Marble	<input type="checkbox"/> Granite	<input type="checkbox"/> Sandstone	<input type="checkbox"/> Slate			
<input type="checkbox"/> Brick	<input type="checkbox"/> Iron	<input type="checkbox"/> Other: _____

V. MATERIAL CONDITIONS						
<input checked="" type="checkbox"/> Biological - Algae	<input type="checkbox"/> Biological - Lichens	<input checked="" type="checkbox"/> Crack	<input type="checkbox"/> Delamination/Exfoliation			
<input checked="" type="checkbox"/> Disaggregation/Erosion	<input type="checkbox"/> Graffiti	<input checked="" type="checkbox"/> Off base (missing)	<input type="checkbox"/> Off base (adjacent)			
<input type="checkbox"/> Missing Fragment (s)	<input type="checkbox"/> Previous Repair	<input checked="" type="checkbox"/> Soiling	<input type="checkbox"/> Sunken			
<input type="checkbox"/> Tilt	<input type="checkbox"/> Corrosion					
<input checked="" type="checkbox"/> Other:	Tongue at base of marker - original attachment to base.					
VI. TREATMENT RECOMMENDATIONS						
<input type="checkbox"/> Archaeology	<input type="checkbox"/> Excavate	<input type="checkbox"/> Reset on exist base	<input checked="" type="checkbox"/> Reset on salvaged base (if poss)

<input checked="" type="checkbox"/> Clean/bio removal	<input type="checkbox"/> Consolidate	<input type="checkbox"/> Composite repair	<input checked="" type="checkbox"/> Pin/adhesive repair			
<input checked="" type="checkbox"/> Other:	Locate proper burial location. Identify appropriate base with tongue cavity. Re-set base on pea gravel/mortar pad. Reinstall headstone with tongue in mortared cavity.					
VI. PHOTOGRAPHS						
Photo 1:			Photo 2:

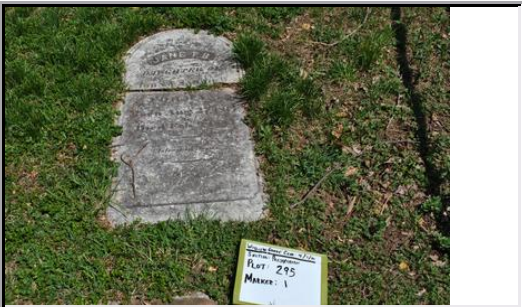
I. BURIAL INFORMATION					II. PRIORITIZATION	
First name	Last name	Birth	Death	Survey date	Condition	Prioritization
Jane	Forman	1814	1885	4/7/2010	Poor	Moderate term
III. LOCATION						
Cemetery Section	Plot/Marker Number	Original Location	Original Marker/Feature			
Presbyterian	295.01	Yes	Yes			
IV. MARKER INFORMATION						
Marker Type	Height:	Width:	Depth:			
Headstone w/ base	48	22	4			
<input checked="" type="checkbox"/> Marble	<input type="checkbox"/> Granite	<input type="checkbox"/> Sandstone	<input type="checkbox"/> Slate			
<input type="checkbox"/> Brick	<input type="checkbox"/> Iron	<input type="checkbox"/> Other:

V. MATERIAL CONDITIONS						
<input checked="" type="checkbox"/> Biological - Algae	<input type="checkbox"/> Biological - Lichens	<input checked="" type="checkbox"/> Crack	<input type="checkbox"/> Delamination/Exfoliation			
<input type="checkbox"/> Disaggregation/Erosion	<input type="checkbox"/> Graffiti	<input checked="" type="checkbox"/> Off base (missing)	<input type="checkbox"/> Off base (adjacent)			
<input type="checkbox"/> Missing Fragment (s)	<input type="checkbox"/> Previous Repair	<input checked="" type="checkbox"/> Soiling	<input type="checkbox"/> Sunken			
<input type="checkbox"/> Tilt	<input type="checkbox"/> Corrosion					
<input type="checkbox"/> Other:						
VI. TREATMENT RECOMMENDATIONS						
<input type="checkbox"/> Archaeology	<input type="checkbox"/> Excavate	<input type="checkbox"/> Reset on exist base	<input checked="" type="checkbox"/> Reset on salvaged base (if poss)			
<input checked="" type="checkbox"/> Clean/bio removal	<input type="checkbox"/> Consolidate	<input checked="" type="checkbox"/> Composite repair	<input checked="" type="checkbox"/> Pin/adhesive repair

<input checked="" type="checkbox"/> Other:	Locate proper burial location. Identify appropriate base with tongue cavity. Re-set base on pea gravel/mortar pad. Reinstall headstone with tongue in mortared cavity.					
VI. PHOTOGRAPHS						
Photo 1:			Photo 2:

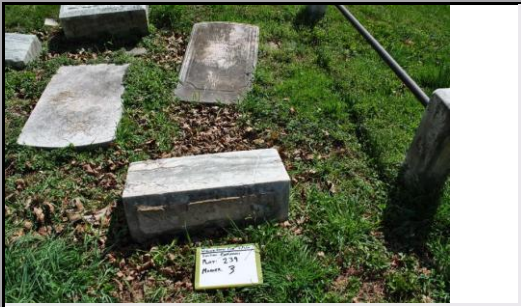
I. BURIAL INFORMATION					II. PRIORITIZATION	
First name	Last name	Birth	Death	Survey date	Condition	Prioritization
Emma	Bodine		1897	4/7/2010	Poor	Moderate term
III. LOCATION						
Cemetery Section	Plot/Marker Number	Original Location	Original Marker/Feature			
Cheesman	239.03	Yes	Yes			
IV. MARKER INFORMATION						
Marker Type						
Headstone w/ base		Height: 42	Width: 24	Depth: 5		
<input checked="" type="checkbox"/> Marble	<input type="checkbox"/> Granite	<input type="checkbox"/> Sandstone	<input type="checkbox"/> Slate			
<input type="checkbox"/> Brick	<input type="checkbox"/> Iron	<input type="checkbox"/> Other: _____

V. MATERIAL CONDITIONS						
<input checked="" type="checkbox"/> Biological - Algae	<input type="checkbox"/> Biological - Lichens	<input type="checkbox"/> Crack	<input type="checkbox"/> Delamination/Exfoliation			
<input checked="" type="checkbox"/> Disaggregation/Erosion	<input type="checkbox"/> Graffiti	<input type="checkbox"/> Off base (missing)	<input checked="" type="checkbox"/> Off base (adjacent)			
<input type="checkbox"/> Missing Fragment (s)	<input type="checkbox"/> Previous Repair	<input type="checkbox"/> Soiling	<input type="checkbox"/> Sunken			
<input type="checkbox"/> Tilt	<input type="checkbox"/> Corrosion					
<input checked="" type="checkbox"/> Other:	Inscription is face down, not possible to identify without first excavating.					
VI. TREATMENT RECOMMENDATIONS						
<input checked="" type="checkbox"/> Archaeology	<input checked="" type="checkbox"/> Excavate	<input checked="" type="checkbox"/> Reset on exist base	<input type="checkbox"/> Reset on salvaged base (if poss)

<input checked="" type="checkbox"/> Clean/bio removal	<input type="checkbox"/> Consolidate	<input type="checkbox"/> Composite repair	<input checked="" type="checkbox"/> Pin/adhesive repair			
<input checked="" type="checkbox"/> Other:	Locate proper burial location. Identify appropriate base with flat surface (no cavity). Re-set base on pea gravel/mortar pad. Reinstall headstone with pins to attach headstone to base.					
VI. PHOTOGRAPHS						
Photo 1:			Photo 2:

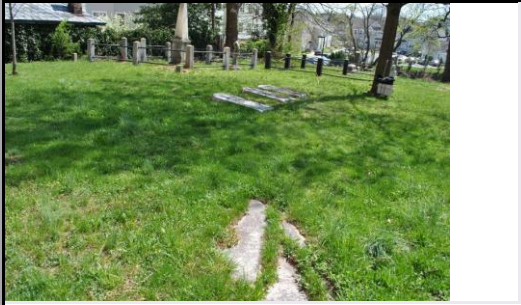
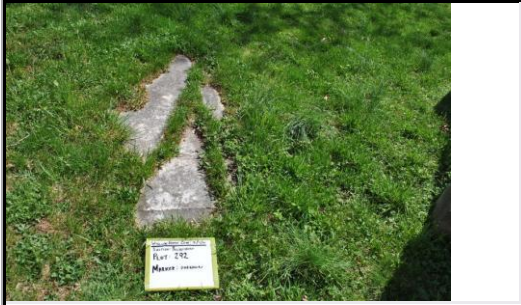
I. BURIAL INFORMATION					II. PRIORITIZATION	
First name	Last name	Birth	Death	Survey date	Condition	Prioritization
				4/7/2010	Poor	Moderate term
III. LOCATION						
Cemetery Section	Plot/Marker Number	Original Location	Original Marker/Feature			
Presbyterian	292.01	Yes	Yes			
IV. MARKER INFORMATION						
Marker Type						
Headstone w/ base		Height:	Width:	Depth:		
<input checked="" type="checkbox"/> Marble	<input type="checkbox"/> Granite	<input type="checkbox"/> Sandstone	<input type="checkbox"/> Slate			
<input type="checkbox"/> Brick	<input type="checkbox"/> Iron	<input type="checkbox"/> Other: _____

V. MATERIAL CONDITIONS						
<input checked="" type="checkbox"/> Biological - Algae	<input type="checkbox"/> Biological - Lichens	<input checked="" type="checkbox"/> Crack	<input type="checkbox"/> Delamination/Exfoliation			
<input type="checkbox"/> Disaggregation/Erosion	<input type="checkbox"/> Graffiti	<input checked="" type="checkbox"/> Off base (missing)	<input type="checkbox"/> Off base (adjacent)			
<input checked="" type="checkbox"/> Missing Fragment (s)	<input type="checkbox"/> Previous Repair	<input checked="" type="checkbox"/> Soiling	<input checked="" type="checkbox"/> Sunken			
<input type="checkbox"/> Tilt	<input type="checkbox"/> Corrosion					
<input checked="" type="checkbox"/> Other:	Inscription is face down, not possible to identify without first excavating.					
VI. TREATMENT RECOMMENDATIONS						
<input checked="" type="checkbox"/> Archaeology	<input checked="" type="checkbox"/> Excavate	<input type="checkbox"/> Reset on exist base	<input checked="" type="checkbox"/> Reset on salvaged base (if poss)

<input checked="" type="checkbox"/> Clean/bio removal	<input type="checkbox"/> Consolidate	<input type="checkbox"/> Composite repair	<input checked="" type="checkbox"/> Pin/adhesive repair			
<input checked="" type="checkbox"/> Other:	Locate proper burial location. Identify appropriate base with tongue cavity. Re-set base on pea gravel/mortar pad. Reinstall headstone with tongue in mortared cavity.					
VI. PHOTOGRAPHS						
Photo 1:			Photo 2:

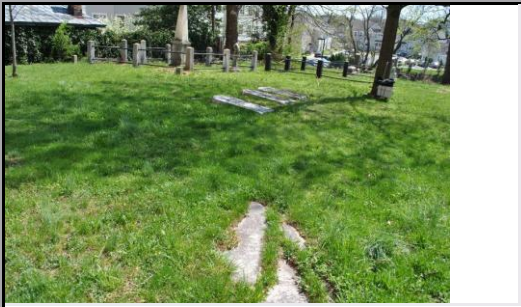
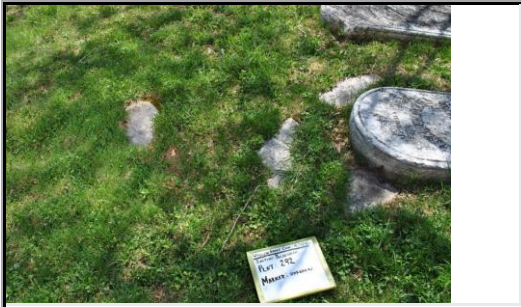
I. BURIAL INFORMATION					II. PRIORITIZATION	
First name	Last name	Birth	Death	Survey date	Condition	Prioritization
				4/7/2010	Poor	Moderate term
III. LOCATION						
Cemetery Section	Plot/Marker Number	Original Location	Original Marker/Feature			
Presbyterian	292.02	Yes	Yes			
IV. MARKER INFORMATION						
Marker Type						
Headstone w/ base		Height:	Width:	Depth:		
<input checked="" type="checkbox"/> Marble	<input type="checkbox"/> Granite	<input type="checkbox"/> Sandstone	<input type="checkbox"/> Slate			
<input type="checkbox"/> Brick	<input type="checkbox"/> Iron	<input type="checkbox"/> Other: _____

V. MATERIAL CONDITIONS						
<input checked="" type="checkbox"/> Biological - Algae	<input type="checkbox"/> Biological - Lichens	<input checked="" type="checkbox"/> Crack	<input type="checkbox"/> Delamination/Exfoliation			
<input checked="" type="checkbox"/> Disaggregation/Erosion	<input type="checkbox"/> Graffiti	<input checked="" type="checkbox"/> Off base (missing)	<input type="checkbox"/> Off base (adjacent)			
<input checked="" type="checkbox"/> Missing Fragment (s)	<input type="checkbox"/> Previous Repair	<input checked="" type="checkbox"/> Soiling	<input checked="" type="checkbox"/> Sunken			
<input type="checkbox"/> Tilt	<input type="checkbox"/> Corrosion					
<input checked="" type="checkbox"/> Other:	Inscription is face down, not possible to identify without first excavating.					
VI. TREATMENT RECOMMENDATIONS						
<input checked="" type="checkbox"/> Archaeology	<input checked="" type="checkbox"/> Excavate	<input type="checkbox"/> Reset on exist base	<input checked="" type="checkbox"/> Reset on salvaged base (if poss)

<input checked="" type="checkbox"/> Clean/bio removal	<input type="checkbox"/> Consolidate	<input type="checkbox"/> Composite repair	<input checked="" type="checkbox"/> Pin/adhesive repair			
<input checked="" type="checkbox"/> Other:	Locate proper burial location. Identify appropriate base with tongue cavity. Re-set base on pea gravel/mortar pad. Reinstall headstone with tongue in mortared cavity.					
VI. PHOTOGRAPHS						
Photo 1:			Photo 2:

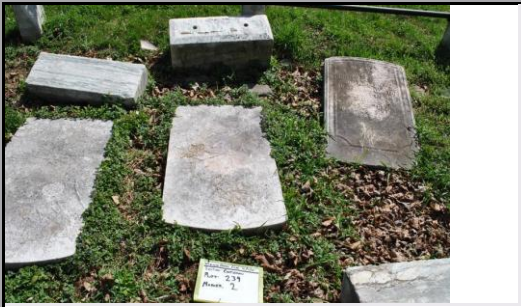
I. BURIAL INFORMATION					II. PRIORITIZATION	
First name	Last name	Birth	Death	Survey date	Condition	Prioritization
Ellen C.	Hill		1886	4/7/2010	Poor	Moderate term
III. LOCATION						
Cemetery Section	Plot/Marker Number	Original Location	Original Marker/Feature			
Cheesman	239.02	Yes	Yes			
IV. MARKER INFORMATION						
Marker Type						
Headstone w/ base		Height: 42	Width: 24	Depth: 5		
<input checked="" type="checkbox"/> Marble	<input type="checkbox"/> Granite	<input type="checkbox"/> Sandstone	<input type="checkbox"/> Slate			
<input type="checkbox"/> Brick	<input type="checkbox"/> Iron	<input type="checkbox"/> Other: _____

V. MATERIAL CONDITIONS						
<input checked="" type="checkbox"/> Biological - Algae	<input type="checkbox"/> Biological - Lichens	<input type="checkbox"/> Crack	<input type="checkbox"/> Delamination/Exfoliation			
<input checked="" type="checkbox"/> Disaggregation/Erosion	<input type="checkbox"/> Graffiti	<input type="checkbox"/> Off base (missing)	<input checked="" type="checkbox"/> Off base (adjacent)			
<input type="checkbox"/> Missing Fragment (s)	<input type="checkbox"/> Previous Repair	<input checked="" type="checkbox"/> Soiling	<input type="checkbox"/> Sunken			
<input type="checkbox"/> Tilt	<input type="checkbox"/> Corrosion					
<input checked="" type="checkbox"/> Other:	Inscription is face down, not possible to identify without first excavating.					
VI. TREATMENT RECOMMENDATIONS						
<input checked="" type="checkbox"/> Archaeology	<input checked="" type="checkbox"/> Excavate	<input checked="" type="checkbox"/> Reset on exist base	<input type="checkbox"/> Reset on salvaged base (if poss)

<input checked="" type="checkbox"/> Clean/bio removal	<input type="checkbox"/> Consolidate	<input type="checkbox"/> Composite repair	<input checked="" type="checkbox"/> Pin/adhesive repair			
<input checked="" type="checkbox"/> Other:	Locate proper burial location. Identify appropriate base with flat surface (no cavity). Re-set base on pea gravel/mortar pad. Reinstall headstone with pins to attach headstone to base.					
VI. PHOTOGRAPHS						
Photo 1:			Photo 2:

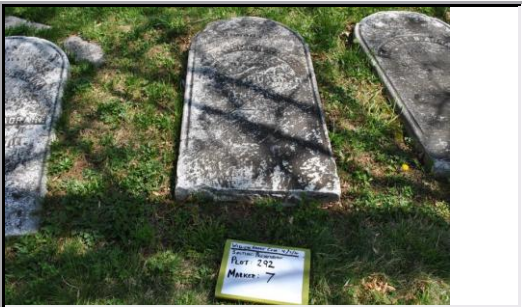
VI. PHOTOGRAPHS	
Photo 1:

I. BURIAL INFORMATION					II. PRIORITIZATION	
First name	Last name	Birth	Death	Survey date	Condition	Prioritization
M.S.G.	Adrain	1817	1886	4/7/2010	Poor	Moderate term

V. MATERIAL CONDITIONS			
<input type="checkbox"/> Biological - Algae	<input type="checkbox"/> Biological - Lichens	<input type="checkbox"/> Crack	<input type="checkbox"/> Delamination/Exfoliation
<input type="checkbox"/> Disaggregation/Erosion	<input type="checkbox"/> Graffiti	<input checked="" type="checkbox"/> Off base (missing)	<input type="checkbox"/> Off base (adjacent)
<input type="checkbox"/> Missing Fragment (s)	<input type="checkbox"/> Previous Repair	<input type="checkbox"/> Soiling	<input type="checkbox"/> Sunken
<input type="checkbox"/> Tilt	<input type="checkbox"/> Corrosion		
<input type="checkbox"/> Other:	_____

VI. TREATMENT RECOMMENDATIONS			
<input checked="" type="checkbox"/> Archaeology	<input type="checkbox"/> Excavate	<input type="checkbox"/> Reset on exist base	<input checked="" type="checkbox"/> Reset on salvaged base (if poss)
<input checked="" type="checkbox"/> Clean/bio removal	<input type="checkbox"/> Consolidate	<input type="checkbox"/> Composite repair	<input type="checkbox"/> Pin/adhesive repair
<input checked="" type="checkbox"/> Other:	Locate proper burial location. Identify appropriate base with tongue cavity. Re-set base on pea gravel/mortar pad. Reinstall headstone with tongue in mortared cavity.

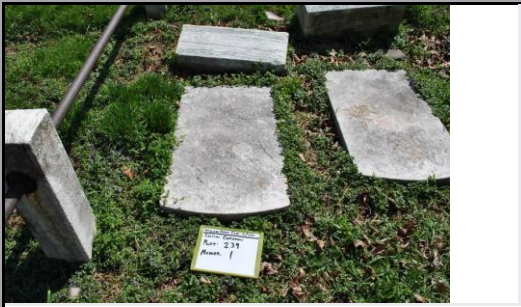
I. BURIAL INFORMATION					II. PRIORITIZATION	
First name	Last name	Birth	Death	Survey date	Condition	Prioritization
Charles S.	Hill		1884	4/7/2010	Poor	Moderate term
III. LOCATION						
Cemetery Section	Plot/Marker Number	Original Location	Original Marker/Feature			
Cheesman	239.01	Yes	Yes			
IV. MARKER INFORMATION						
Marker Type						
Headstone w/ base		Height: 42	Width: 24	Depth: 5		
<input checked="" type="checkbox"/> Marble	<input type="checkbox"/> Granite	<input type="checkbox"/> Sandstone	<input type="checkbox"/> Slate			
<input type="checkbox"/> Brick	<input type="checkbox"/> Iron	<input type="checkbox"/> Other: _____

V. MATERIAL CONDITIONS						
<input checked="" type="checkbox"/> Biological - Algae	<input type="checkbox"/> Biological - Lichens	<input type="checkbox"/> Crack	<input type="checkbox"/> Delamination/Exfoliation			
<input checked="" type="checkbox"/> Disaggregation/Erosion	<input type="checkbox"/> Graffiti	<input type="checkbox"/> Off base (missing)	<input checked="" type="checkbox"/> Off base (adjacent)			
<input type="checkbox"/> Missing Fragment (s)	<input type="checkbox"/> Previous Repair	<input checked="" type="checkbox"/> Soiling	<input type="checkbox"/> Sunken			
<input type="checkbox"/> Tilt	<input type="checkbox"/> Corrosion					
<input checked="" type="checkbox"/> Other:	Inscription is face down, not possible to identify without first excavating.					
VI. TREATMENT RECOMMENDATIONS						
<input checked="" type="checkbox"/> Archaeology	<input checked="" type="checkbox"/> Excavate	<input checked="" type="checkbox"/> Reset on exist base	<input type="checkbox"/> Reset on salvaged base (if poss)

<input checked="" type="checkbox"/> Clean/bio removal	<input type="checkbox"/> Consolidate	<input type="checkbox"/> Composite repair	<input type="checkbox"/> Pin/adhesive repair			
<input checked="" type="checkbox"/> Other:	Locate proper burial location. Identify appropriate base with flat surface (no cavity). Re-set base on pea gravel/mortar pad. Reinstall headstone with pins to attach headstone to base.					
VI. PHOTOGRAPHS						
Photo 1:			Photo 2:
