HISTORIC PRESERVATION PLAN

WILLOW GROVE CEMETERY

New Brunswick, Middlesex County, New Jersey

DATE: 4 October 2010

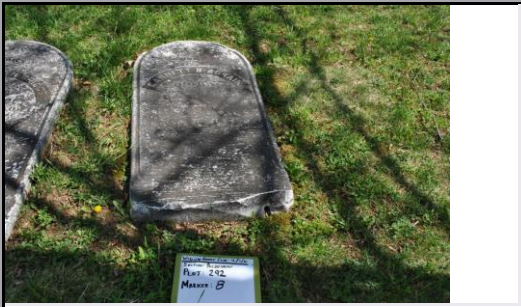
I. BURIAL INFORMATION					II. PRIORITIZATION	
First name	Last name	Birth	Death	Survey date	Condition	Prioritization
Garnett	Adrain	1815	1878	4/7/2010	Poor	Moderate term
III. LOCATION						
Cemetery Section	Plot/Marker Number	Original Location	Original Marker/Feature			
Presbyterian	292.08	Yes	Yes			
IV. MARKER INFORMATION						
Marker Type						
Headstone w/ base		Height: 48	Width: 24	Depth: 4		
<input checked="" type="checkbox"/> Marble	<input type="checkbox"/> Granite	<input type="checkbox"/> Sandstone	<input type="checkbox"/> Slate			
<input type="checkbox"/> Brick	<input type="checkbox"/> Iron	<input type="checkbox"/> Other: _____

V. MATERIAL CONDITIONS						
<input checked="" type="checkbox"/> Biological - Algae	<input type="checkbox"/> Biological - Lichens	<input type="checkbox"/> Crack	<input type="checkbox"/> Delamination/Exfoliation			
<input type="checkbox"/> Disaggregation/Erosion	<input type="checkbox"/> Graffiti	<input checked="" type="checkbox"/> Off base (missing)	<input type="checkbox"/> Off base (adjacent)			
<input type="checkbox"/> Missing Fragment (s)	<input type="checkbox"/> Previous Repair	<input checked="" type="checkbox"/> Soiling	<input type="checkbox"/> Sunken			
<input type="checkbox"/> Tilt	<input type="checkbox"/> Corrosion					
<input checked="" type="checkbox"/> Other:	Anchor cavities at bottom of main headstone.					
VI. TREATMENT RECOMMENDATIONS						
<input checked="" type="checkbox"/> Archaeology	<input type="checkbox"/> Excavate	<input type="checkbox"/> Reset on exist base	<input checked="" type="checkbox"/> Reset on salvaged base (if poss)

<input checked="" type="checkbox"/> Clean/bio removal	<input type="checkbox"/> Consolidate	<input checked="" type="checkbox"/> Composite repair	<input type="checkbox"/> Pin/adhesive repair			
<input checked="" type="checkbox"/> Other:	Locate proper burial location. Identify appropriate base with tongue cavity. Re-set base on pea gravel/mortar pad. Reinstall headstone with tongue in mortared cavity.					
VI. PHOTOGRAPHS						
Photo 1:			Photo 2:

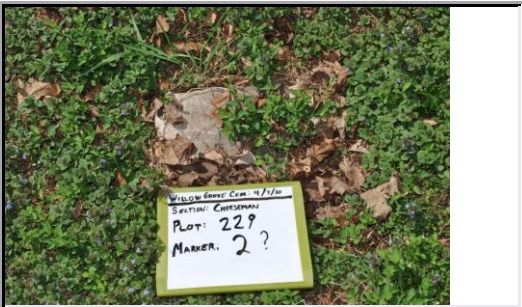
I. BURIAL INFORMATION					II. PRIORITIZATION	
First name	Last name	Birth	Death	Survey date	Condition	Prioritization
Anna	Van Marten			4/7/2010	Poor	Moderate term
III. LOCATION						
Cemetery Section	Plot/Marker Number	Original Location	Original Marker/Feature			
Cheesman	229.02	Unknown	Yes			
IV. MARKER INFORMATION						
Marker Type						
Headstone		Height:	Width:	Depth:		
<input checked="" type="checkbox"/> Marble	<input type="checkbox"/> Granite	<input type="checkbox"/> Sandstone	<input type="checkbox"/> Slate			
<input type="checkbox"/> Brick	<input type="checkbox"/> Iron	<input type="checkbox"/> Other: _____

V. MATERIAL CONDITIONS						
<input checked="" type="checkbox"/> Biological - Algae	<input type="checkbox"/> Biological - Lichens	<input type="checkbox"/> Crack	<input type="checkbox"/> Delamination/Exfoliation			
<input type="checkbox"/> Disaggregation/Erosion	<input type="checkbox"/> Graffiti	<input type="checkbox"/> Off base (missing)	<input type="checkbox"/> Off base (adjacent)			
<input type="checkbox"/> Missing Fragment (s)	<input type="checkbox"/> Previous Repair	<input checked="" type="checkbox"/> Soiling	<input checked="" type="checkbox"/> Sunken			
<input type="checkbox"/> Tilt	<input type="checkbox"/> Corrosion					
<input checked="" type="checkbox"/> Other:	Marker has sunk to a degree which precludes its unequivocal identification or determination of conditions+potential treatments. Unknown whether this is a full marker or fragment only.					
VI. TREATMENT RECOMMENDATIONS						
<input checked="" type="checkbox"/> Archaeology	<input checked="" type="checkbox"/> Excavate	<input type="checkbox"/> Reset on exist base	<input checked="" type="checkbox"/> Reset on salvaged base (if poss)

<input checked="" type="checkbox"/> Clean/bio removal	<input type="checkbox"/> Consolidate	<input type="checkbox"/> Composite repair	<input type="checkbox"/> Pin/adhesive repair			
<input checked="" type="checkbox"/> Other:	Review and revise treatment program after excavation.					
VI. PHOTOGRAPHS						
Photo 1:			Photo 2:

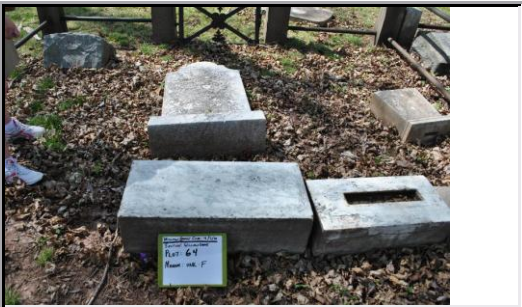
I. BURIAL INFORMATION					II. PRIORITIZATION	
First name	Last name	Birth	Death	Survey date	Condition	Prioritization
				4/7/2010	Fair	Short Term
III. LOCATION						
Cemetery Section	Plot/Marker Number	Original Location	Original Marker/Feature			
Willow Grove	064.F	Unknown	Yes			
IV. MARKER INFORMATION						
Marker Type						
Headstone w/ base		Height: 56	Width: 32	Depth: 14		
<input checked="" type="checkbox"/> Marble	<input type="checkbox"/> Granite	<input type="checkbox"/> Sandstone	<input type="checkbox"/> Slate			
<input type="checkbox"/> Brick	<input type="checkbox"/> Iron	<input type="checkbox"/> Other: _____

V. MATERIAL CONDITIONS						
<input checked="" type="checkbox"/> Biological - Algae	<input type="checkbox"/> Biological - Lichens	<input checked="" type="checkbox"/> Crack	<input type="checkbox"/> Delamination/Exfoliation			
<input checked="" type="checkbox"/> Disaggregation/Erosion	<input type="checkbox"/> Graffiti	<input type="checkbox"/> Off base (missing)	<input checked="" type="checkbox"/> Off base (adjacent)			
<input type="checkbox"/> Missing Fragment (s)	<input type="checkbox"/> Previous Repair	<input type="checkbox"/> Soiling	<input type="checkbox"/> Sunken			
<input type="checkbox"/> Tilt	<input type="checkbox"/> Corrosion					
<input checked="" type="checkbox"/> Other:	Marker fragments have been toppled and may constitute a safety hazard.					
VI. TREATMENT RECOMMENDATIONS						
<input checked="" type="checkbox"/> Archaeology	<input type="checkbox"/> Excavate	<input checked="" type="checkbox"/> Reset on exist base	<input type="checkbox"/> Reset on salvaged base (if poss)

<input checked="" type="checkbox"/> Clean/bio removal	<input type="checkbox"/> Consolidate	<input type="checkbox"/> Composite repair	<input type="checkbox"/> Pin/adhesive repair			
<input checked="" type="checkbox"/> Other:	Locate proper burial location. Re-set existing base on pea gravel/mortar pad. Reinstall headstone with pins to attach headstone to base.					
VI. PHOTOGRAPHS						
Photo 1:			Photo 2:

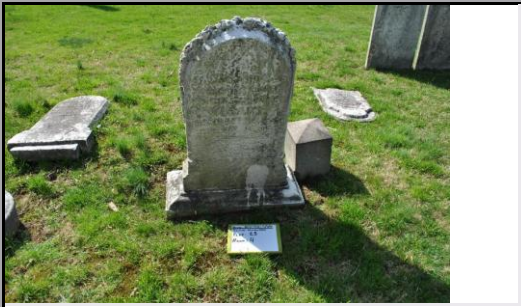
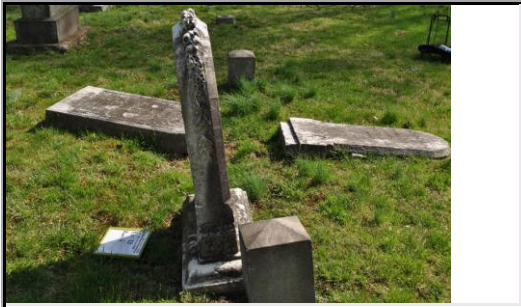
I. BURIAL INFORMATION					II. PRIORITIZATION	
First name	Last name	Birth	Death	Survey date	Condition	Prioritization
James Thomas	Hobart	1841	1857	4/7/2010	Fair	Short Term
III. LOCATION						
Cemetery Section	Plot/Marker Number	Original Location	Original Marker/Feature			
Willow Grove	025.04	Yes	Yes			
IV. MARKER INFORMATION						
Marker Type						
Headstone w/ base		Height: 44	Width: 33	Depth: 14		
<input checked="" type="checkbox"/> Marble	<input type="checkbox"/> Granite	<input type="checkbox"/> Sandstone	<input type="checkbox"/> Slate			
<input type="checkbox"/> Brick	<input type="checkbox"/> Iron	<input checked="" type="checkbox"/> Other: Concrete base

V. MATERIAL CONDITIONS						
<input checked="" type="checkbox"/> Biological - Algae	<input checked="" type="checkbox"/> Biological - Lichens	<input type="checkbox"/> Crack	<input type="checkbox"/> Delamination/Exfoliation			
<input type="checkbox"/> Disaggregation/Erosion	<input type="checkbox"/> Graffiti	<input type="checkbox"/> Off base (missing)	<input type="checkbox"/> Off base (adjacent)			
<input type="checkbox"/> Missing Fragment (s)	<input type="checkbox"/> Previous Repair	<input type="checkbox"/> Soiling	<input type="checkbox"/> Sunken			
<input checked="" type="checkbox"/> Tilt	<input type="checkbox"/> Corrosion					
<input type="checkbox"/> Other:						
VI. TREATMENT RECOMMENDATIONS						
<input type="checkbox"/> Archaeology	<input checked="" type="checkbox"/> Excavate	<input checked="" type="checkbox"/> Reset on exist base	<input type="checkbox"/> Reset on salvaged base (if poss)			
<input checked="" type="checkbox"/> Clean/bio removal	<input type="checkbox"/> Consolidate	<input type="checkbox"/> Composite repair	<input type="checkbox"/> Pin/adhesive repair

VII. ADDITIONAL INFORMATION						
Detailed floral band on top of marker is fairly unique within this cemetery.

<input checked="" type="checkbox"/> Other:	Immediate concern due to tilt, potential loss if marker collapses. Dismantle, install new mortar pad, re-set on stabilized ground. Archaeology may be required with ground disturbance.					
VI. PHOTOGRAPHS						
Photo 1:			Photo 2:

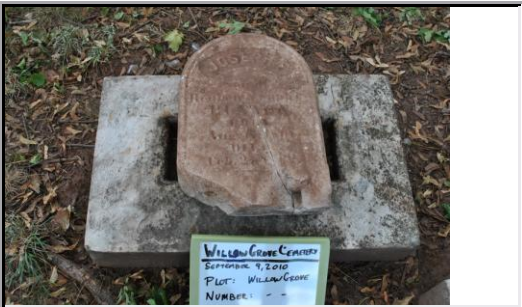
I. BURIAL INFORMATION					II. PRIORITIZATION	
First name	Last name	Birth	Death	Survey date	Condition	Prioritization
Joseph		0		9/9/2010	Fair	Short Term
III. LOCATION						
Cemetery Section	Plot/Marker Number	Original Location	Original Marker/Feature			
Willow Grove	067.07	Unknown	Yes			
IV. MARKER INFORMATION						
Marker Type						
Headstone w/ base Height: 16 Width: 12 Depth: 3						
<input checked="" type="checkbox"/> Marble	<input type="checkbox"/> Granite	<input type="checkbox"/> Sandstone	<input type="checkbox"/> Slate			
<input type="checkbox"/> Brick	<input type="checkbox"/> Iron	<input type="checkbox"/> Other: _____

V. MATERIAL CONDITIONS						
<input checked="" type="checkbox"/> Biological - Algae	<input checked="" type="checkbox"/> Biological - Lichens	<input checked="" type="checkbox"/> Crack	<input type="checkbox"/> Delamination/Exfoliation			
<input checked="" type="checkbox"/> Disaggregation/Erosion	<input type="checkbox"/> Graffiti	<input checked="" type="checkbox"/> Off base (missing)	<input type="checkbox"/> Off base (adjacent)			
<input checked="" type="checkbox"/> Missing Fragment (s)	<input type="checkbox"/> Previous Repair	<input checked="" type="checkbox"/> Soiling	<input type="checkbox"/> Sunken			
<input type="checkbox"/> Tilt	<input type="checkbox"/> Corrosion					
<input checked="" type="checkbox"/> Other:	Inscription is illegible due to erosion/soiling.					
VI. TREATMENT RECOMMENDATIONS						
<input type="checkbox"/> Archaeology	<input type="checkbox"/> Excavate	<input type="checkbox"/> Reset on exist base	<input checked="" type="checkbox"/> Reset on salvaged base (if poss)

VII. ADDITIONAL INFORMATION						
Headstone not associated with base it is lying on.

<input checked="" type="checkbox"/> Clean/bio removal	<input type="checkbox"/> Consolidate	<input checked="" type="checkbox"/> Composite repair	<input type="checkbox"/> Pin/adhesive repair			
<input checked="" type="checkbox"/> Other:	Marker is susceptible to vandalizm or theft. Record and store as soon as possible. Archaeology may be necessary to determine original location.					
VI. PHOTOGRAPHS						
Photo 1:			Photo 2:

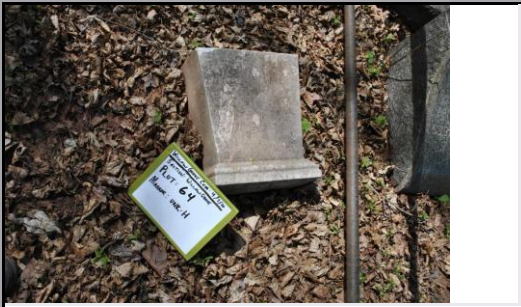
I. BURIAL INFORMATION					II. PRIORITIZATION	
First name	Last name	Birth	Death	Survey date	Condition	Prioritization
				4/7/2010	Fair	Short Term
III. LOCATION						
Cemetery Section	Plot/Marker Number	Original Location	Original Marker/Feature			
Willow Grove	064.H	Unknown	Yes			
IV. MARKER INFORMATION						
Marker Type						
Headstone w/ base		Height: 17	Width: 15	Depth: 8		
<input checked="" type="checkbox"/> Marble	<input type="checkbox"/> Granite	<input type="checkbox"/> Sandstone	<input type="checkbox"/> Slate			
<input type="checkbox"/> Brick	<input type="checkbox"/> Iron	<input type="checkbox"/> Other: _____

V. MATERIAL CONDITIONS						
<input checked="" type="checkbox"/> Biological - Algae	<input type="checkbox"/> Biological - Lichens	<input type="checkbox"/> Crack	<input type="checkbox"/> Delamination/Exfoliation			
<input type="checkbox"/> Disaggregation/Erosion	<input type="checkbox"/> Graffiti	<input checked="" type="checkbox"/> Off base (missing)	<input type="checkbox"/> Off base (adjacent)			
<input checked="" type="checkbox"/> Missing Fragment (s)	<input type="checkbox"/> Previous Repair	<input checked="" type="checkbox"/> Soiling	<input type="checkbox"/> Sunken			
<input type="checkbox"/> Tilt	<input type="checkbox"/> Corrosion					
<input checked="" type="checkbox"/> Other:	May be associated with other fragments in this section of the cemetery.					
VI. TREATMENT RECOMMENDATIONS						
<input type="checkbox"/> Archaeology	<input type="checkbox"/> Excavate	<input type="checkbox"/> Reset on exist base	<input checked="" type="checkbox"/> Reset on salvaged base (if poss)

<input checked="" type="checkbox"/> Clean/bio removal	<input type="checkbox"/> Consolidate	<input type="checkbox"/> Composite repair	<input type="checkbox"/> Pin/adhesive repair			
<input checked="" type="checkbox"/> Other:	Locate associated fragments. Locate proper burial location. Re-set existing base on pea gravel/mortar pad. Reinstall headstone with pins to attach headstone to base.					
VI. PHOTOGRAPHS						
Photo 1:			Photo 2:

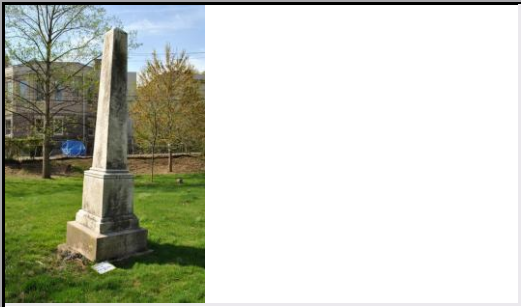
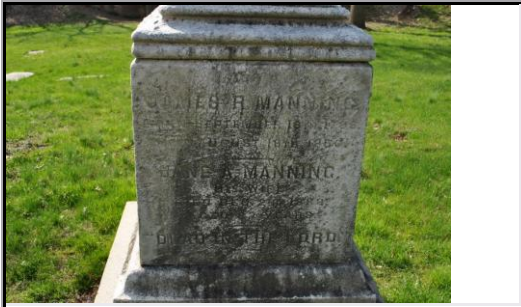
I. BURIAL INFORMATION					II. PRIORITIZATION	
First name	Last name	Birth	Death	Survey date	Condition	Prioritization
James R, Jane A	Manning	1798	1856	4/7/2010	Fair	Short Term
III. LOCATION						
Cemetery Section	Plot/Marker Number	Original Location	Original Marker/Feature			
Willow Grove	012.01	Yes	Yes			
IV. MARKER INFORMATION						
Marker Type	Height:	Width:	Depth:			
Obelisk	120	37	37			
<input checked="" type="checkbox"/> Marble	<input checked="" type="checkbox"/> Granite	<input type="checkbox"/> Sandstone	<input type="checkbox"/> Slate			
<input type="checkbox"/> Brick	<input type="checkbox"/> Iron	<input type="checkbox"/> Other:

V. MATERIAL CONDITIONS						
<input checked="" type="checkbox"/> Biological - Algae	<input type="checkbox"/> Biological - Lichens	<input type="checkbox"/> Crack	<input type="checkbox"/> Delamination/Exfoliation			
<input checked="" type="checkbox"/> Disaggregation/Erosion	<input type="checkbox"/> Graffiti	<input type="checkbox"/> Off base (missing)	<input type="checkbox"/> Off base (adjacent)			
<input type="checkbox"/> Missing Fragment (s)	<input type="checkbox"/> Previous Repair	<input type="checkbox"/> Soiling	<input type="checkbox"/> Sunken			
<input checked="" type="checkbox"/> Tilt	<input type="checkbox"/> Corrosion					
<input checked="" type="checkbox"/> Other:	Moderate tilt may present immediate risk for collapse and/or life safety.					
VI. TREATMENT RECOMMENDATIONS						
<input type="checkbox"/> Archaeology	<input type="checkbox"/> Excavate	<input checked="" type="checkbox"/> Reset on exist base	<input type="checkbox"/> Reset on salvaged base (if poss)

<input checked="" type="checkbox"/> Clean/bio removal	<input type="checkbox"/> Consolidate	<input type="checkbox"/> Composite repair	<input type="checkbox"/> Pin/adhesive repair			
<input checked="" type="checkbox"/> Other:	Recommend assessment in near future. Dismantle, stabilize ground, install new mortar pad, re-assemble, repoint and clean (if desired).					
VI. PHOTOGRAPHS						
Photo 1:			Photo 2:

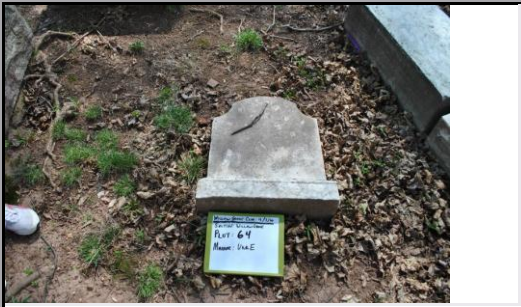
I. BURIAL INFORMATION					II. PRIORITIZATION	
First name	Last name	Birth	Death	Survey date	Condition	Prioritization
				4/7/2010	Fair	Short Term
III. LOCATION						
Cemetery Section	Plot/Marker Number	Original Location	Original Marker/Feature			
Willow Grove	064.E	Unknown	Yes			
IV. MARKER INFORMATION						
Marker Type						
Headstone w/ base		Height: 22	Width: 22	Depth: 6		
<input checked="" type="checkbox"/> Marble	<input type="checkbox"/> Granite	<input type="checkbox"/> Sandstone	<input type="checkbox"/> Slate			
<input type="checkbox"/> Brick	<input type="checkbox"/> Iron	<input type="checkbox"/> Other: _____

V. MATERIAL CONDITIONS						
<input checked="" type="checkbox"/> Biological - Algae	<input type="checkbox"/> Biological - Lichens	<input type="checkbox"/> Crack	<input type="checkbox"/> Delamination/Exfoliation			
<input type="checkbox"/> Disaggregation/Erosion	<input type="checkbox"/> Graffiti	<input checked="" type="checkbox"/> Off base (missing)	<input type="checkbox"/> Off base (adjacent)			
<input type="checkbox"/> Missing Fragment (s)	<input type="checkbox"/> Previous Repair	<input checked="" type="checkbox"/> Soiling	<input type="checkbox"/> Sunken			
<input type="checkbox"/> Tilt	<input type="checkbox"/> Corrosion					
<input checked="" type="checkbox"/> Other:	Marker has been removed from base, and moved from original location.					
VI. TREATMENT RECOMMENDATIONS						
<input checked="" type="checkbox"/> Archaeology	<input type="checkbox"/> Excavate	<input type="checkbox"/> Reset on exist base	<input checked="" type="checkbox"/> Reset on salvaged base (if poss)

<input checked="" type="checkbox"/> Clean/bio removal	<input type="checkbox"/> Consolidate	<input type="checkbox"/> Composite repair	<input type="checkbox"/> Pin/adhesive repair			
<input checked="" type="checkbox"/> Other:	Marker is susceptible to vandalism or theft. Record and store as soon as possible. Archaeology may be necessary to determine original location.					
VI. PHOTOGRAPHS						
Photo 1:			Photo 2:

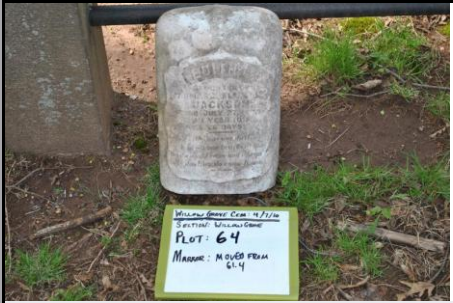
I. BURIAL INFORMATION					II. PRIORITIZATION	
First name	Last name	Birth	Death	Survey date	Condition	Prioritization
Edith	Jackson			4/7/2010	Fair	Short Term
III. LOCATION						
Cemetery Section	Plot/Marker Number	Original Location	Original Marker/Feature			
Willow Grove	061.04	No	Yes			
IV. MARKER INFORMATION						
Marker Type						
Headstone w/ base		Height: 16	Width: 10	Depth: 5		
<input checked="" type="checkbox"/> Marble	<input type="checkbox"/> Granite	<input type="checkbox"/> Sandstone	<input type="checkbox"/> Slate			
<input type="checkbox"/> Brick	<input type="checkbox"/> Iron	<input type="checkbox"/> Other: _____

V. MATERIAL CONDITIONS						
<input checked="" type="checkbox"/> Biological - Algae	<input type="checkbox"/> Biological - Lichens	<input type="checkbox"/> Crack	<input type="checkbox"/> Delamination/Exfoliation			
<input checked="" type="checkbox"/> Disaggregation/Erosion	<input type="checkbox"/> Graffiti	<input checked="" type="checkbox"/> Off base (missing)	<input type="checkbox"/> Off base (adjacent)			
<input type="checkbox"/> Missing Fragment (s)	<input type="checkbox"/> Previous Repair	<input type="checkbox"/> Soiling	<input type="checkbox"/> Sunken			
<input type="checkbox"/> Tilt	<input type="checkbox"/> Corrosion					
<input checked="" type="checkbox"/> Other:	Headstone has been removed from base, and moved from original location.					
VI. TREATMENT RECOMMENDATIONS						
<input type="checkbox"/> Archaeology	<input type="checkbox"/> Excavate	<input type="checkbox"/> Reset on exist base	<input checked="" type="checkbox"/> Reset on salvaged base (if poss)

<input checked="" type="checkbox"/> Clean/bio removal	<input type="checkbox"/> Consolidate	<input type="checkbox"/> Composite repair	<input type="checkbox"/> Pin/adhesive repair			
<input checked="" type="checkbox"/> Other:	Marker is susceptible to vandalism or theft. Record and store as soon as possible. Re-set on appropriate base if possible.					
VI. PHOTOGRAPHS						
Photo 1:			Photo 2:

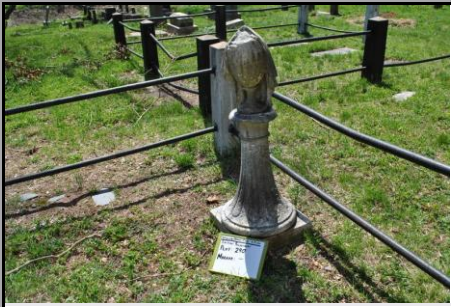
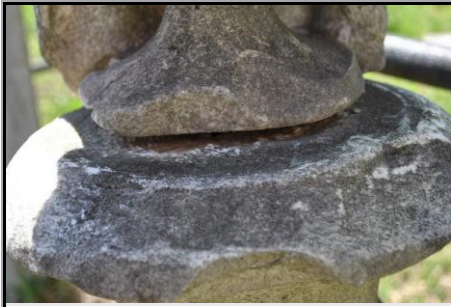
I. BURIAL INFORMATION					II. PRIORITIZATION	
First name	Last name	Birth	Death	Survey date	Condition	Prioritization
				4/7/2010	Fair	Short Term
III. LOCATION						
Cemetery Section	Plot/Marker Number	Original Location	Original Marker/Feature			
Presbyterian	292.02	Yes	Yes			
IV. MARKER INFORMATION						
Marker Type	Site Feature	Height:	Width:	Depth:		
		52				
<input checked="" type="checkbox"/> Marble	<input type="checkbox"/> Granite	<input type="checkbox"/> Sandstone	<input type="checkbox"/> Slate			
<input type="checkbox"/> Brick	<input type="checkbox"/> Iron	<input type="checkbox"/> Other: _____

V. MATERIAL CONDITIONS						
<input checked="" type="checkbox"/> Biological - Algae	<input checked="" type="checkbox"/> Biological - Lichens	<input type="checkbox"/> Crack	<input type="checkbox"/> Delamination/Exfoliation			
<input checked="" type="checkbox"/> Disaggregation/Erosion	<input type="checkbox"/> Graffiti	<input type="checkbox"/> Off base (missing)	<input type="checkbox"/> Off base (adjacent)			
<input checked="" type="checkbox"/> Missing Fragment (s)	<input type="checkbox"/> Previous Repair	<input checked="" type="checkbox"/> Soiling	<input type="checkbox"/> Sunken			
<input type="checkbox"/> Tilt	<input type="checkbox"/> Corrosion					
<input checked="" type="checkbox"/> Other:	Eagle statue on pedestal. Eagle head has been lost to vandalism. Joints between sections are missing.					
VI. TREATMENT RECOMMENDATIONS						
<input checked="" type="checkbox"/> Archaeology	<input type="checkbox"/> Excavate	<input type="checkbox"/> Reset on exist base	<input type="checkbox"/> Reset on salvaged base (if poss)

<input checked="" type="checkbox"/> Clean/bio removal	<input type="checkbox"/> Consolidate	<input checked="" type="checkbox"/> Composite repair	<input type="checkbox"/> Pin/adhesive repair			
<input checked="" type="checkbox"/> Other:	Immediate concern is stabilizing remainder of Eagle figure, which is loose and could be stolen. Consider archaeology to determine whether missing fragments are nearby; possible recreation if desired. Repoint.					
VI. PHOTOGRAPHS						
Photo 1:			Photo 2:

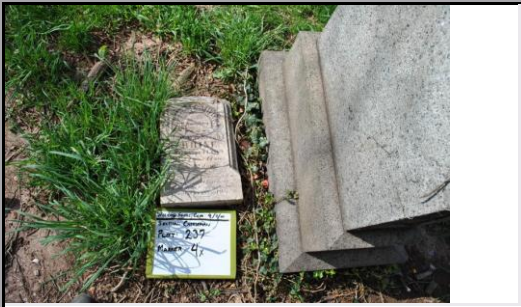
I. BURIAL INFORMATION					II. PRIORITIZATION	
First name	Last name	Birth	Death	Survey date	Condition	Prioritization
Little Julia	Rhine		1869	4/7/2010	Good	Short Term
III. LOCATION						
Cemetery Section	Plot/Marker Number	Original Location	Original Marker/Feature			
Cheesman	237.04.1	No	Yes			
IV. MARKER INFORMATION						
Marker Type						
Headstone w/ base		Height: 15	Width: 10	Depth: 3		
<input checked="" type="checkbox"/> Marble	<input type="checkbox"/> Granite	<input type="checkbox"/> Sandstone	<input type="checkbox"/> Slate			
<input type="checkbox"/> Brick	<input type="checkbox"/> Iron	<input type="checkbox"/> Other: _____

V. MATERIAL CONDITIONS						
<input type="checkbox"/> Biological - Algae	<input type="checkbox"/> Biological - Lichens	<input type="checkbox"/> Crack	<input type="checkbox"/> Delamination/Exfoliation			
<input checked="" type="checkbox"/> Disaggregation/Erosion	<input type="checkbox"/> Graffiti	<input checked="" type="checkbox"/> Off base (missing)	<input type="checkbox"/> Off base (adjacent)			
<input type="checkbox"/> Missing Fragment (s)	<input type="checkbox"/> Previous Repair	<input checked="" type="checkbox"/> Soiling	<input type="checkbox"/> Sunken			
<input type="checkbox"/> Tilt	<input type="checkbox"/> Corrosion					
<input type="checkbox"/> Other:	_____					
VI. TREATMENT RECOMMENDATIONS						
<input checked="" type="checkbox"/> Archaeology	<input type="checkbox"/> Excavate	<input type="checkbox"/> Reset on exist base	<input checked="" type="checkbox"/> Reset on salvaged base (if poss)

VII. ADDITIONAL INFORMATION						
Marker has been moved from its original location (Plot 102.2).

<input checked="" type="checkbox"/> Clean/bio removal	<input type="checkbox"/> Consolidate	<input type="checkbox"/> Composite repair	<input type="checkbox"/> Pin/adhesive repair			
<input checked="" type="checkbox"/> Other:	Marker is susceptible to theft or vandalism. Record and store immediately. Relocate to proper plot.					
VI. PHOTOGRAPHS						
Photo 1:			Photo 2:

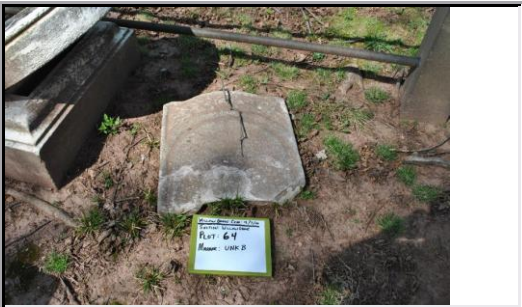
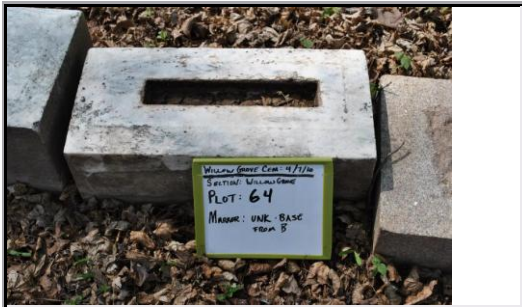
I. BURIAL INFORMATION					II. PRIORITIZATION	
First name	Last name	Birth	Death	Survey date	Condition	Prioritization
				4/7/2010	Poor	Short Term
III. LOCATION						
Cemetery Section	Plot/Marker Number	Original Location	Original Marker/Feature			
Willow Grove	064.B	Unknown	Yes			
IV. MARKER INFORMATION						
Marker Type						
Headstone w/ base		Height: 26	Width: 22	Depth: 4		
<input checked="" type="checkbox"/> Marble	<input type="checkbox"/> Granite	<input type="checkbox"/> Sandstone	<input type="checkbox"/> Slate			
<input type="checkbox"/> Brick	<input type="checkbox"/> Iron	<input type="checkbox"/> Other: _____

V. MATERIAL CONDITIONS						
<input checked="" type="checkbox"/> Biological - Algae	<input type="checkbox"/> Biological - Lichens	<input type="checkbox"/> Crack	<input type="checkbox"/> Delamination/Exfoliation			
<input type="checkbox"/> Disaggregation/Erosion	<input type="checkbox"/> Graffiti	<input type="checkbox"/> Off base (missing)	<input type="checkbox"/> Off base (adjacent)			
<input checked="" type="checkbox"/> Missing Fragment (s)	<input type="checkbox"/> Previous Repair	<input type="checkbox"/> Soiling	<input type="checkbox"/> Sunken			
<input type="checkbox"/> Tilt	<input type="checkbox"/> Corrosion					
<input checked="" type="checkbox"/> Other:	Marker has been removed from base, and moved from original location.					
VI. TREATMENT RECOMMENDATIONS						
<input type="checkbox"/> Archaeology	<input type="checkbox"/> Excavate	<input type="checkbox"/> Reset on exist base	<input type="checkbox"/> Reset on salvaged base (if poss)

<input checked="" type="checkbox"/> Clean/bio removal	<input type="checkbox"/> Consolidate	<input type="checkbox"/> Composite repair	<input type="checkbox"/> Pin/adhesive repair			
<input checked="" type="checkbox"/> Other:	Marker is susceptible to vandalism or theft. Record and store as soon as possible. There is probably not enough material left to restore this marker.					
VI. PHOTOGRAPHS						
Photo 1:			Photo 2:

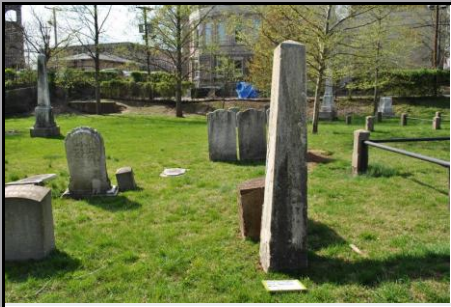
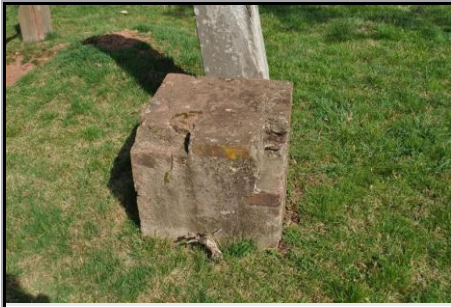
I. BURIAL INFORMATION					II. PRIORITIZATION	
First name	Last name	Birth	Death	Survey date	Condition	Prioritization
				4/7/2010	Poor	Short Term
III. LOCATION						
Cemetery Section	Plot/Marker Number	Original Location	Original Marker/Feature			
Willow Grove	025.06	Unknown	Yes			
IV. MARKER INFORMATION						
Marker Type						
Obelisk	Height: 72	Width: 12	Depth: 12			
<input checked="" type="checkbox"/> Marble	<input type="checkbox"/> Granite	<input checked="" type="checkbox"/> Sandstone	<input type="checkbox"/> Slate			
<input type="checkbox"/> Brick	<input type="checkbox"/> Iron	<input checked="" type="checkbox"/> Other: Marble obelisk off of sandstone base.

V. MATERIAL CONDITIONS						
<input checked="" type="checkbox"/> Biological - Algae	<input checked="" type="checkbox"/> Biological - Lichens	<input type="checkbox"/> Crack	<input type="checkbox"/> Delamination/Exfoliation			
<input checked="" type="checkbox"/> Disaggregation/Erosion	<input type="checkbox"/> Graffiti	<input type="checkbox"/> Off base (missing)	<input type="checkbox"/> Off base (adjacent)			
<input checked="" type="checkbox"/> Missing Fragment (s)	<input type="checkbox"/> Previous Repair	<input type="checkbox"/> Soiling	<input type="checkbox"/> Sunken			
<input checked="" type="checkbox"/> Tilt	<input type="checkbox"/> Corrosion					
<input checked="" type="checkbox"/> Other:	The stability of the obelisk, which has been set into the ground adjacent to the base from which it has been removed is unclear.					
VI. TREATMENT RECOMMENDATIONS						
<input checked="" type="checkbox"/> Archaeology	<input checked="" type="checkbox"/> Excavate	<input checked="" type="checkbox"/> Reset on exist base	<input type="checkbox"/> Reset on salvaged base (if poss)

<input checked="" type="checkbox"/> Clean/bio removal	<input type="checkbox"/> Consolidate	<input type="checkbox"/> Composite repair	<input type="checkbox"/> Pin/adhesive repair			
<input checked="" type="checkbox"/> Other:	Immediate concern due to tilt, potential loss if marker collapses. Dismantle, install new mortar pad, re-set on stabilized ground. Archaeology may be required with ground disturbance.					
VI. PHOTOGRAPHS						
Photo 1:			Photo 2:

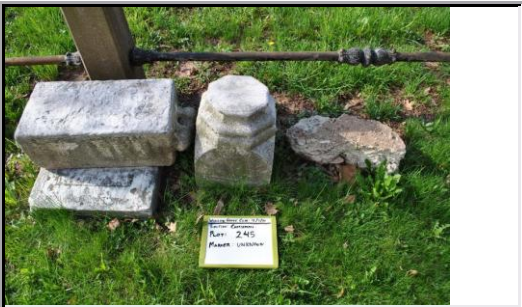
I. BURIAL INFORMATION					II. PRIORITIZATION	
First name	Last name	Birth	Death	Survey date	Condition	Prioritization
				4/7/2010	Poor	Short Term
III. LOCATION						
Cemetery Section	Plot/Marker Number	Original Location	Original Marker/Feature			
Cheesman	245.02	Unknown	Yes			
IV. MARKER INFORMATION						
Marker Type						
Headstone w/ base Height: <input type="text"/> Width: <input type="text"/> Depth: <input type="text"/>						
<input checked="" type="checkbox"/> Marble	<input type="checkbox"/> Granite	<input type="checkbox"/> Sandstone	<input type="checkbox"/> Slate			
<input type="checkbox"/> Brick	<input type="checkbox"/> Iron	<input checked="" type="checkbox"/> Other: <input type="text" value="Concrete"/>

V. MATERIAL CONDITIONS						
<input checked="" type="checkbox"/> Biological - Algae	<input type="checkbox"/> Biological - Lichens	<input type="checkbox"/> Crack	<input type="checkbox"/> Delamination/Exfoliation			
<input checked="" type="checkbox"/> Disaggregation/Erosion	<input type="checkbox"/> Graffiti	<input checked="" type="checkbox"/> Off base (missing)	<input checked="" type="checkbox"/> Off base (adjacent)			
<input checked="" type="checkbox"/> Missing Fragment (s)	<input type="checkbox"/> Previous Repair	<input checked="" type="checkbox"/> Soiling	<input type="checkbox"/> Sunken			
<input type="checkbox"/> Tilt	<input type="checkbox"/> Corrosion					
<input checked="" type="checkbox"/> Other:	<input type="text" value="Fragments may be from multiple markers. One fragment has an animal figure on top, possibly marker for a child's grave."/>					
VI. TREATMENT RECOMMENDATIONS						
<input checked="" type="checkbox"/> Archaeology	<input type="checkbox"/> Excavate	<input type="checkbox"/> Reset on exist base	<input type="checkbox"/> Reset on salvaged base (if poss)

<input checked="" type="checkbox"/> Clean/bio removal	<input type="checkbox"/> Consolidate	<input type="checkbox"/> Composite repair	<input type="checkbox"/> Pin/adhesive repair			
<input checked="" type="checkbox"/> Other:	<input type="text" value="Archaeology and inventory to locate missing fragments. Fragments are at risk of theft or vandalism, should be recorded and stored immediately."/>					
VI. PHOTOGRAPHS						
Photo 1:			Photo 2:

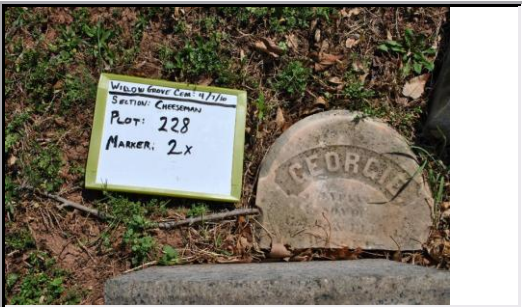
I. BURIAL INFORMATION					II. PRIORITIZATION	
First name	Last name	Birth	Death	Survey date	Condition	Prioritization
Georgie		0		4/7/2010	Poor	Short Term
III. LOCATION						
Cemetery Section	Plot/Marker Number	Original Location	Original Marker/Feature			
Cheesman	228.02.1	No	Yes			
IV. MARKER INFORMATION						
Marker Type						
Headstone w/ base		Height: 12	Width: 12	Depth: 3		
<input checked="" type="checkbox"/> Marble	<input type="checkbox"/> Granite	<input type="checkbox"/> Sandstone	<input type="checkbox"/> Slate			
<input type="checkbox"/> Brick	<input type="checkbox"/> Iron	<input type="checkbox"/> Other: _____

V. MATERIAL CONDITIONS						
<input checked="" type="checkbox"/> Biological - Algae	<input type="checkbox"/> Biological - Lichens	<input type="checkbox"/> Crack	<input type="checkbox"/> Delamination/Exfoliation			
<input checked="" type="checkbox"/> Disaggregation/Erosion	<input type="checkbox"/> Graffiti	<input checked="" type="checkbox"/> Off base (missing)	<input type="checkbox"/> Off base (adjacent)			
<input checked="" type="checkbox"/> Missing Fragment (s)	<input type="checkbox"/> Previous Repair	<input checked="" type="checkbox"/> Soiling	<input type="checkbox"/> Sunken			
<input type="checkbox"/> Tilt	<input type="checkbox"/> Corrosion					
<input checked="" type="checkbox"/> Other:	Fragment only.					
VI. TREATMENT RECOMMENDATIONS						
<input type="checkbox"/> Archaeology	<input type="checkbox"/> Excavate	<input type="checkbox"/> Reset on exist base	<input type="checkbox"/> Reset on salvaged base (if poss)

VII. ADDITIONAL INFORMATION						
Fragment only. Marker most likely does not belong to this family plot.

<input checked="" type="checkbox"/> Clean/bio removal	<input type="checkbox"/> Consolidate	<input type="checkbox"/> Composite repair	<input type="checkbox"/> Pin/adhesive repair			
<input checked="" type="checkbox"/> Other:	Treatment to be determined based on location of other fragments.					
VI. PHOTOGRAPHS						
Photo 1:			Photo 2:

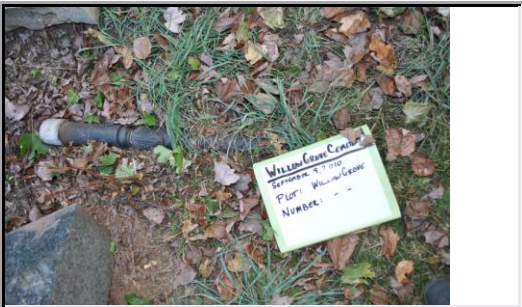
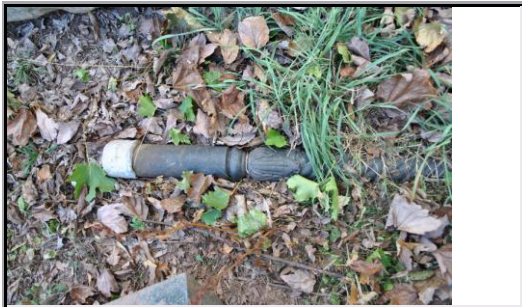
I. BURIAL INFORMATION					II. PRIORITIZATION	
First name	Last name	Birth	Death	Survey date	Condition	Prioritization
		0		9/9/2010	Poor	Short Term
III. LOCATION						
Cemetery Section	Plot/Marker Number	Original Location	Original Marker/Feature			
Willow Grove	133.12	Unknown	Yes			
IV. MARKER INFORMATION						
Marker Type	Site Feature	Height:	Width:	Depth:		
<input type="checkbox"/> Marble	<input type="checkbox"/> Granite	<input type="checkbox"/> Sandstone	<input type="checkbox"/> Slate			
<input type="checkbox"/> Brick	<input checked="" type="checkbox"/> Iron	<input type="checkbox"/> Other: _____

V. MATERIAL CONDITIONS						
<input type="checkbox"/> Biological - Algae	<input type="checkbox"/> Biological - Lichens	<input type="checkbox"/> Crack	<input type="checkbox"/> Delamination/Exfoliation			
<input type="checkbox"/> Disaggregation/Erosion	<input type="checkbox"/> Graffiti	<input type="checkbox"/> Off base (missing)	<input type="checkbox"/> Off base (adjacent)			
<input type="checkbox"/> Missing Fragment (s)	<input type="checkbox"/> Previous Repair	<input type="checkbox"/> Soiling	<input type="checkbox"/> Sunken			
<input type="checkbox"/> Tilt	<input checked="" type="checkbox"/> Corrosion					
<input type="checkbox"/> Other:	_____					
VI. TREATMENT RECOMMENDATIONS						
<input type="checkbox"/> Archaeology	<input checked="" type="checkbox"/> Excavate	<input type="checkbox"/> Reset on exist base	<input type="checkbox"/> Reset on salvaged base (if poss)			
<input type="checkbox"/> Clean/bio removal	<input type="checkbox"/> Consolidate	<input type="checkbox"/> Composite repair	<input type="checkbox"/> Pin/adhesive repair

<input checked="" type="checkbox"/> Other:	Susceptible to vandalizm or theft. Record and store as soon as possible. Archaeology may be necessary to determine original location.					
VI. PHOTOGRAPHS						
Photo 1:			Photo 2:

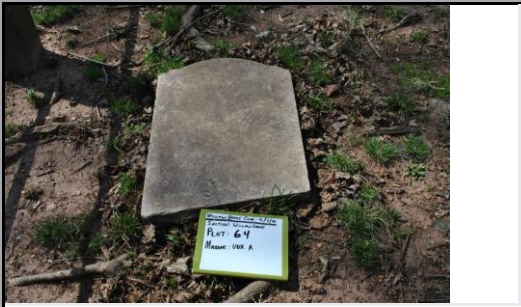
I. BURIAL INFORMATION					II. PRIORITIZATION	
First name	Last name	Birth	Death	Survey date	Condition	Prioritization
				4/7/2010	Poor	Short Term
III. LOCATION						
Cemetery Section	Plot/Marker Number	Original Location	Original Marker/Feature			
Willow Grove	064.A	Unknown	Yes			
IV. MARKER INFORMATION						
Marker Type						
Headstone w/ base		Height: 30	Width: 22	Depth: 3		
<input checked="" type="checkbox"/> Marble	<input type="checkbox"/> Granite	<input type="checkbox"/> Sandstone	<input type="checkbox"/> Slate			
<input type="checkbox"/> Brick	<input type="checkbox"/> Iron	<input type="checkbox"/> Other: _____

V. MATERIAL CONDITIONS						
<input checked="" type="checkbox"/> Biological - Algae	<input type="checkbox"/> Biological - Lichens	<input type="checkbox"/> Crack	<input type="checkbox"/> Delamination/Exfoliation			
<input type="checkbox"/> Disaggregation/Erosion	<input type="checkbox"/> Graffiti	<input checked="" type="checkbox"/> Off base (missing)	<input type="checkbox"/> Off base (adjacent)			
<input checked="" type="checkbox"/> Missing Fragment (s)	<input type="checkbox"/> Previous Repair	<input checked="" type="checkbox"/> Soiling	<input type="checkbox"/> Sunken			
<input type="checkbox"/> Tilt	<input type="checkbox"/> Corrosion					
<input checked="" type="checkbox"/> Other:	Marker has been removed from base, and moved from original location.					
VI. TREATMENT RECOMMENDATIONS						
<input checked="" type="checkbox"/> Archaeology	<input type="checkbox"/> Excavate	<input type="checkbox"/> Reset on exist base	<input type="checkbox"/> Reset on salvaged base (if poss)

<input checked="" type="checkbox"/> Clean/bio removal	<input type="checkbox"/> Consolidate	<input type="checkbox"/> Composite repair	<input type="checkbox"/> Pin/adhesive repair			
<input checked="" type="checkbox"/> Other:	Marker is susceptible to vandalizm or theft. Record and store as soon as possible. Archaeology may be necessary to determine original location. Repair bottom and reset on appropriate base if possible.					
VI. PHOTOGRAPHS						
Photo 1:			Photo 2:
