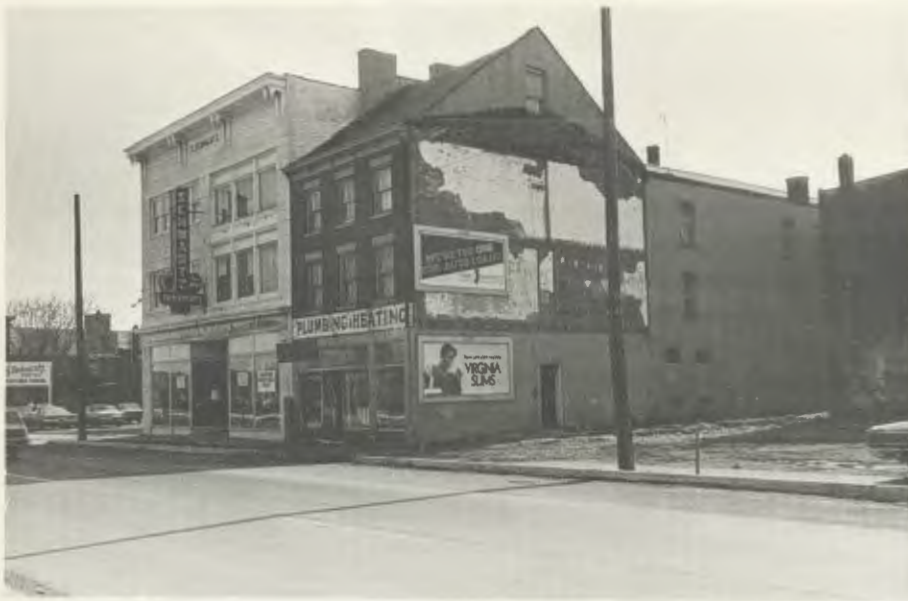
16.

Memorial Parkway looking south from Hiram Street. Although a pleasing example of its period, this older Federal building (c. 1820) has been isolated by vacant lots and the more recent (c. 1910) commercial building adjacent to it.

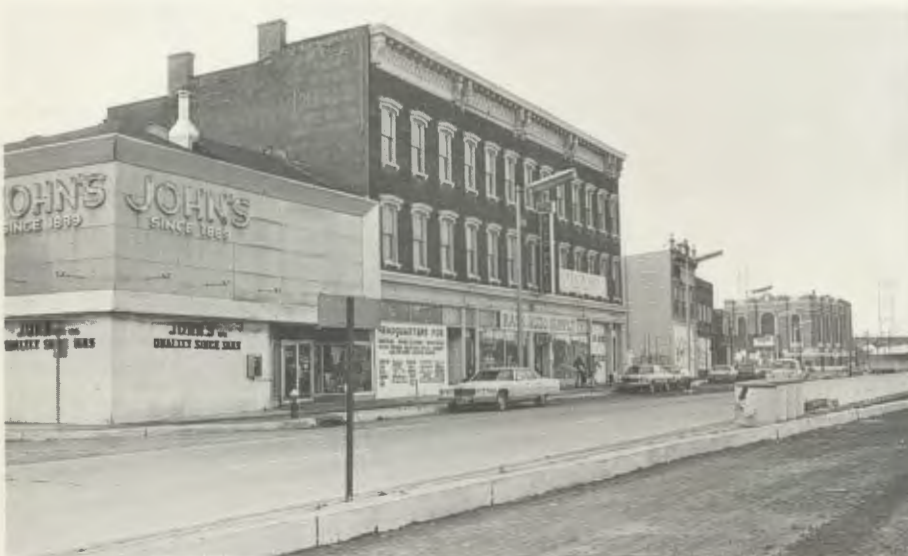
17.

Memorial Parkway looking north from Hiram Street. As with all too many of the few more pleasingly designed buildings in the area, the Victorian King block is surrounded by unsympathetically remodelled buildings (e.g., John's) and vacant lots.

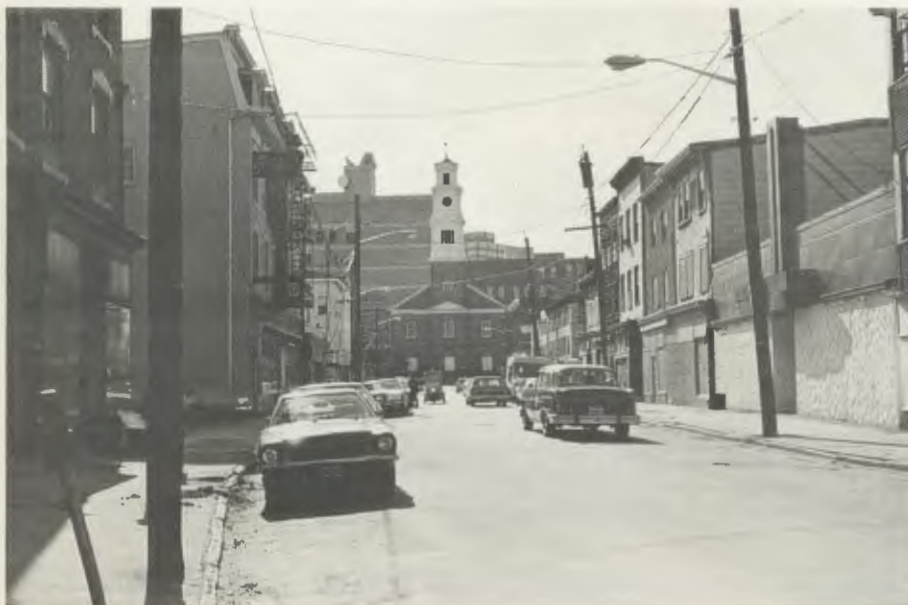
18.

Hiram Street looking west from Memorial Parkway. The hodge-podge of routinely designed, deteriorating buildings forms an unfortunate foreground for the historic Reformed Church, which already has the burden of fighting its backdrop.
